2019 NDACE Conference Bridge Rehab with Local Forces

Nick West, PE
Grand Forks County Engineer

GRAND FORKS
COUNTY
HEART OF THE RED RIVER VALLEY

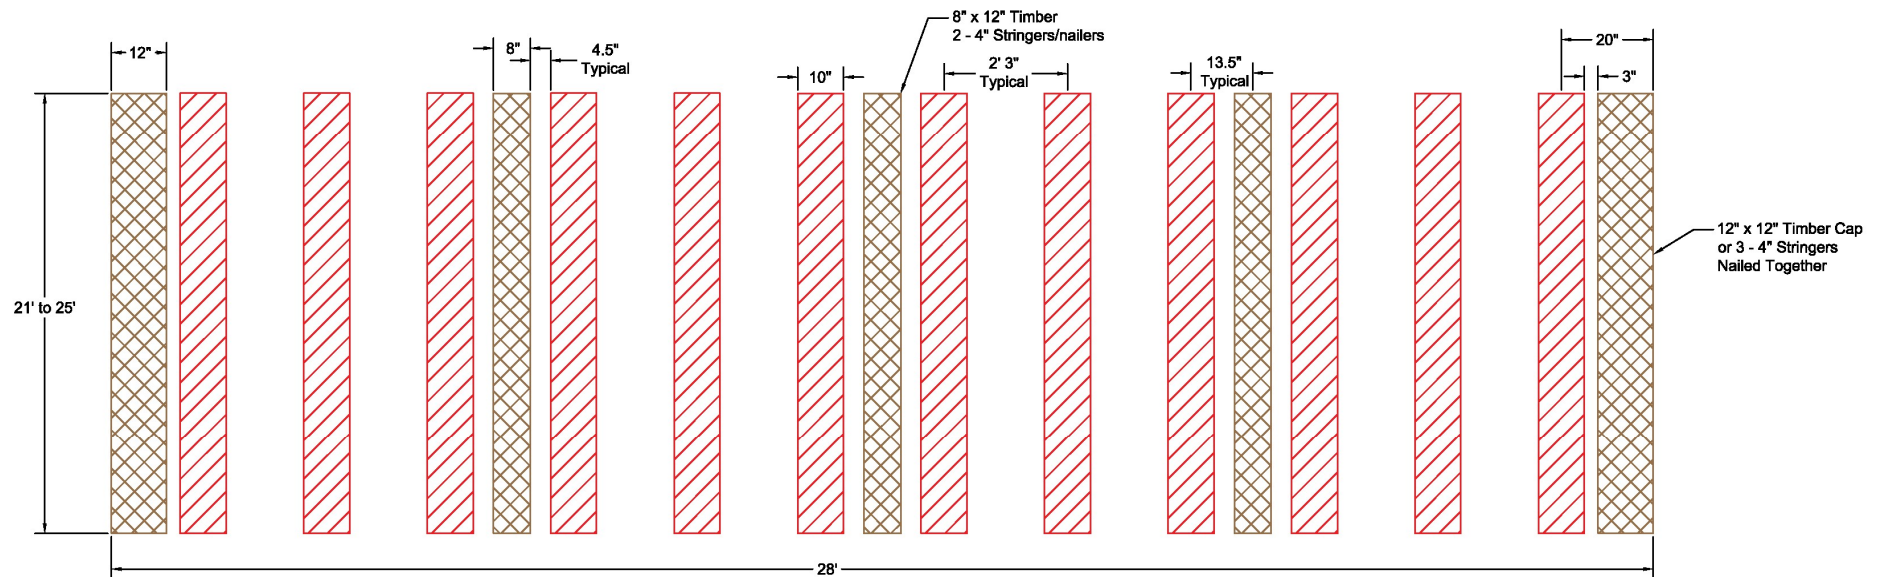
28' Wide Bridge Superstructure Rehabilitation Layout
Span - 21' to 25'
W12x53

W12x53, 10" Flange Width, 12 Each
Rough-Sawn Treated Timber

Maximum allowable metal beam spacing shall be 30". If gravel overburden is expected to be greater than 3", then space beams closer. Spacing is based on a 4" timber deck.

All existing timber shall be inspected for replacement, including wings.

Provide center span sway brace.

Provide angle iron bracket welded under beams and bolted to cap.

Provide angle iron bracket welded above and behind beams.

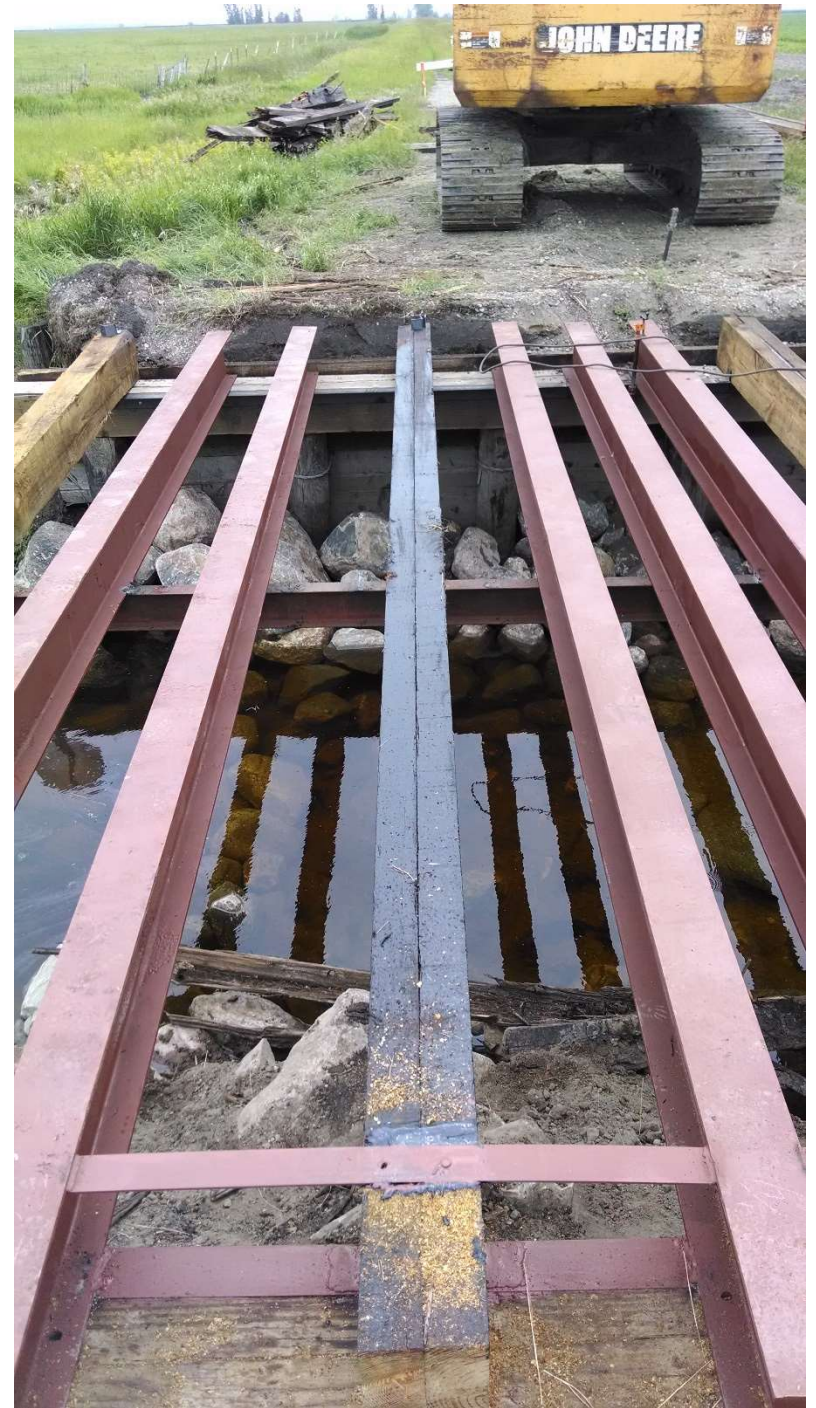
Not Like This

Keep Metal Beam
Spacing Equal

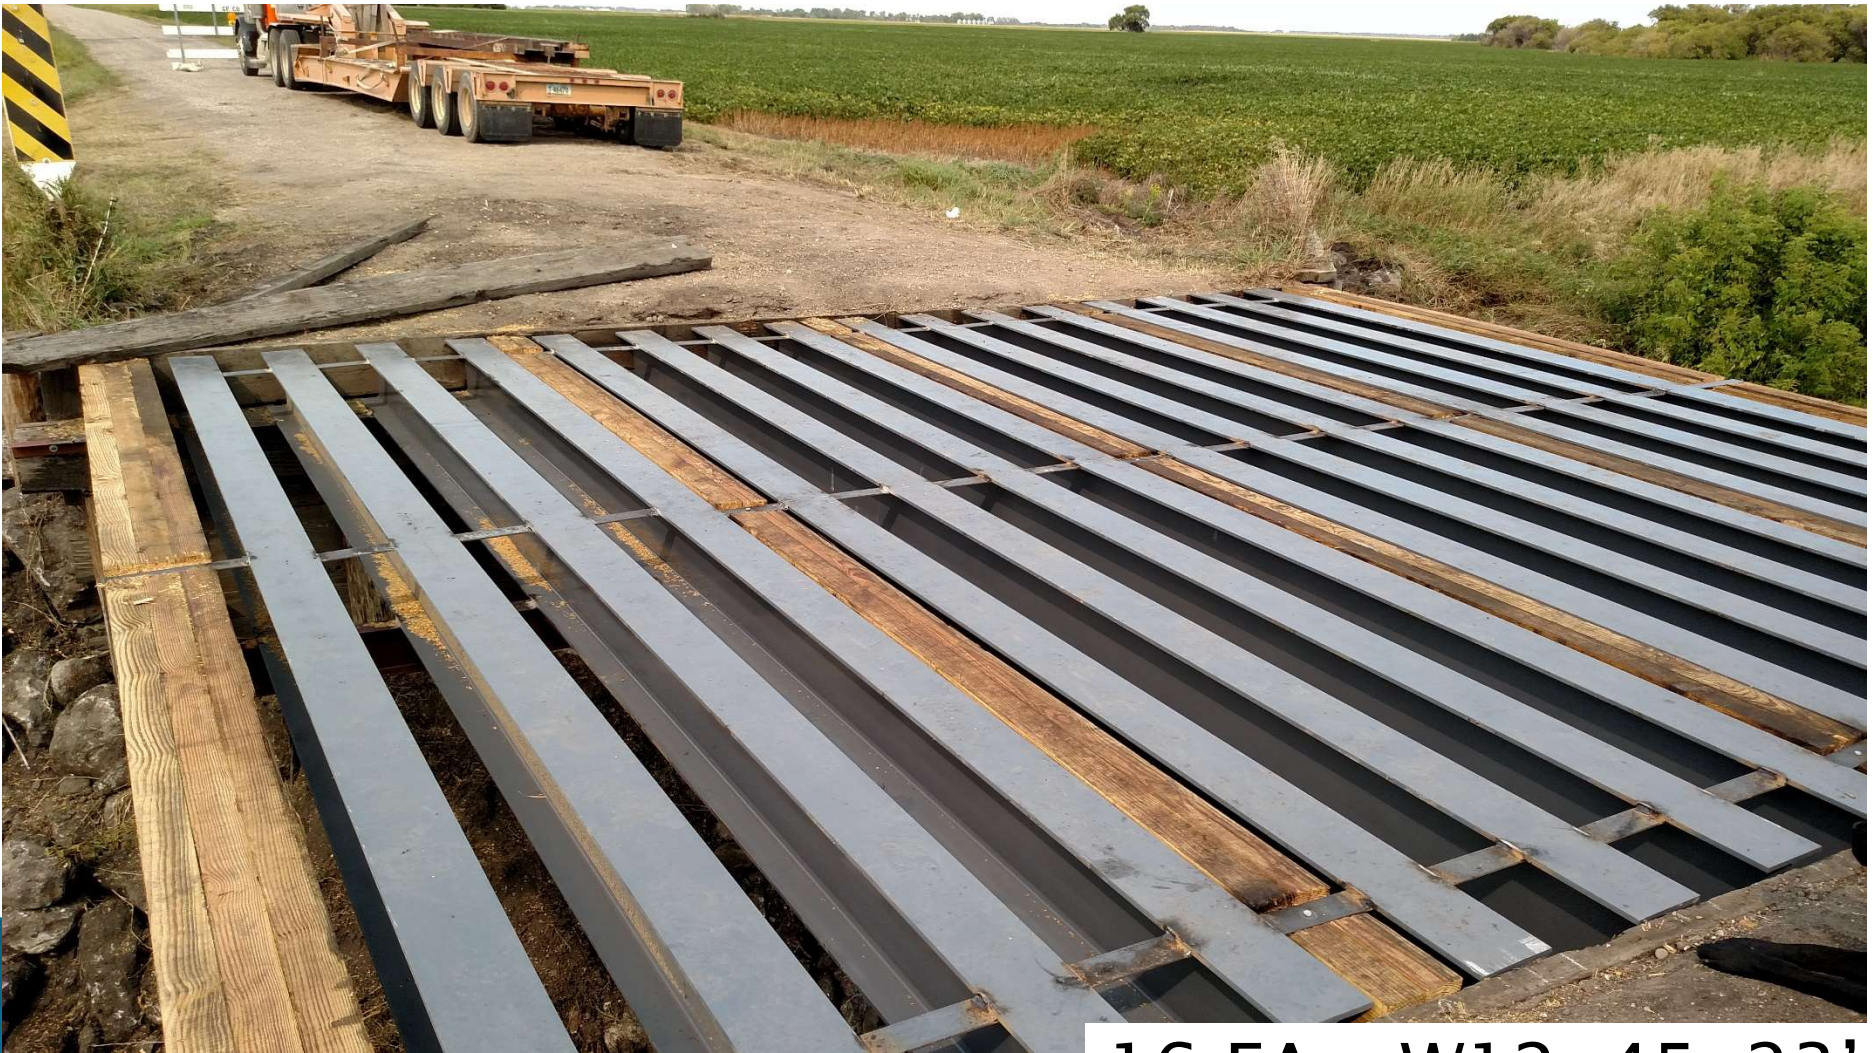
135-34.0 Beam Layout

16 EA - W12x45x23'

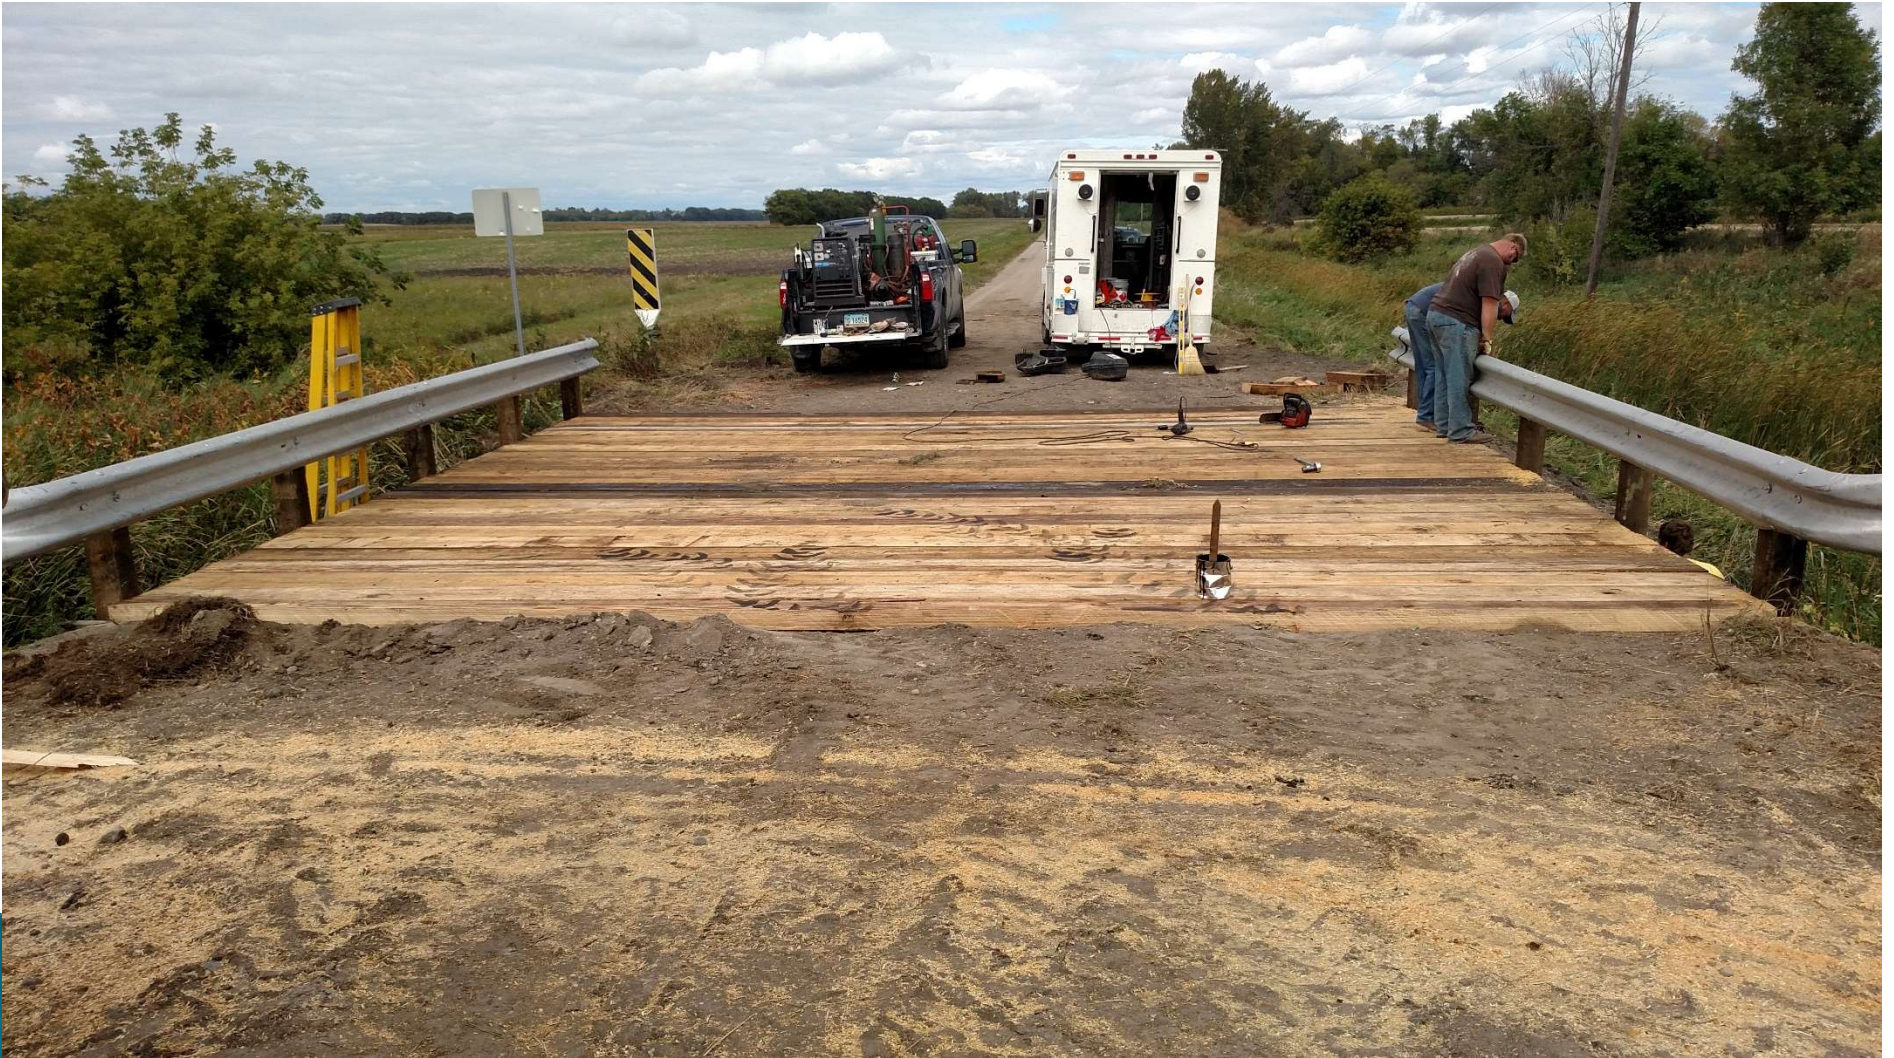
135-34.0 – After

Before	After
Sufficiency Rating	48	97
Condition Deck	7 Good	9 Excellent
Condition Super	6 Satisfactory	9 Excellent
Condition Substructure	6 Satisfactory	7 Good
Operating Rating	8 Tons	96 Tons
Inventory Rating	5 Tons	58 Tons

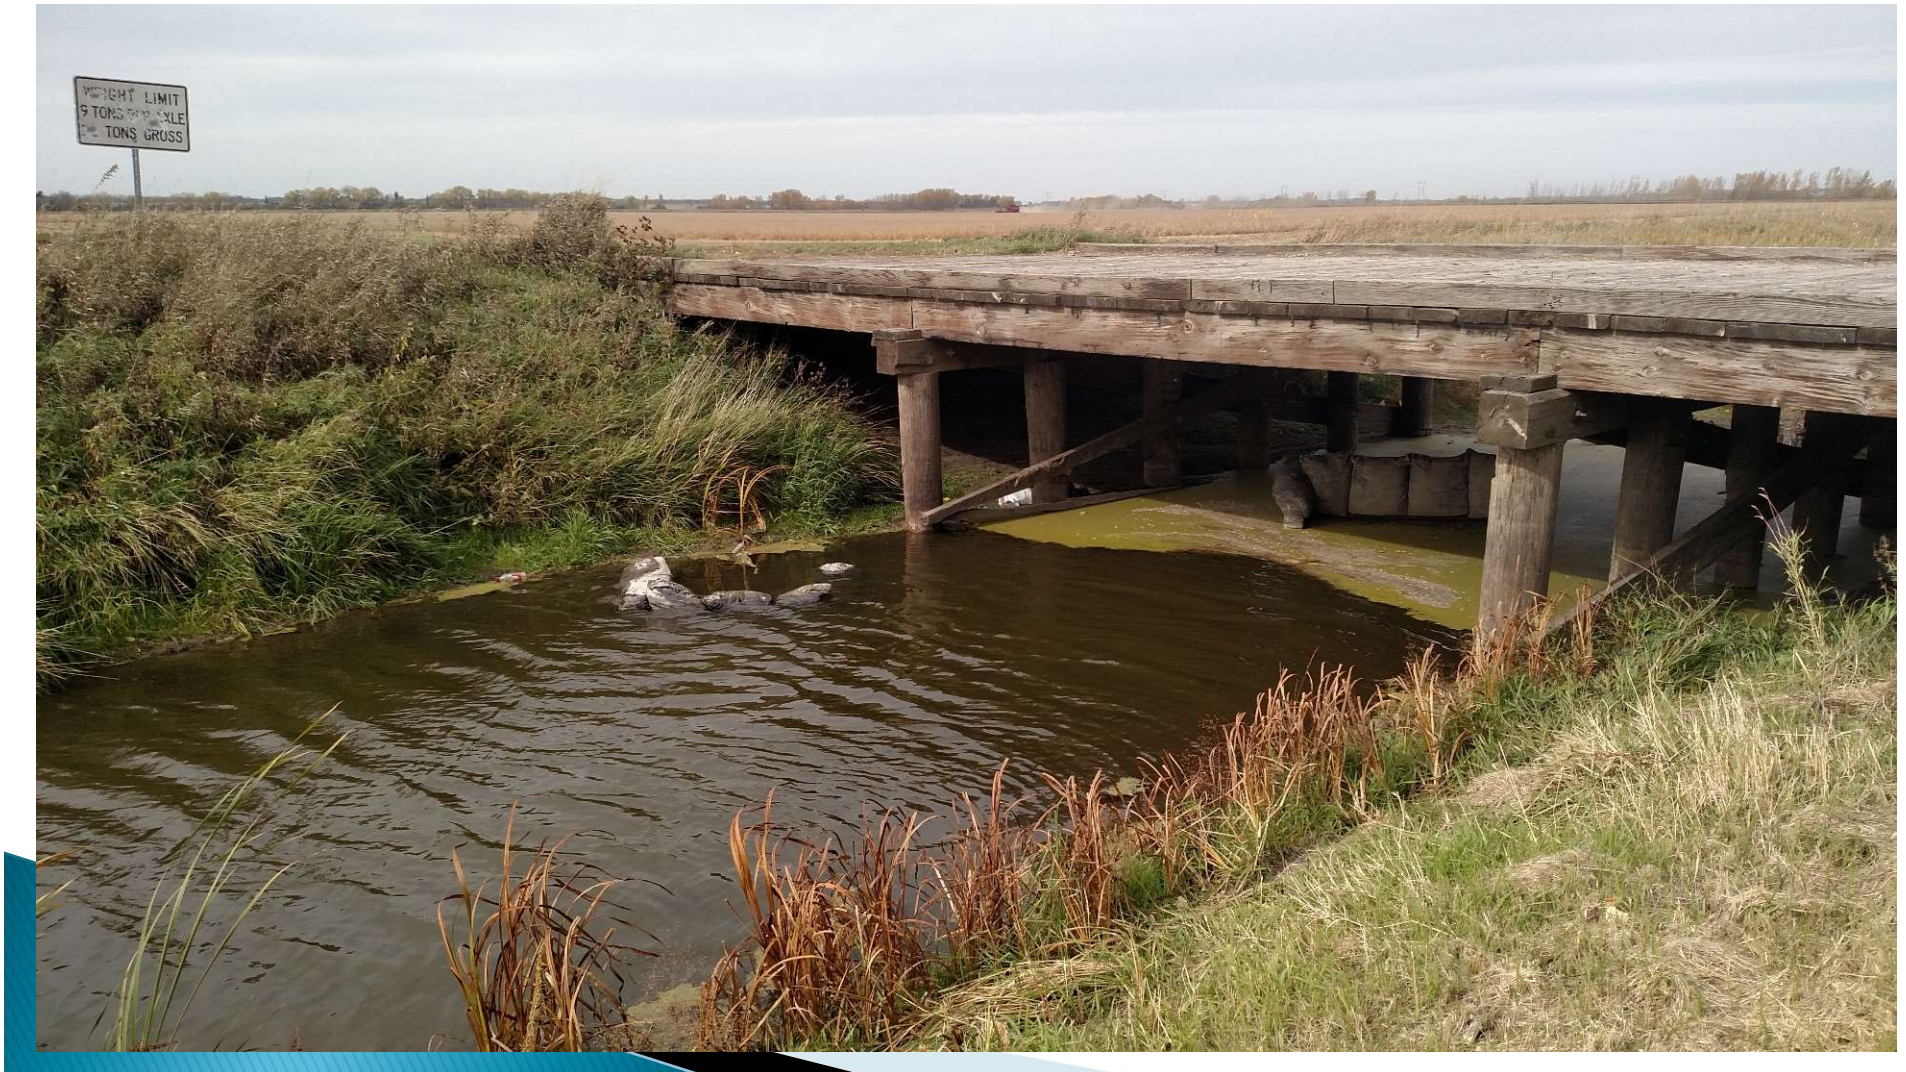
Triple Span Timber – Before Deteriorated Stingers

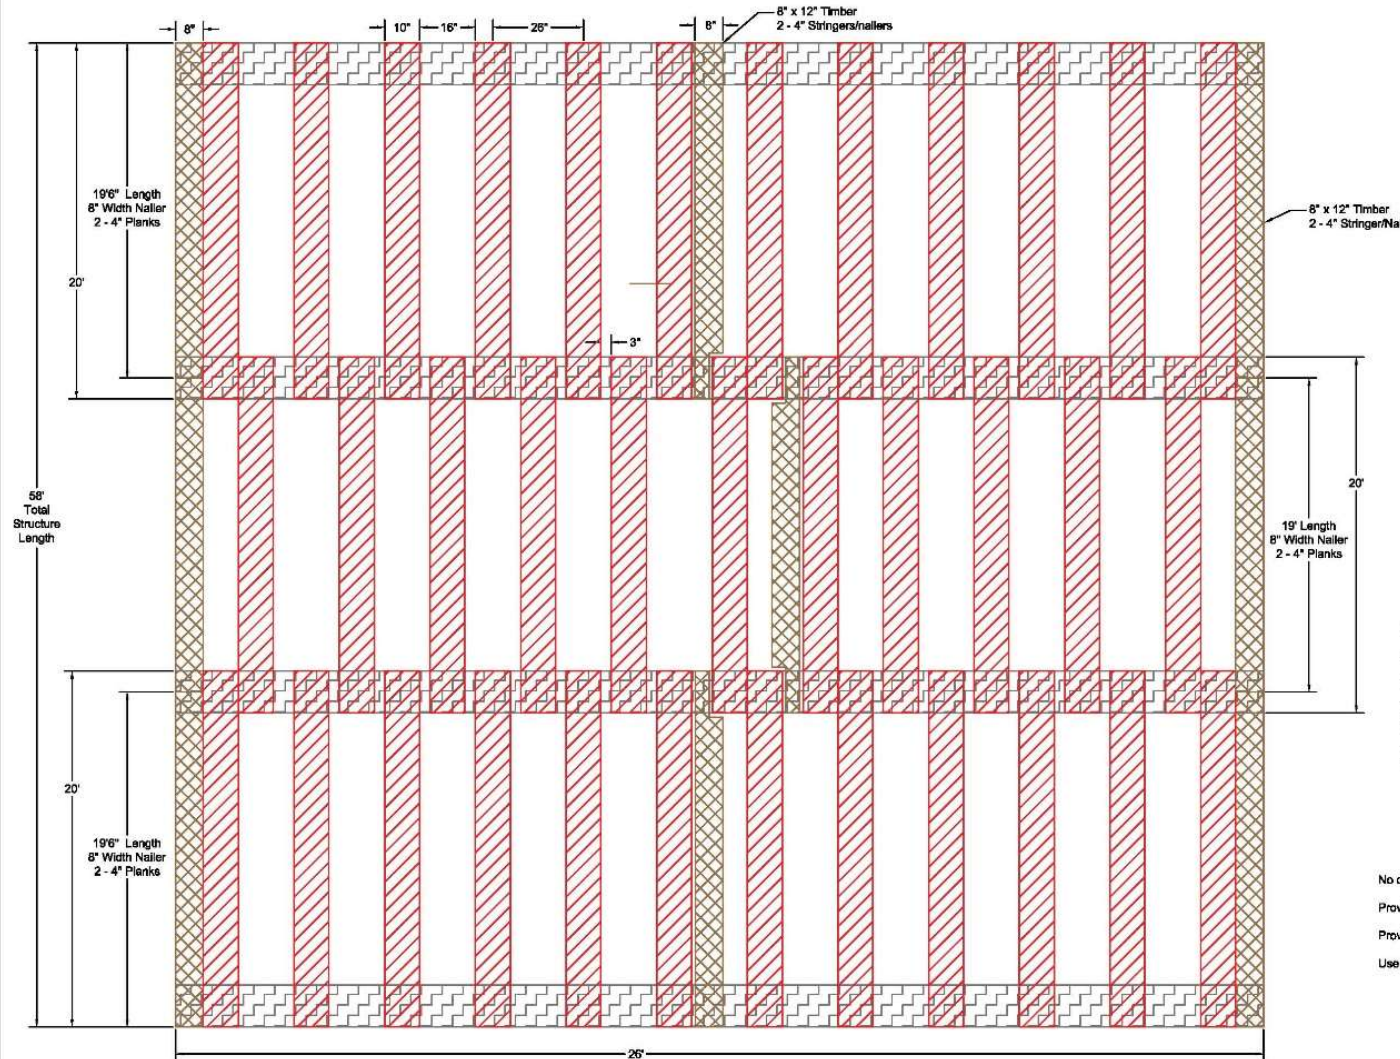
Triple Span Timber – Layout

26' Wide Bridge Superstructure Rehabilitation Layout
 Triple Span
 Clear Span - 18', W12x53 Beam Length 20'
 Larimore 4-8, 110-19.0

-   W12x53, 10" Flange Width, 20' Length, 35 Total
-   Rough-Sawn Treated Timber
-   Existing Timber Cap Abutment/Pier

- Existing 4"x14" Timber Stringers to be salvaged and returned to yard
 - Reuse Existing Timber Caps on Abutments and Piers
 - Coat all Existing Timber and Cut Edges with Copper Naphthenate
 - Existing 3" Timber Deck - Salvage and reuse what we can. Replace bad decking with used 3" decking from inventory in yard
 - Existing Timber Curb Railing - Try to Salvage and reuse, otherwise install new
- No center span sway braces.
- Provide angle iron bracket welded under beams and bolted to caps.
 - Provide angle iron bracket welded above and behind beams.
 - Use used salvaged timber stringers to replace pier cross bracing.

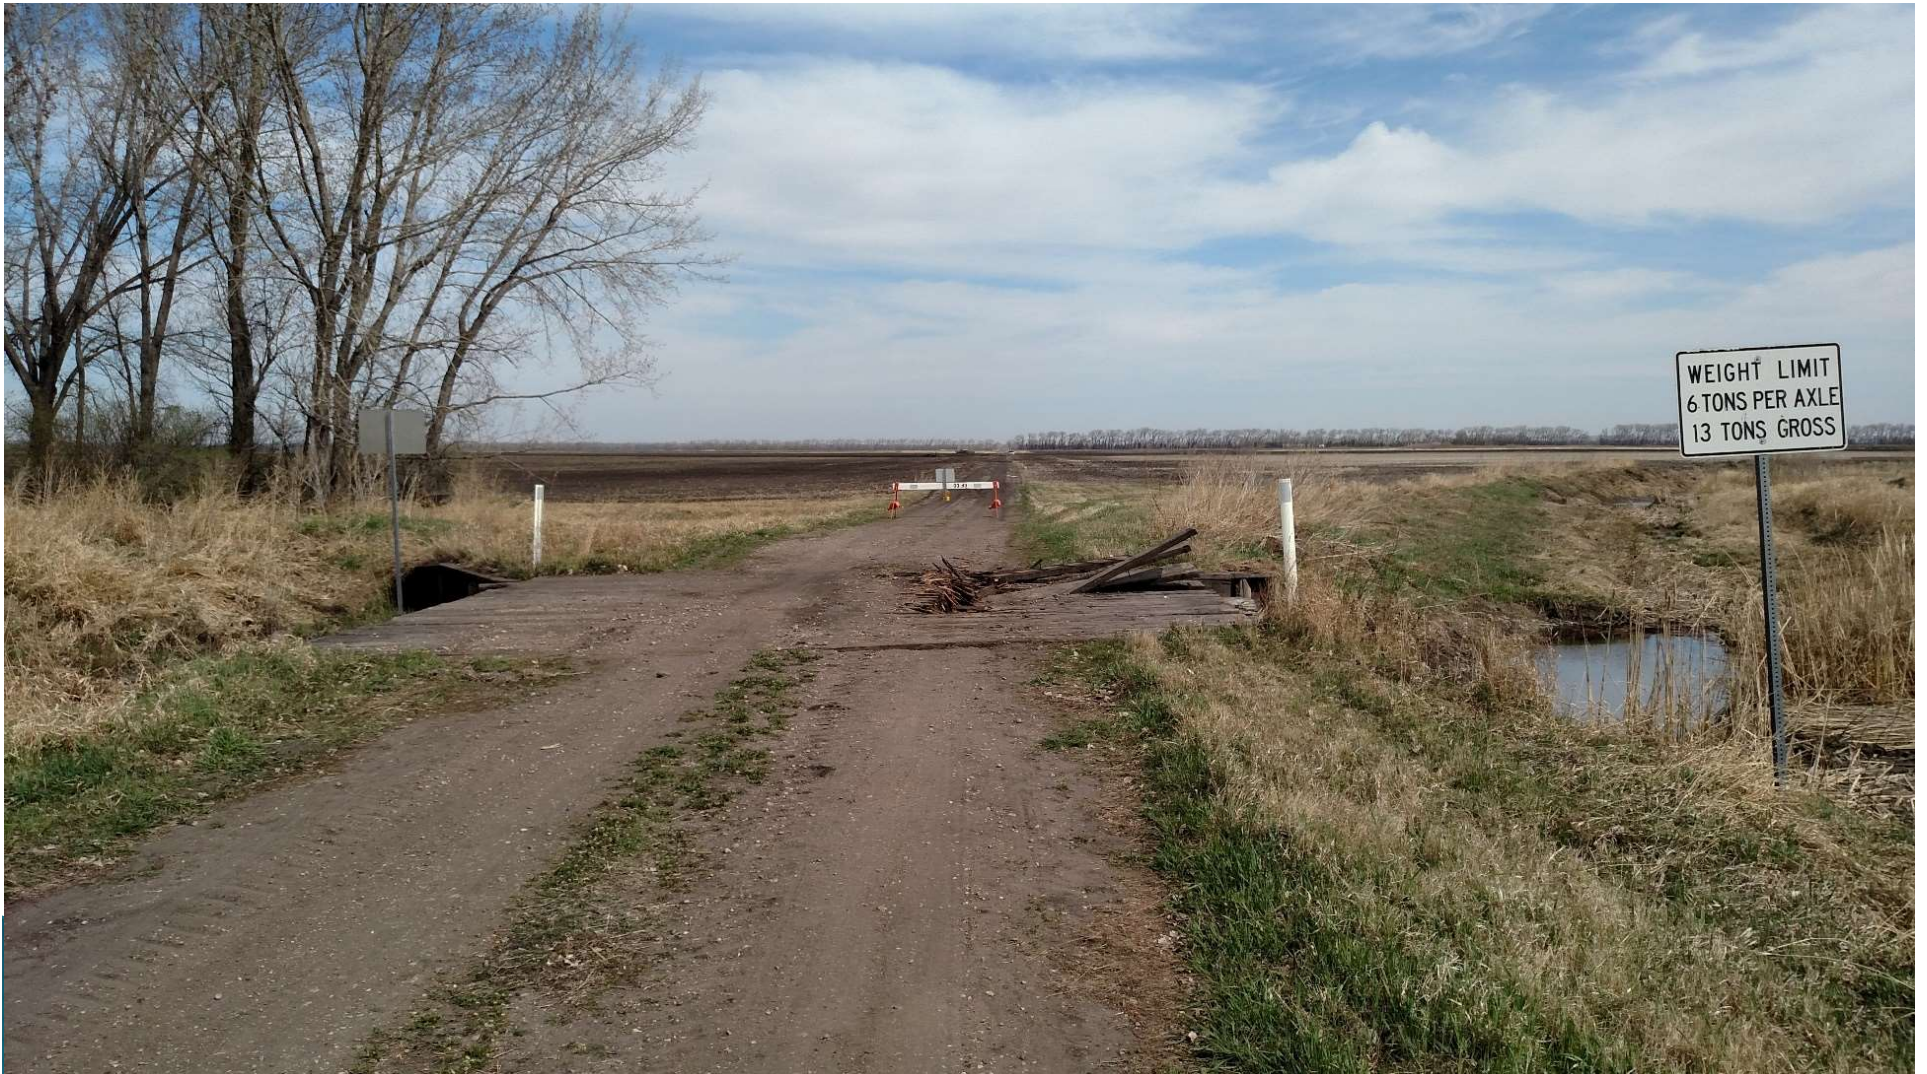
Damaged Timber Bridge

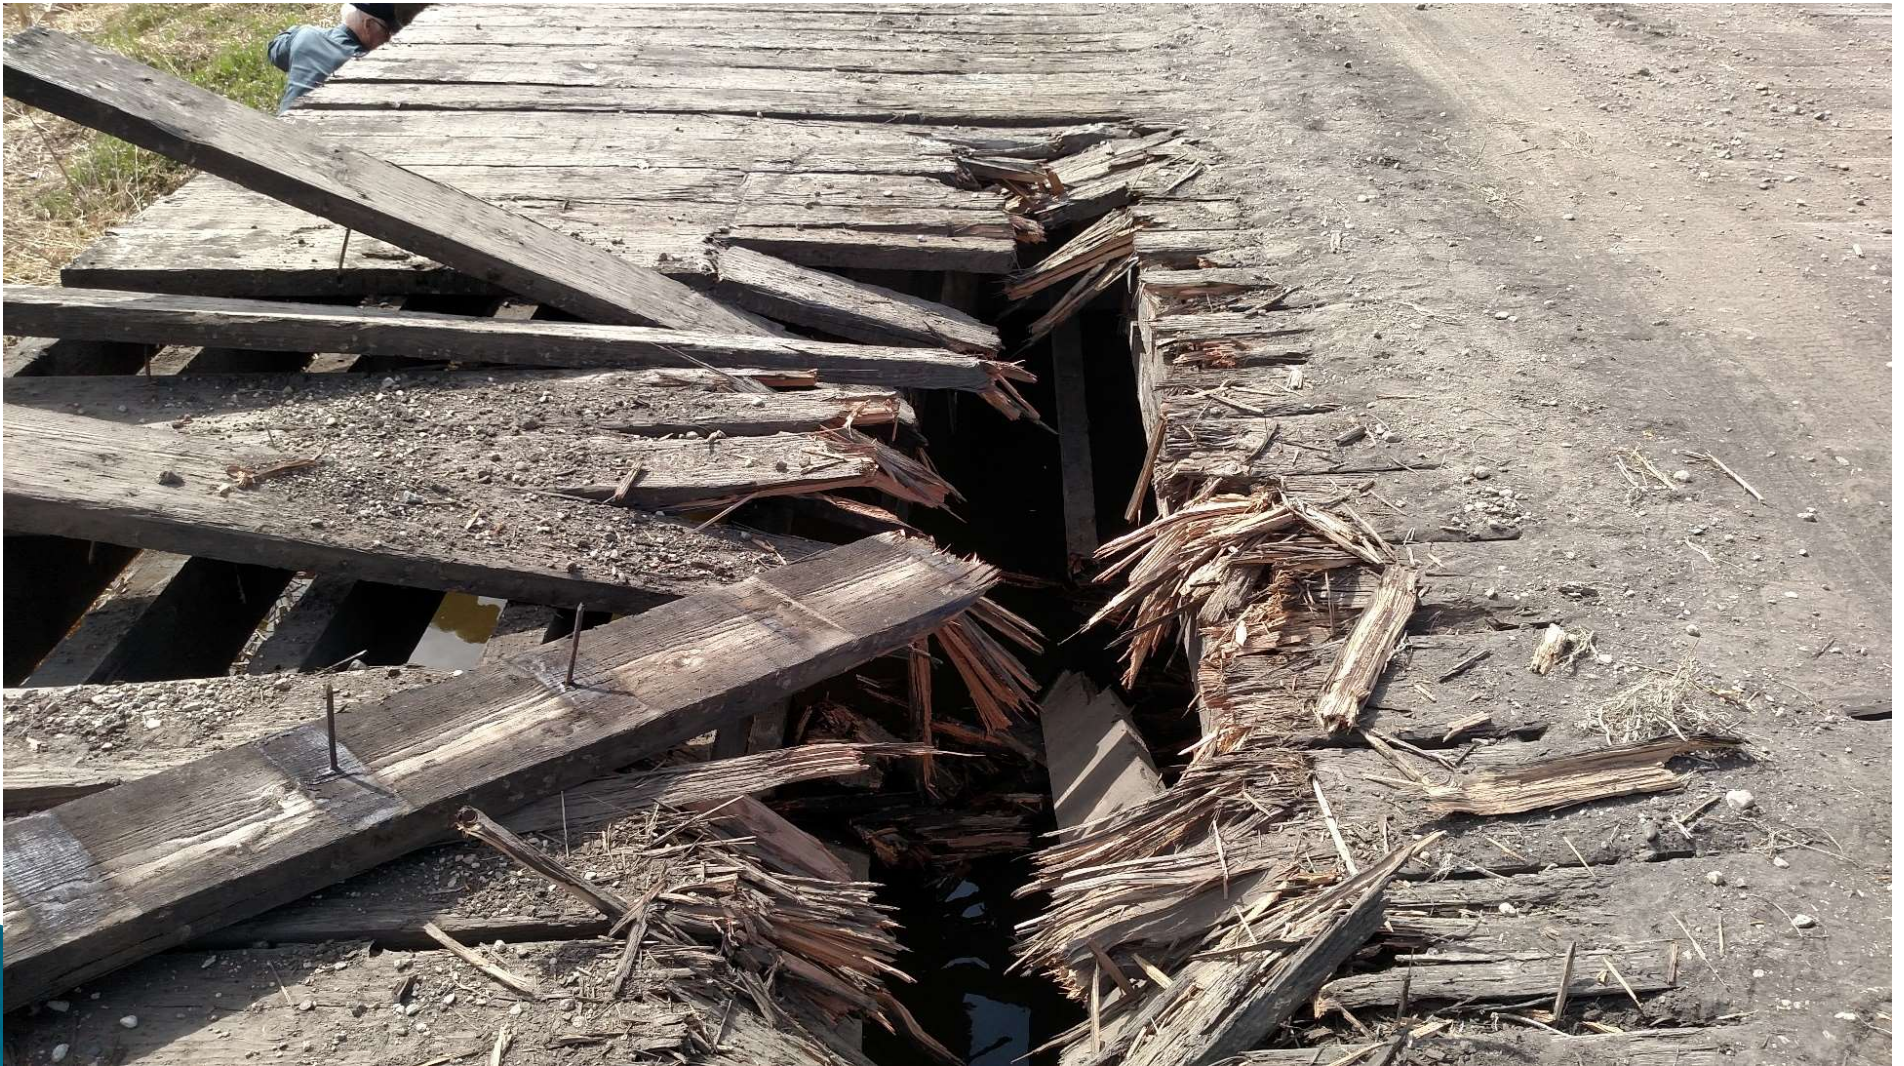
Damaged Bridge

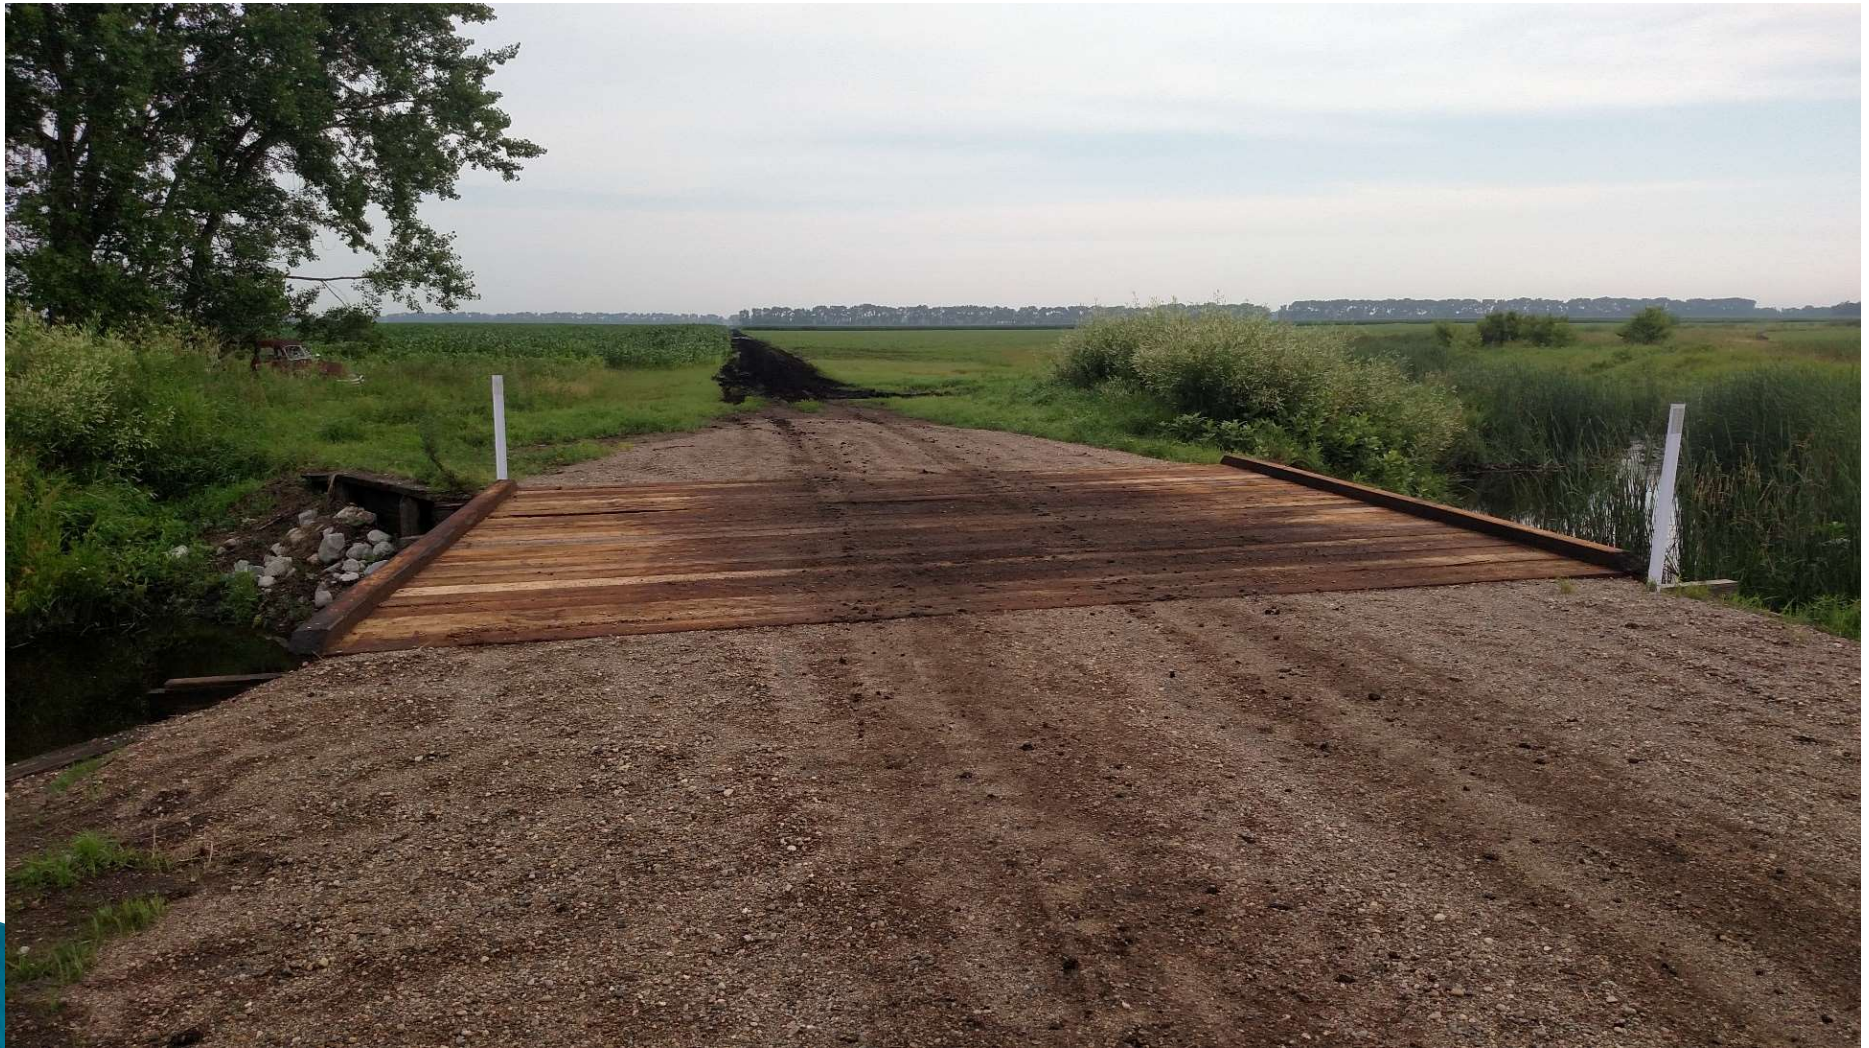
Damaged Bridge Repaired

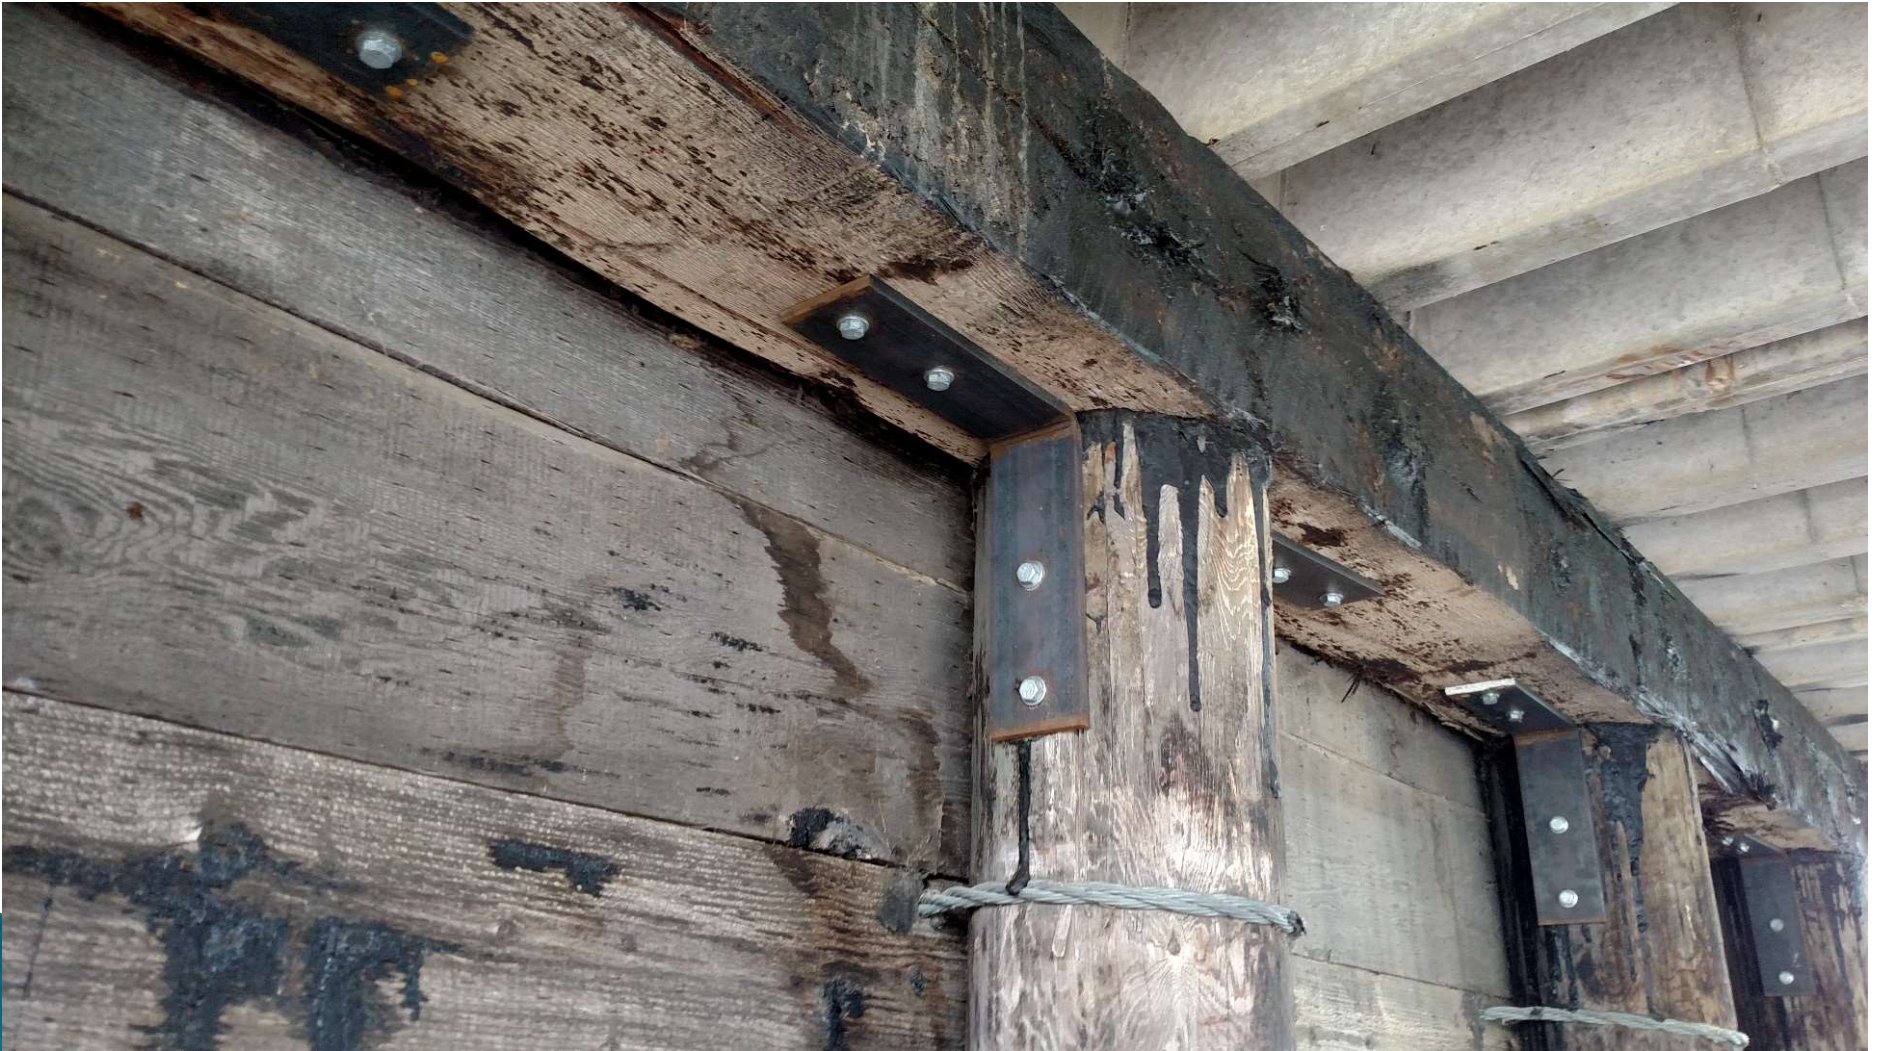
Stabilize Timber Cap

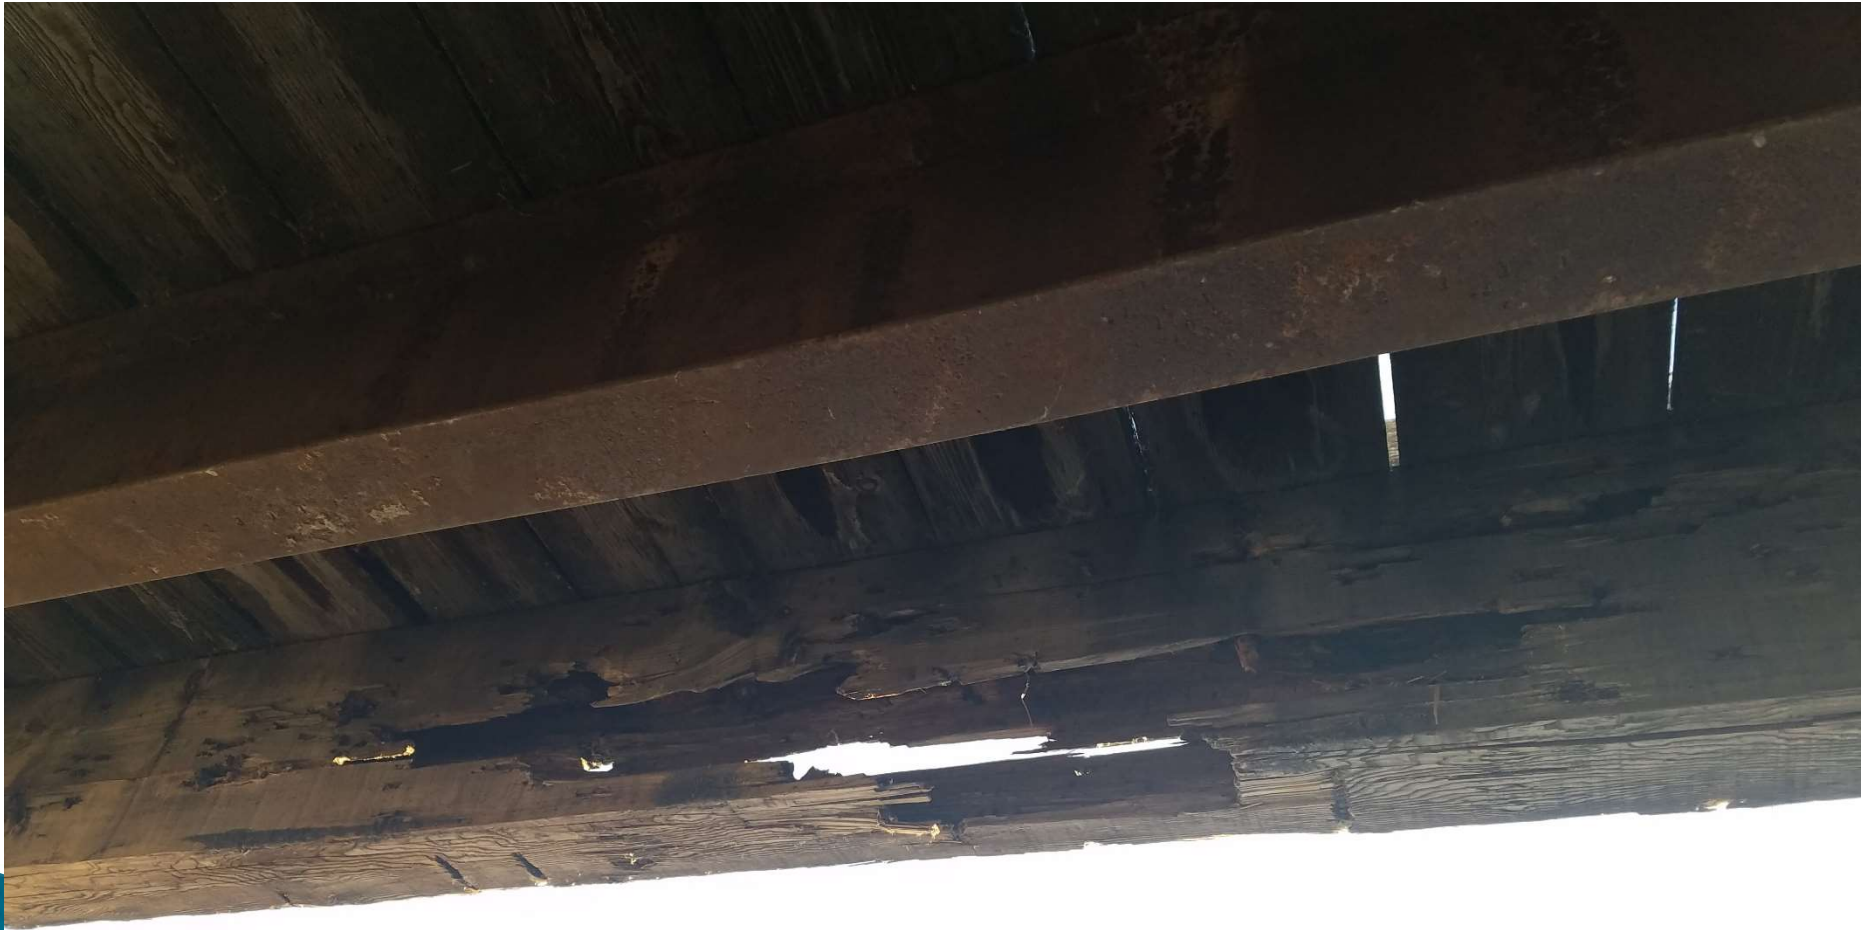
Rotten Timber Stringer

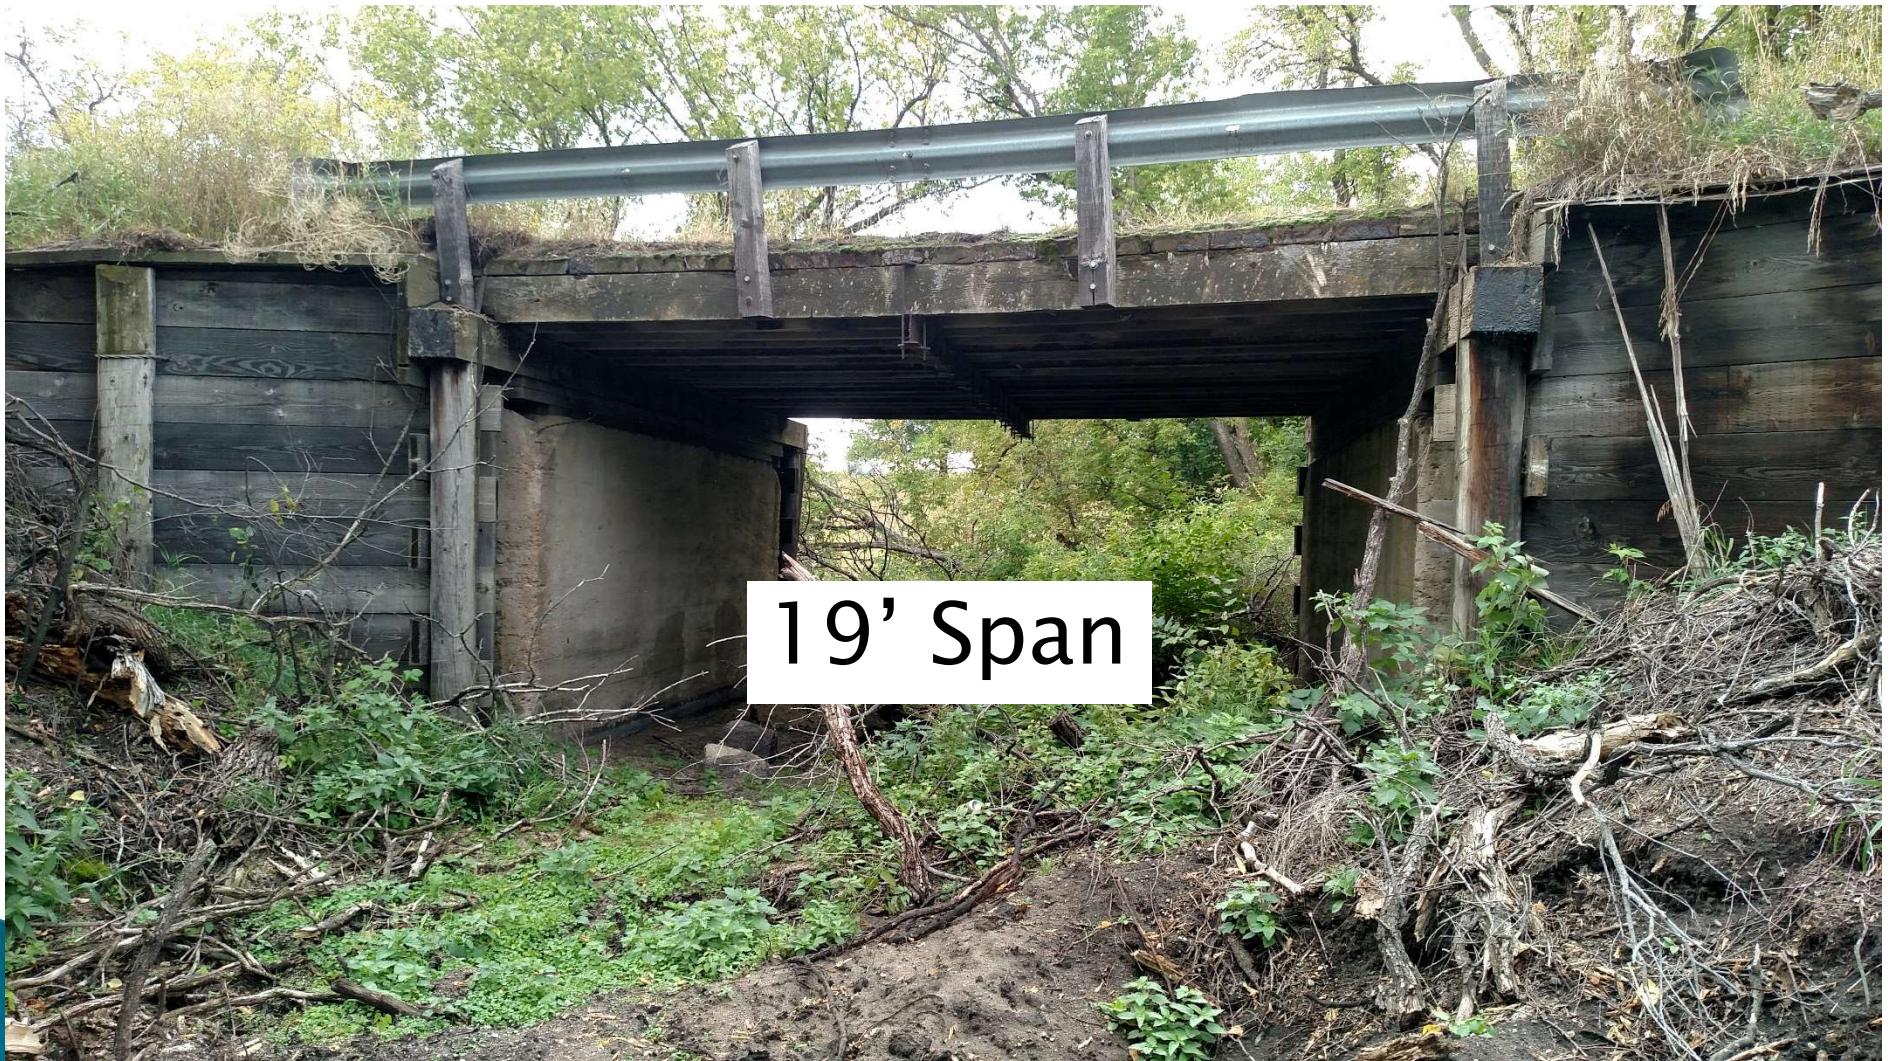
Check Hydraulics – Before
