2019 NDACE Conference Bridge Rehab with Local Forces

Nick West, PE
Grand Forks County Engineer

GRAND FORKS
COUNTY
HEART OF THE RED RIVER VALLEY

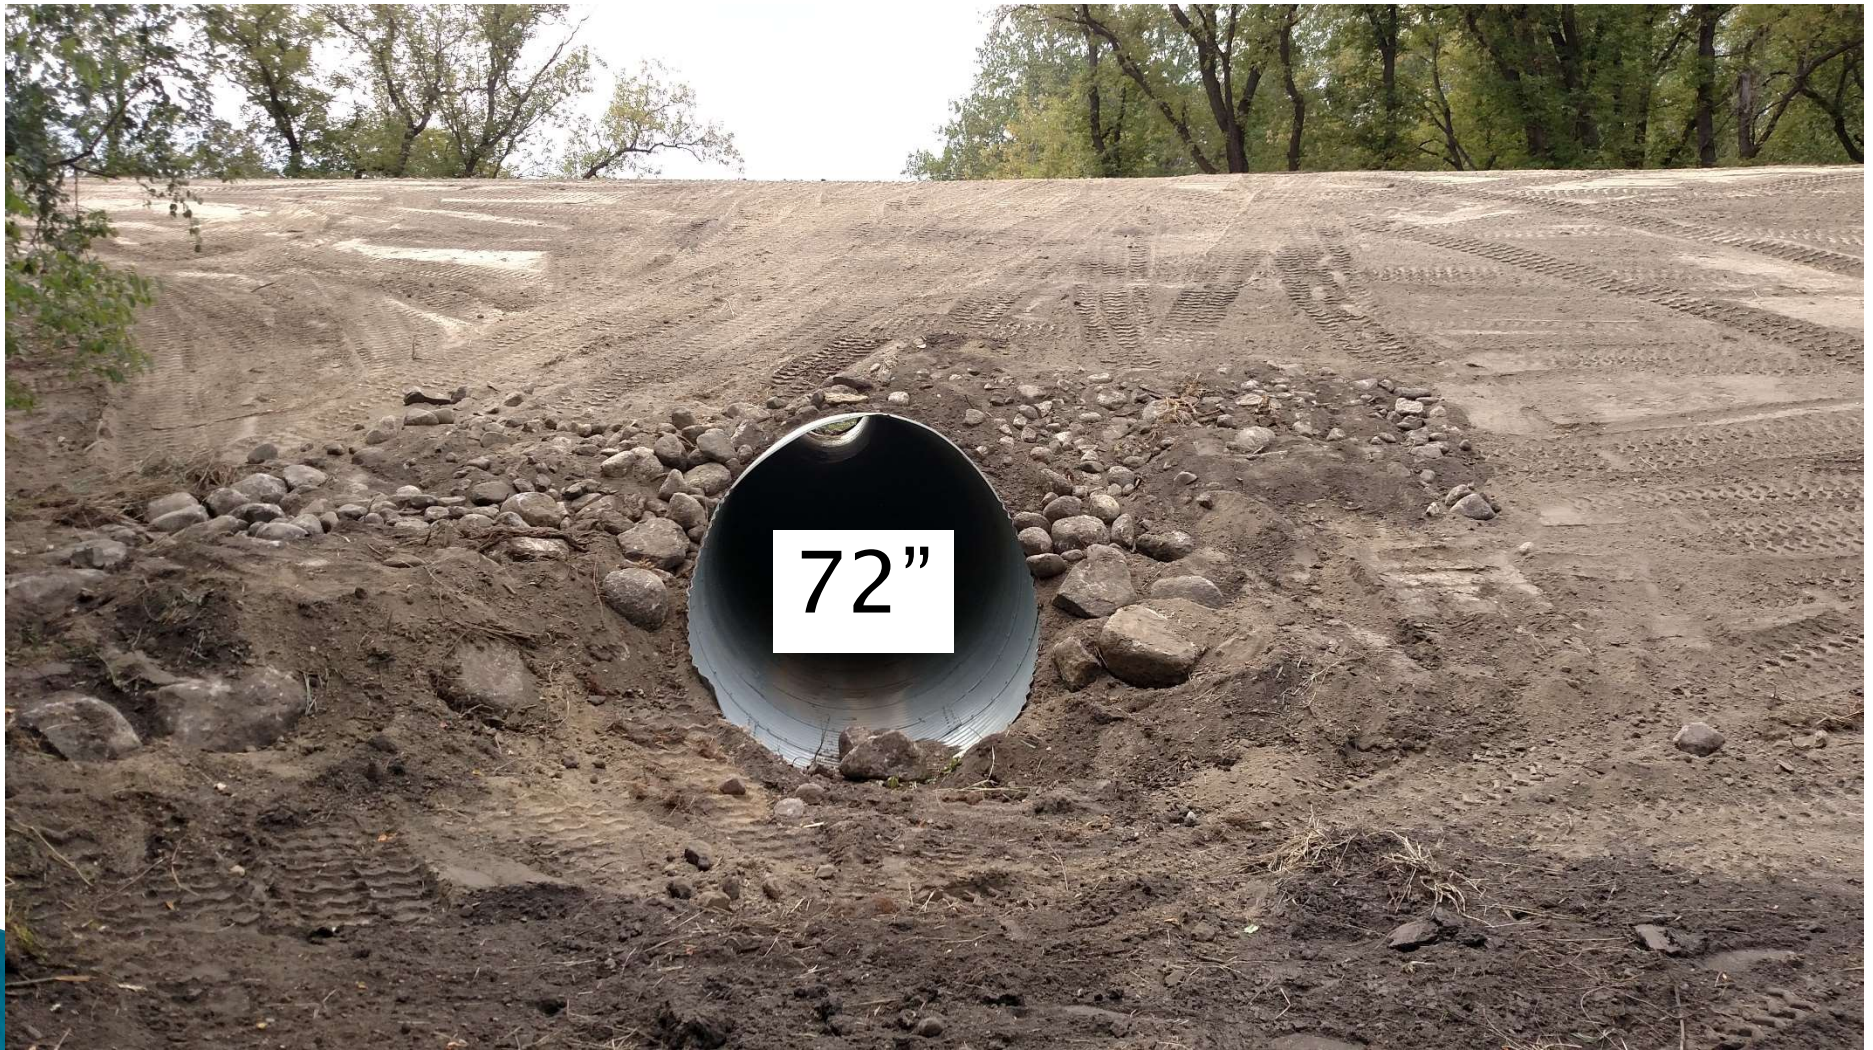
Check Hydraulics – After

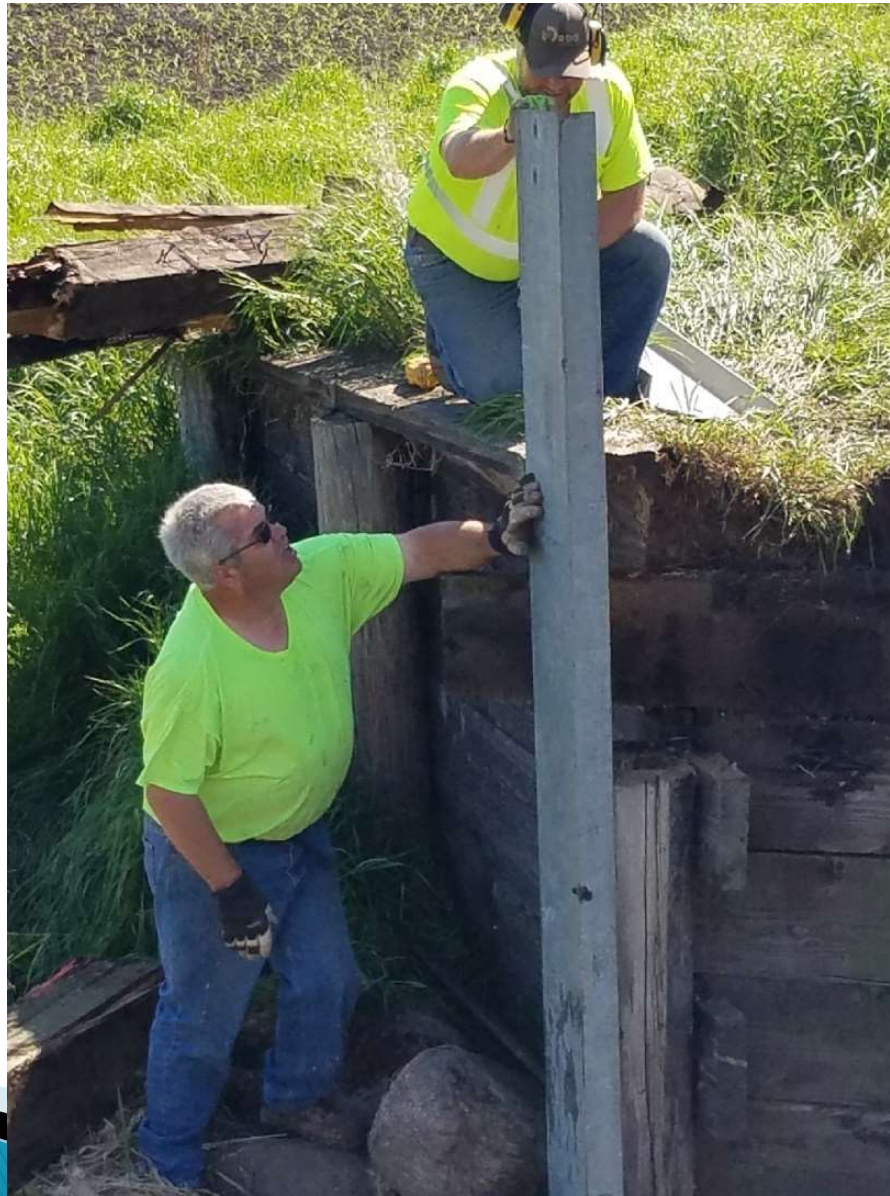
Reinforcing Timber Pile

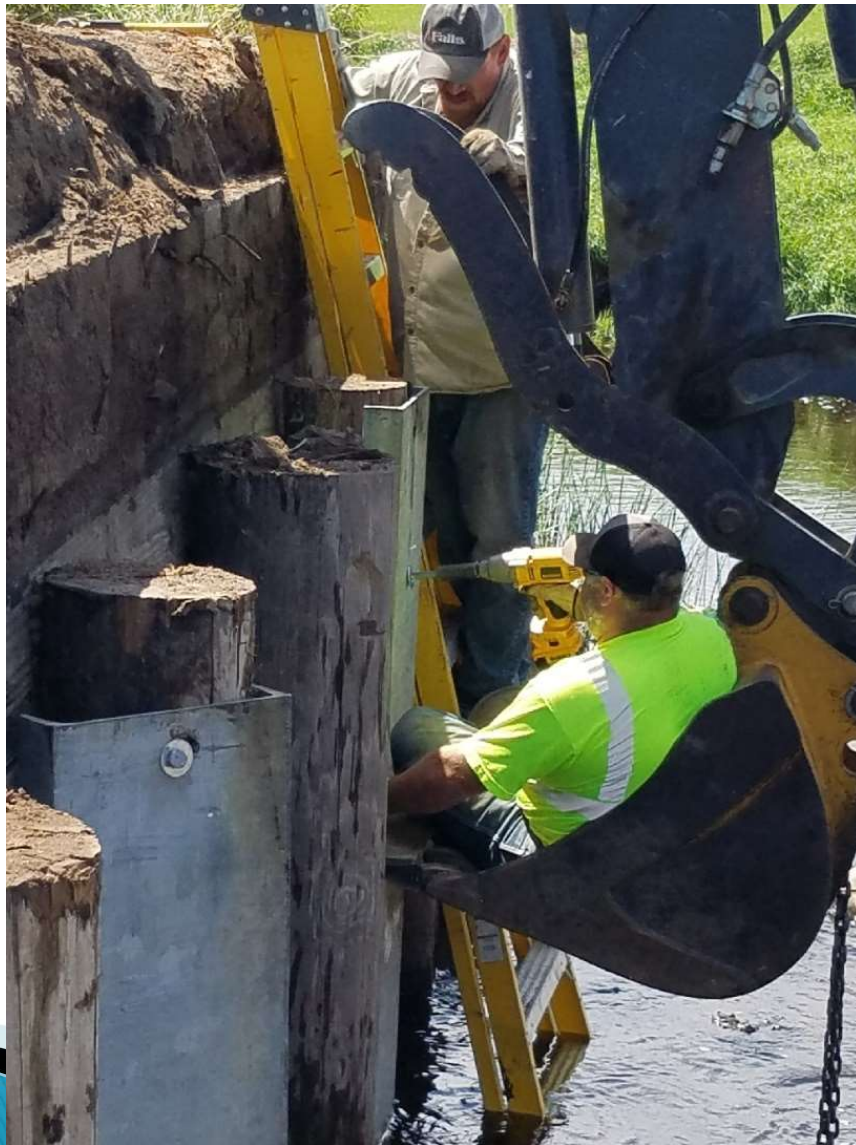
Reinforcing Timber Pile

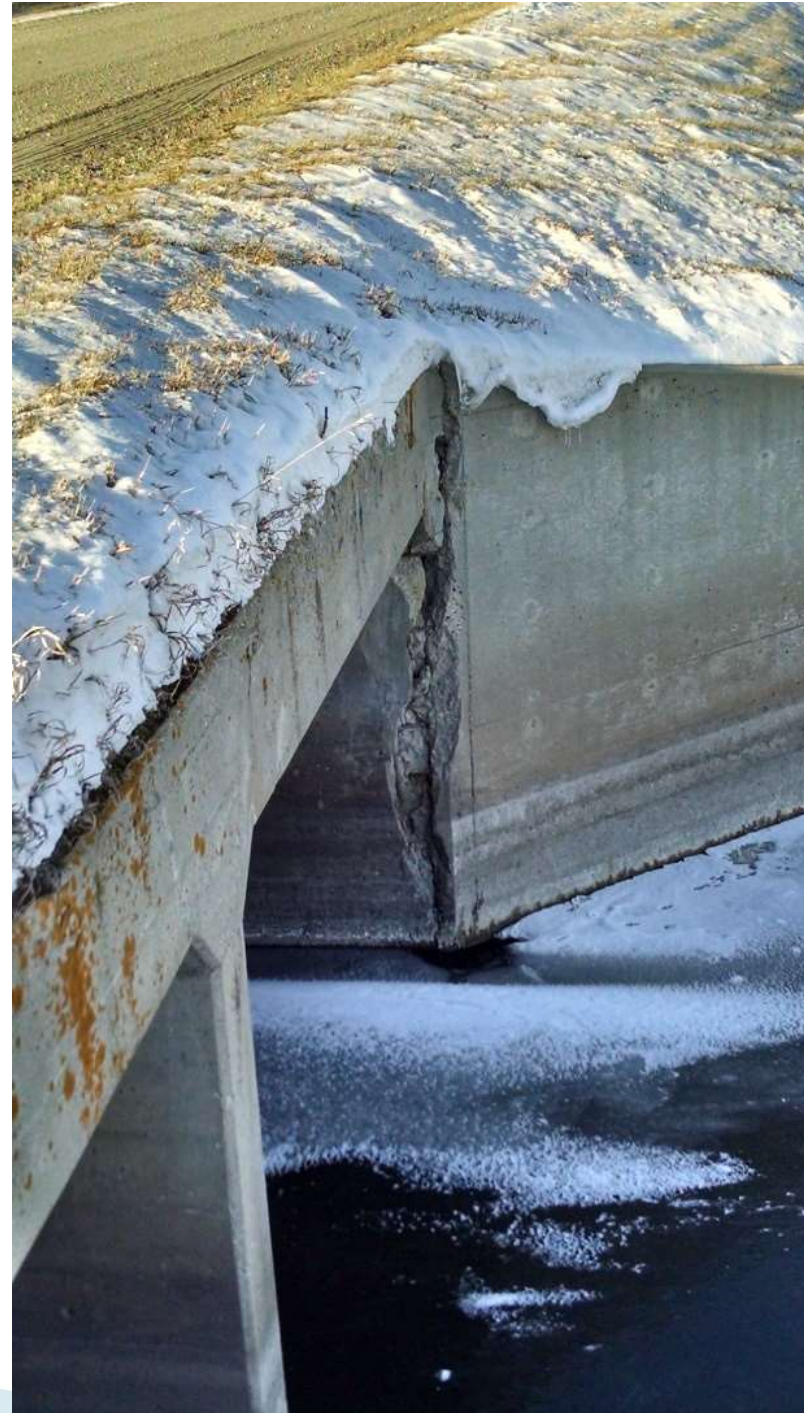
RCBC Broken Wing

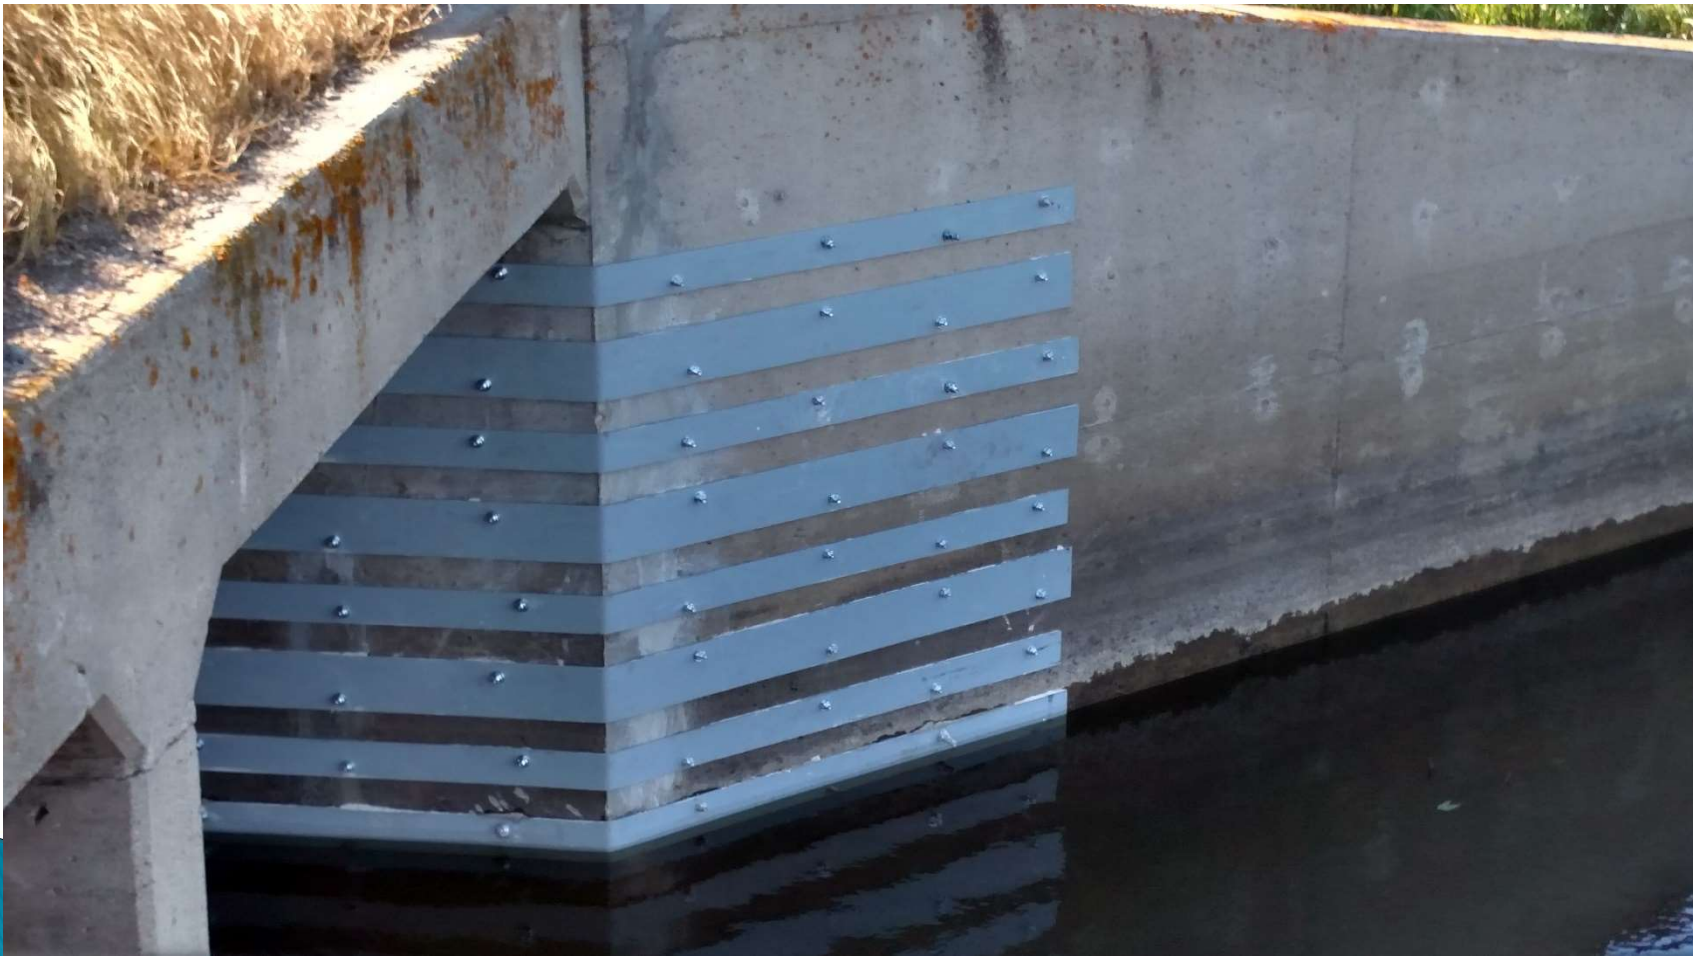
RCBC – Broken Wing

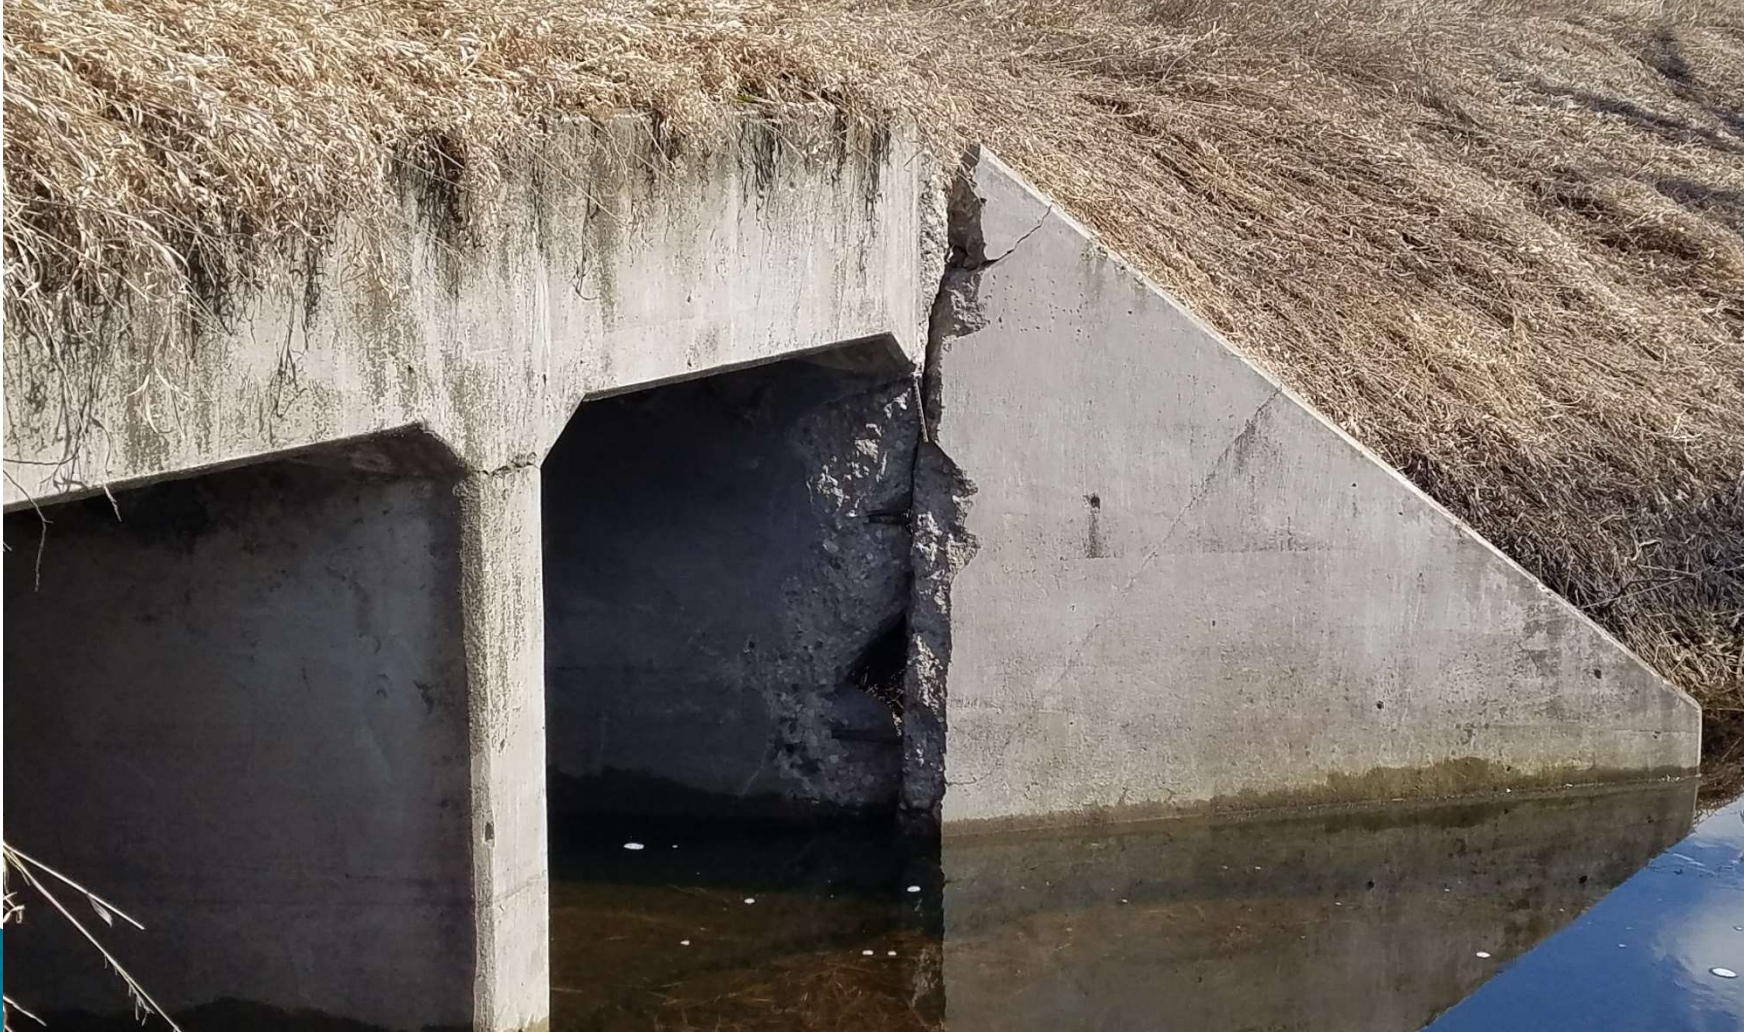
RCBC – Broken Wing

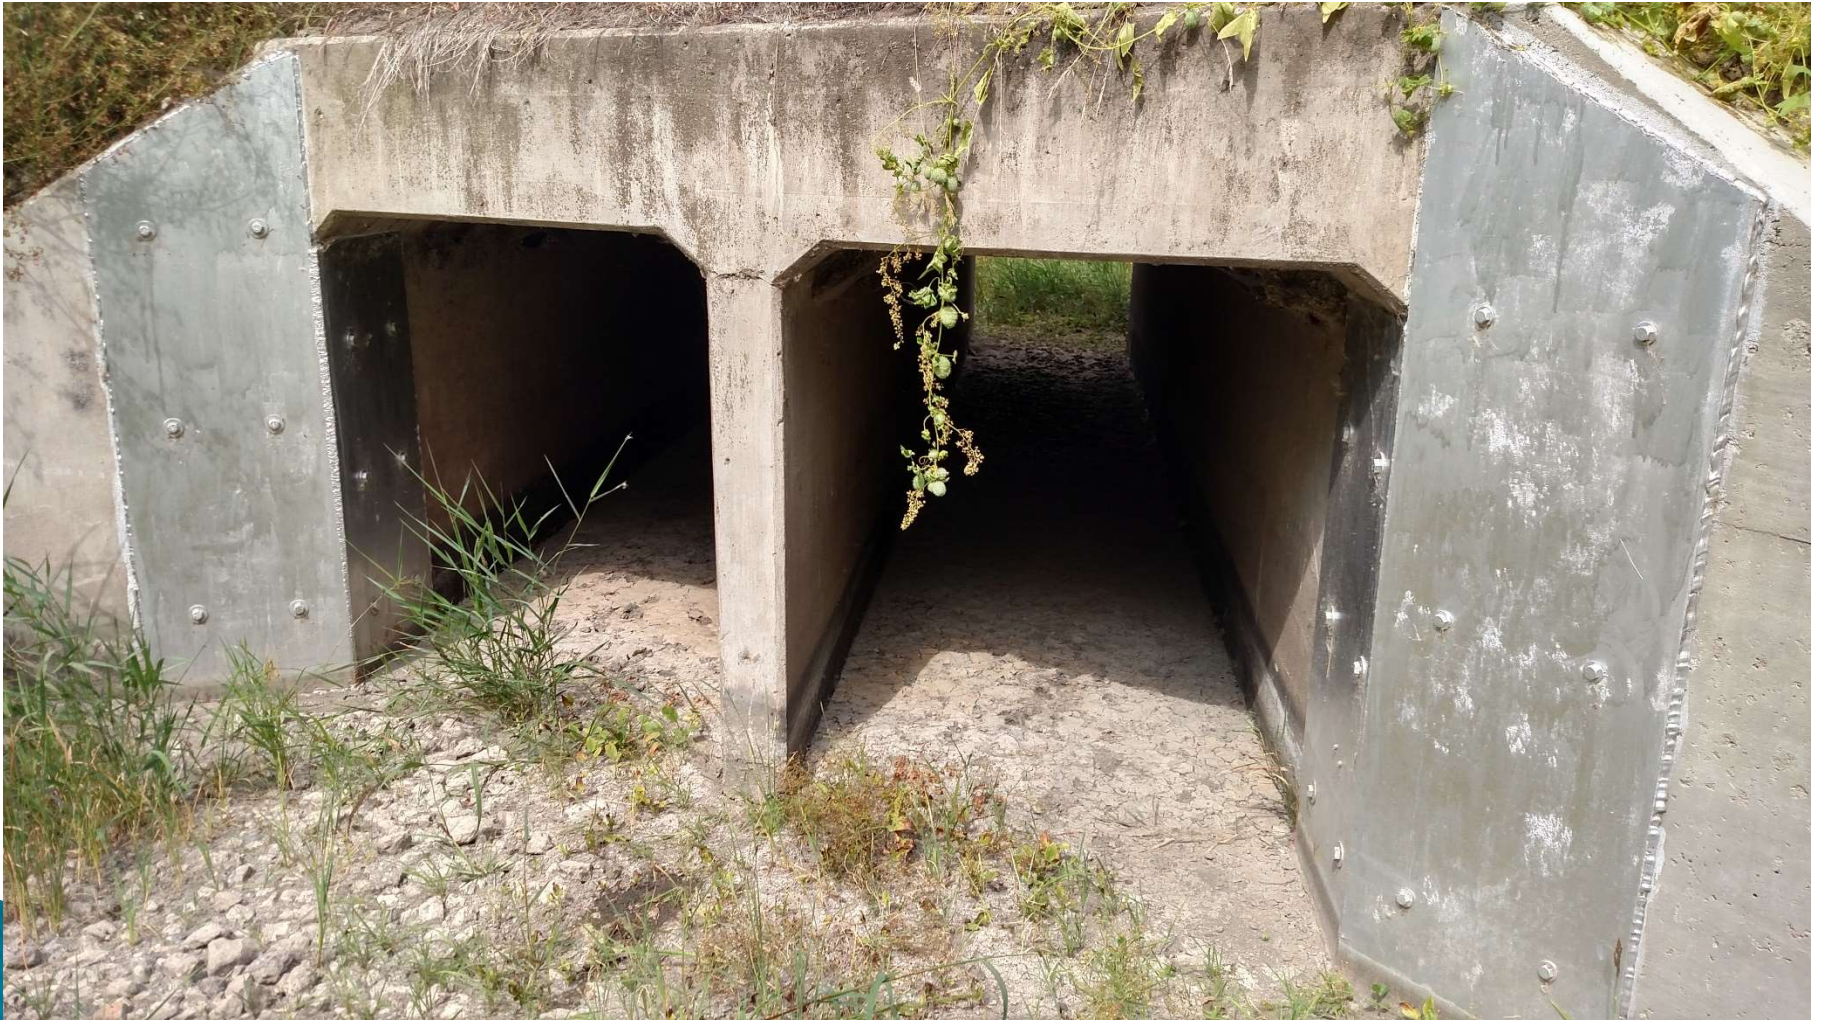
RCBC- Broken Wing

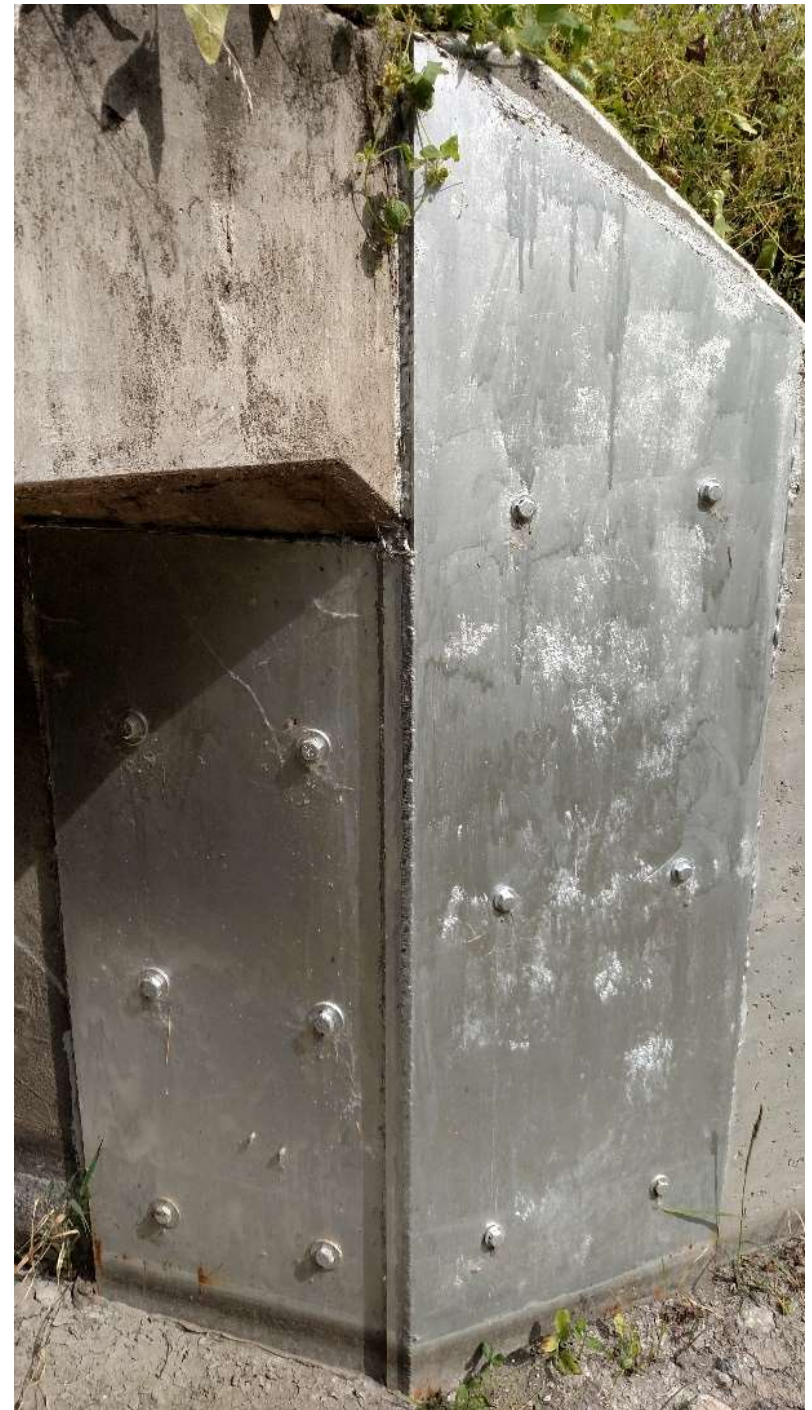
RCBC Broken Wing

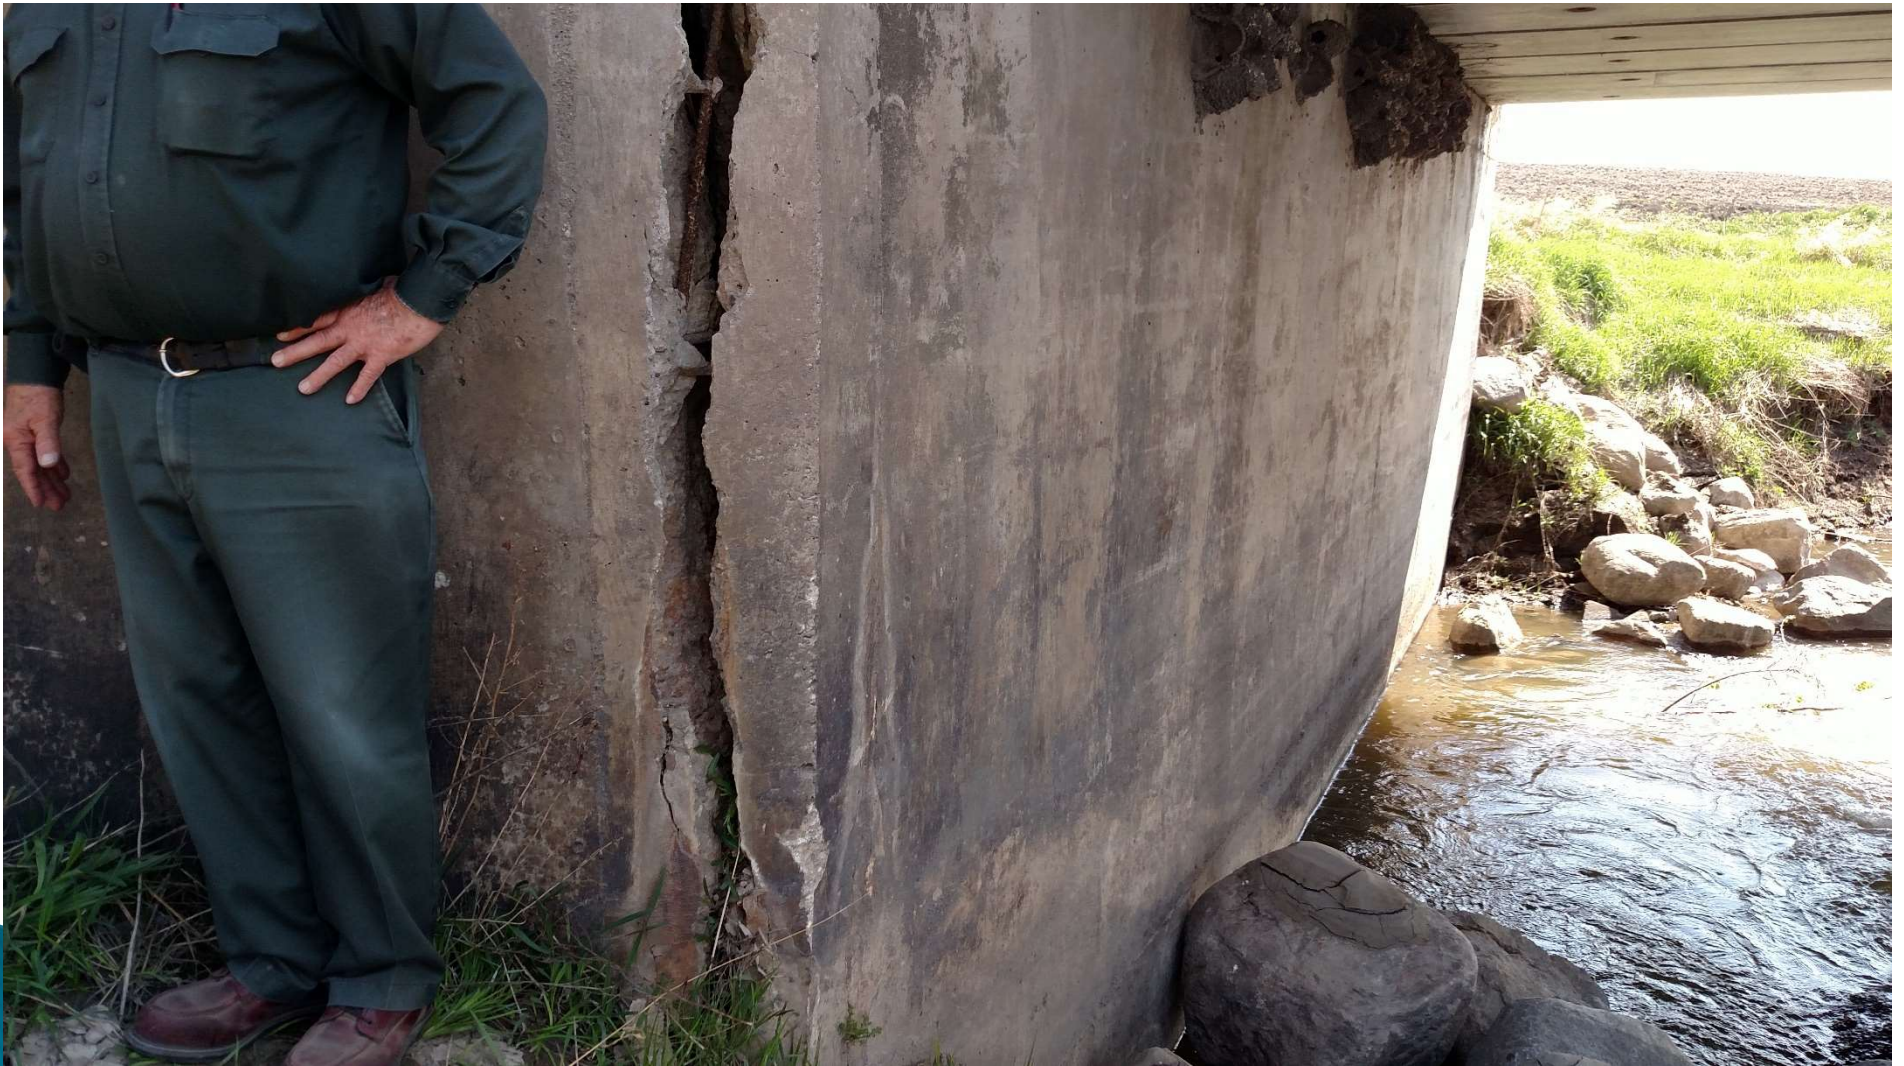
Concrete Bridge Wing – Before

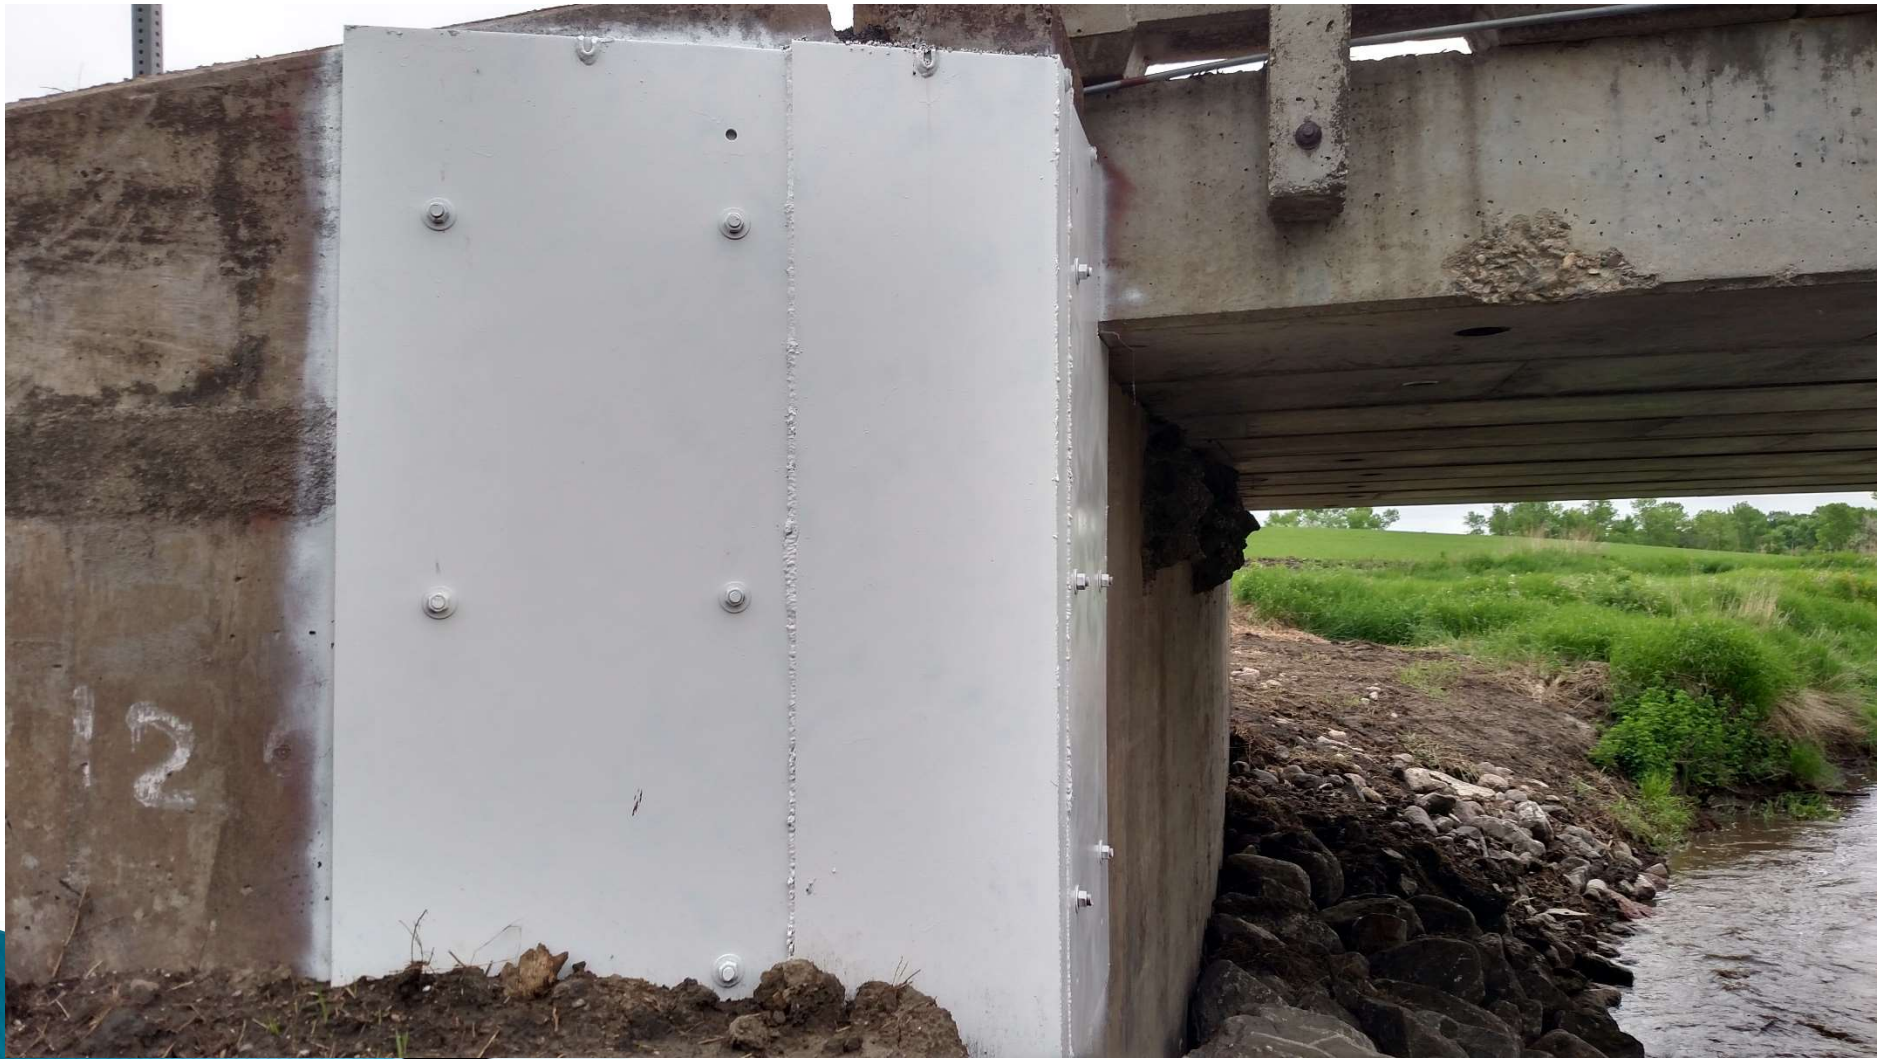
Concrete Bridge Wing – After

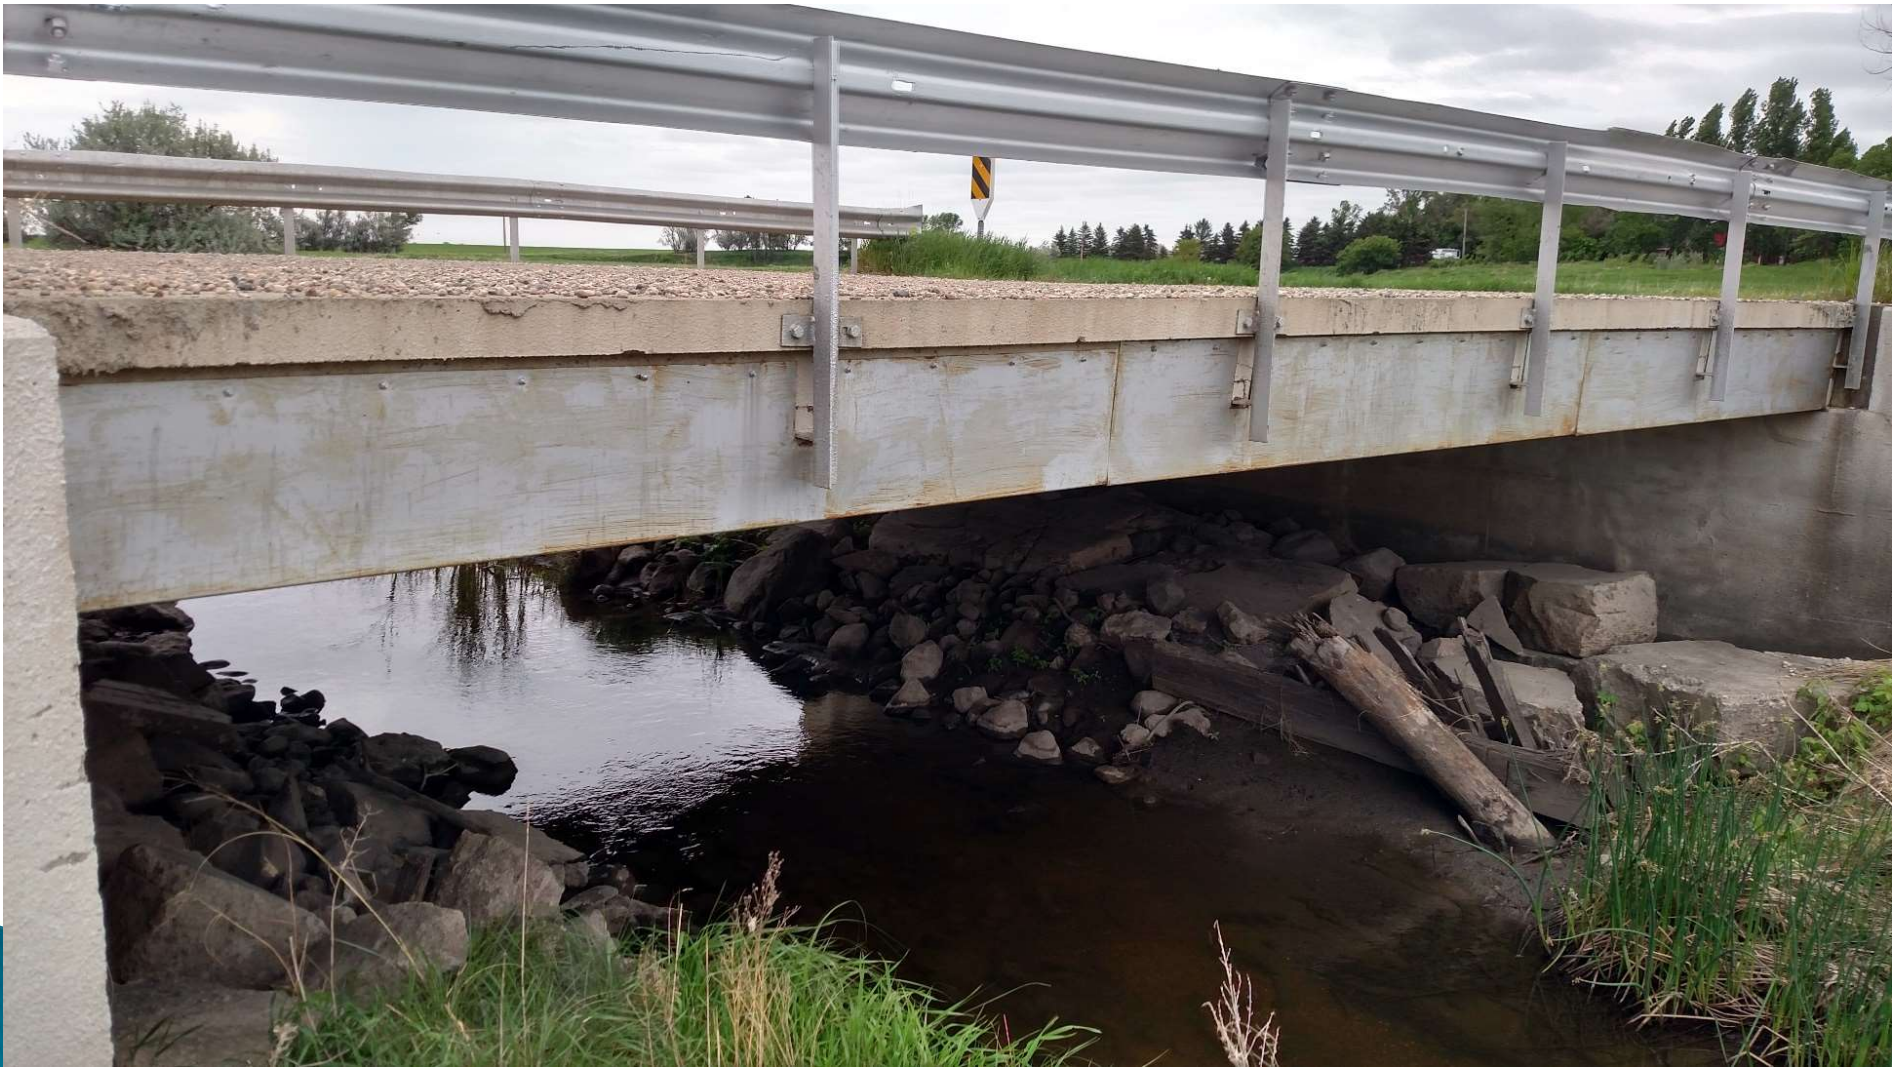
Quad Tee Leading Edge

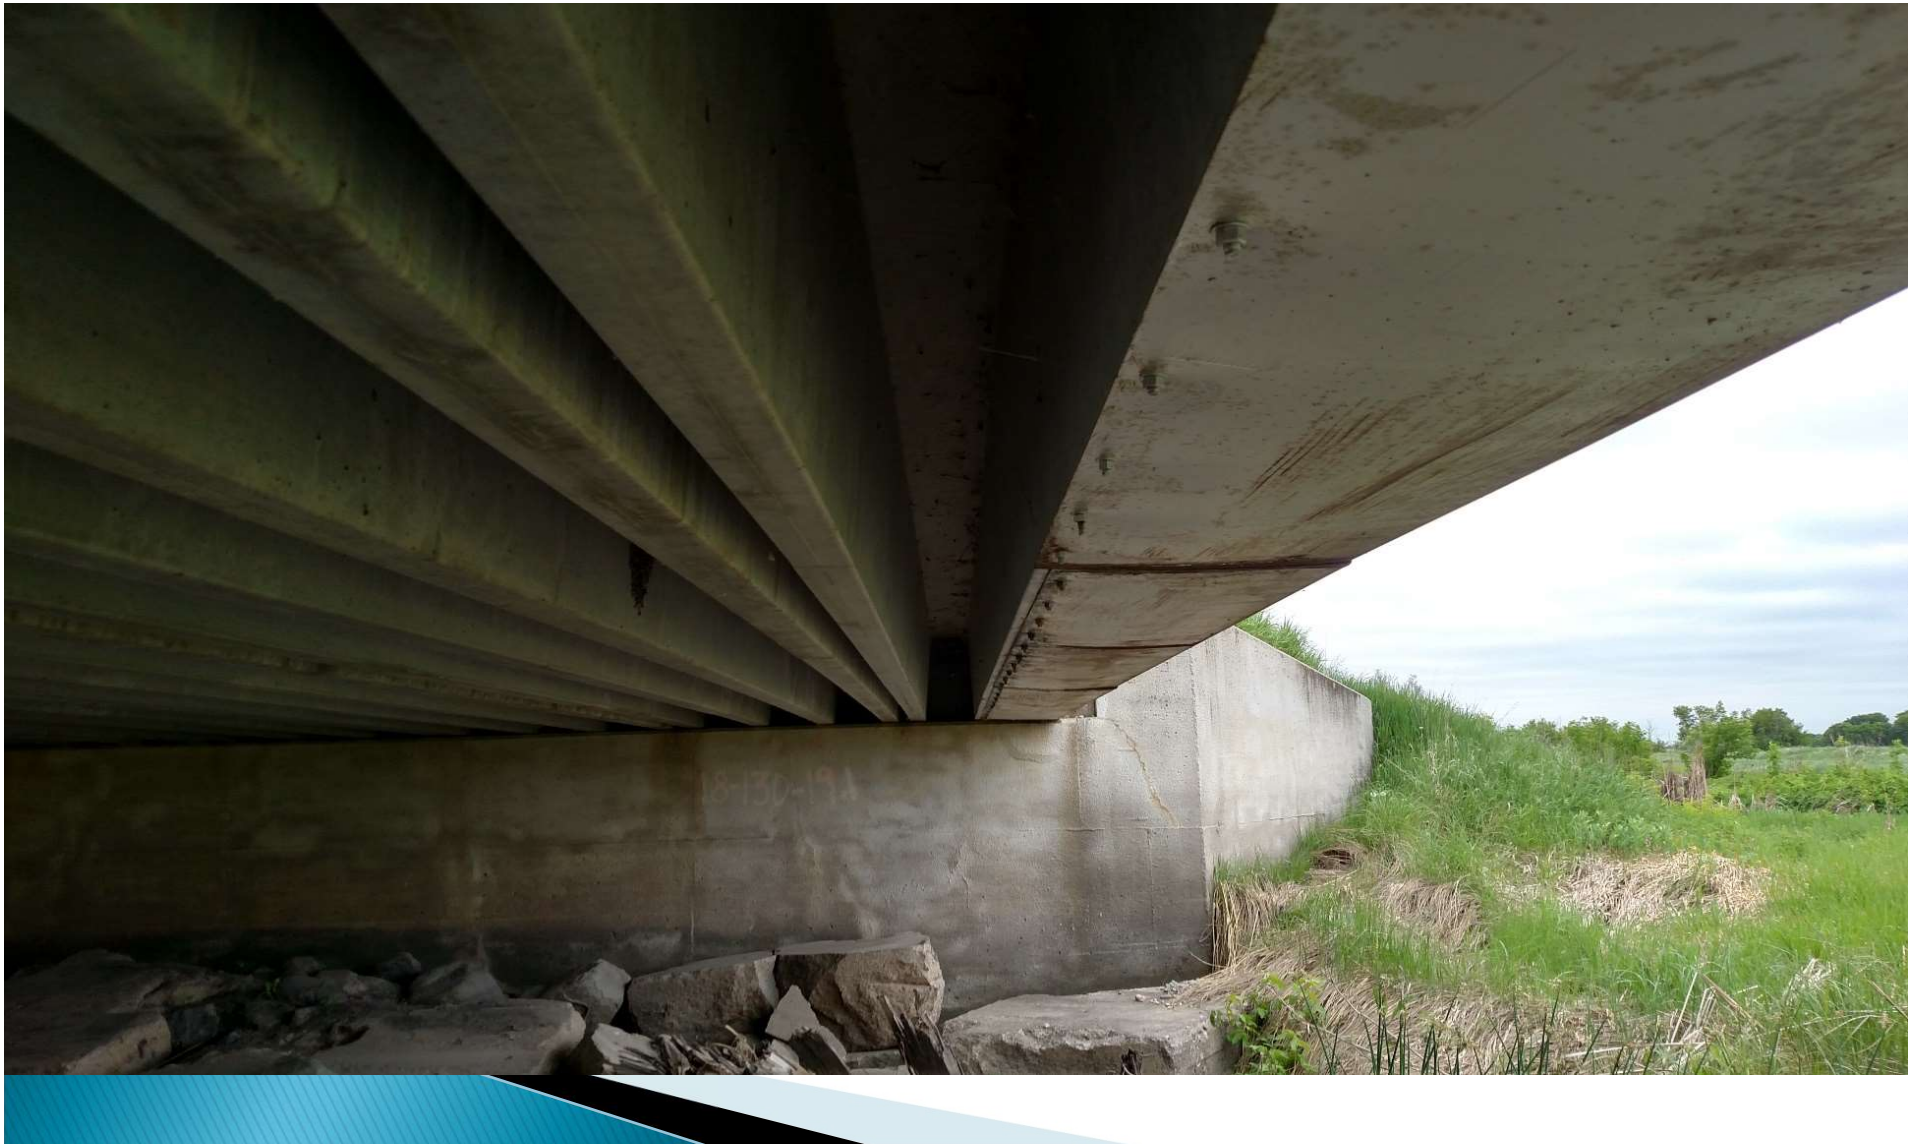
Quad Tee Leading Edge

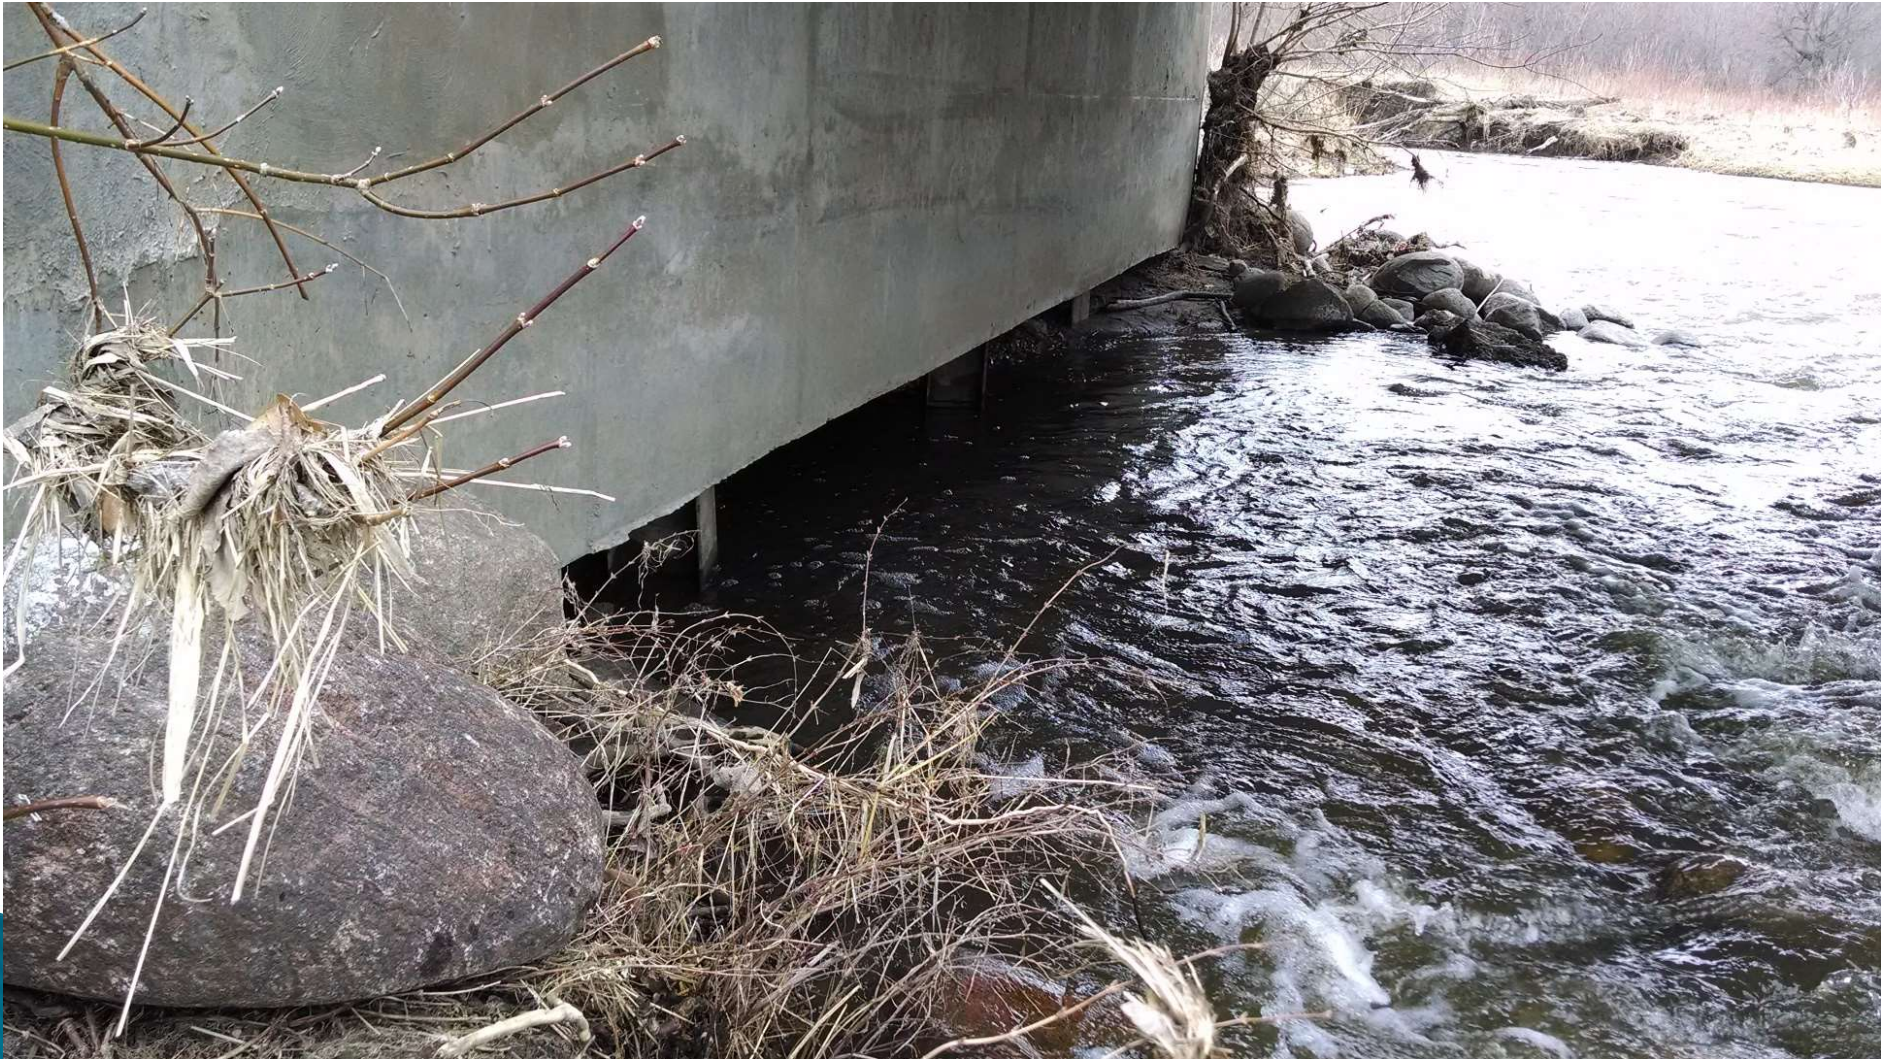
Eroded Under Abutment
