2019 NDACE Conference Bridge Rehab with Local Forces

Nick West, PE
Grand Forks County Engineer

GRAND FORKS
COUNTY
HEART OF THE RED RIVER VALLEY

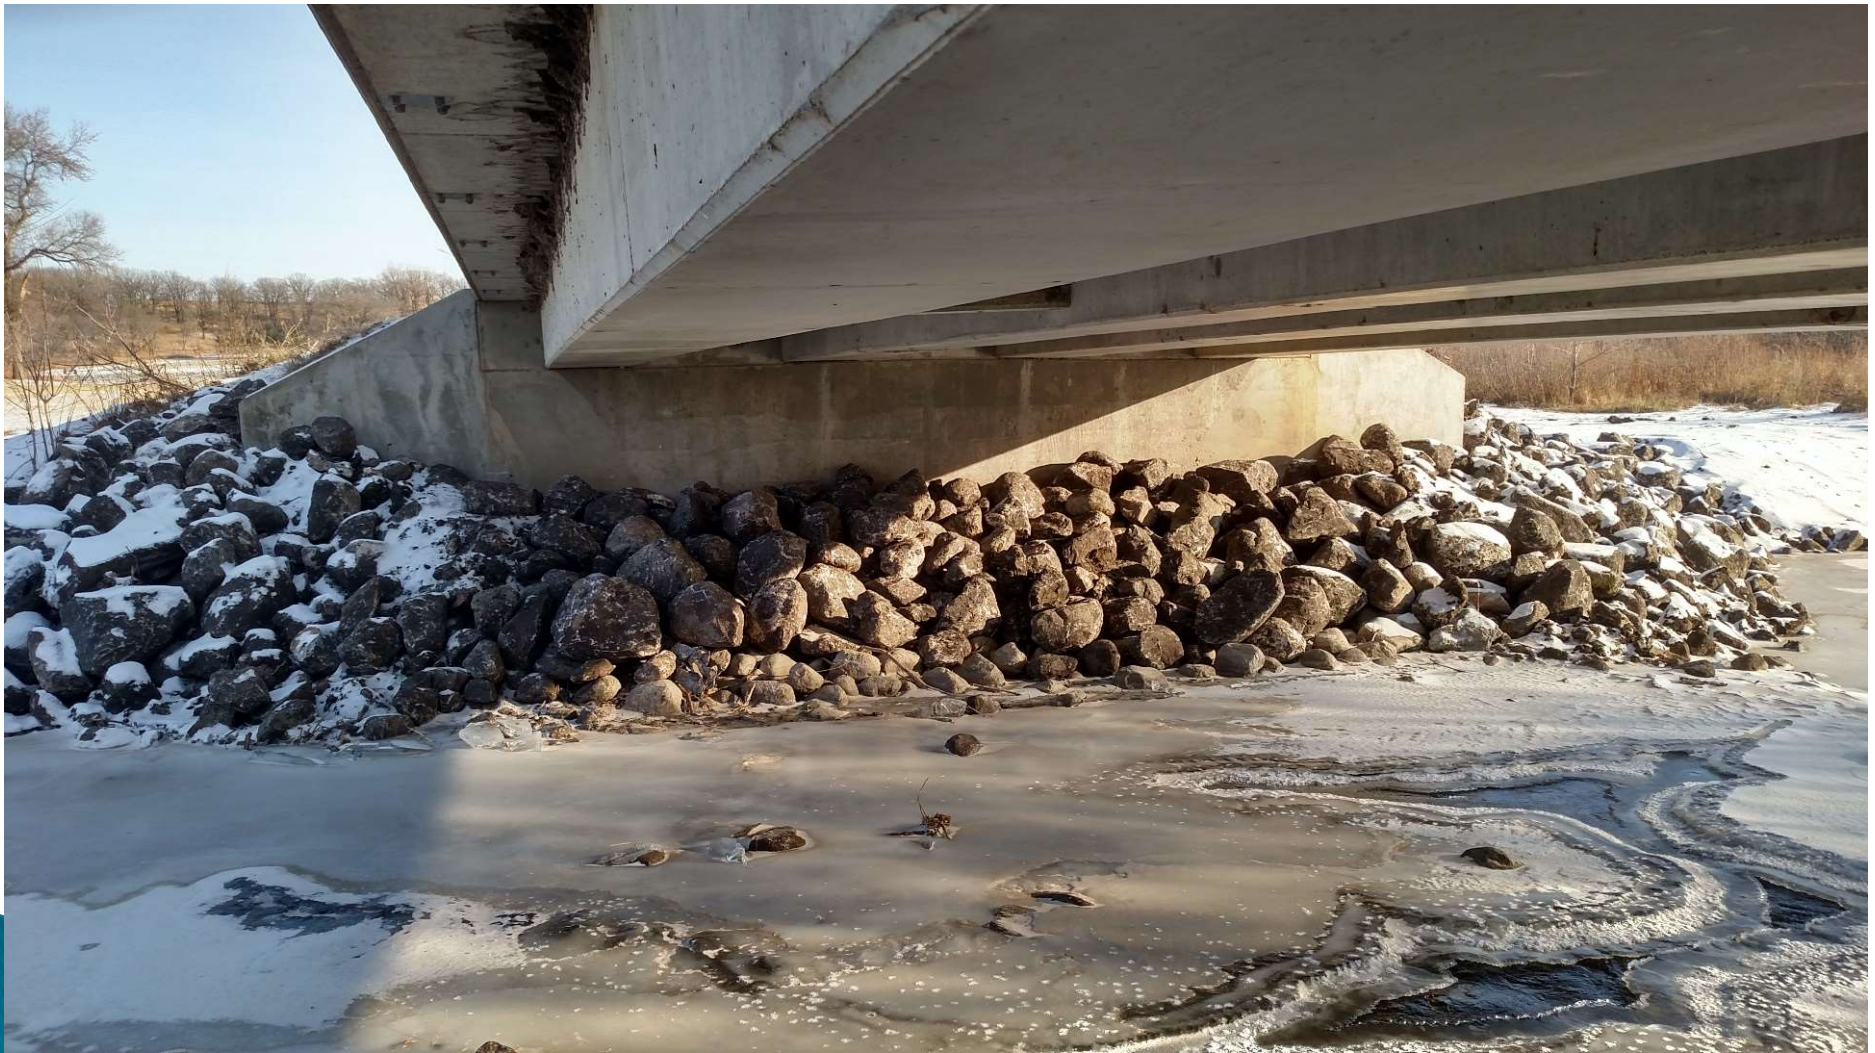
Eroded Abutment – Riprap
