Cold In Place Recycling

Using an Emulsion Binder

Trevor Christianson
Mayo Construction Company
And
Adam Mahaney
Western Asphalt Products

Williams County Road 17

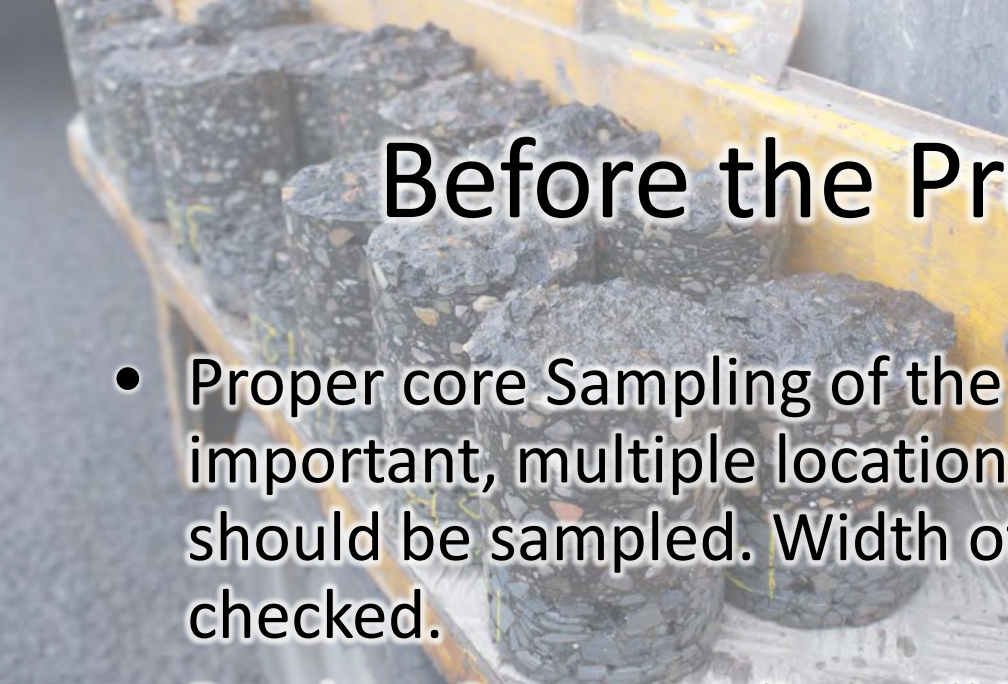
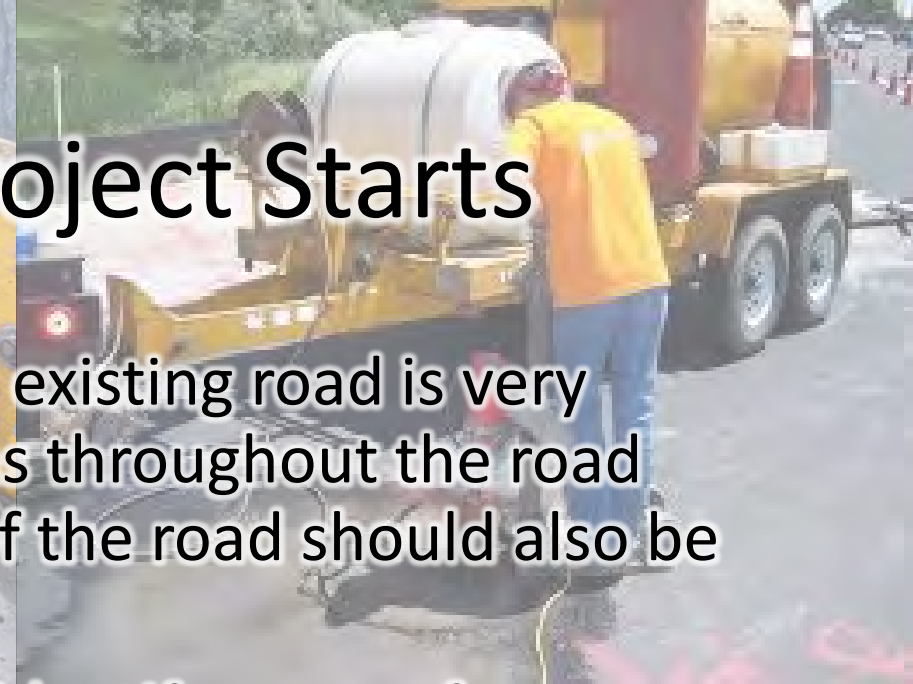
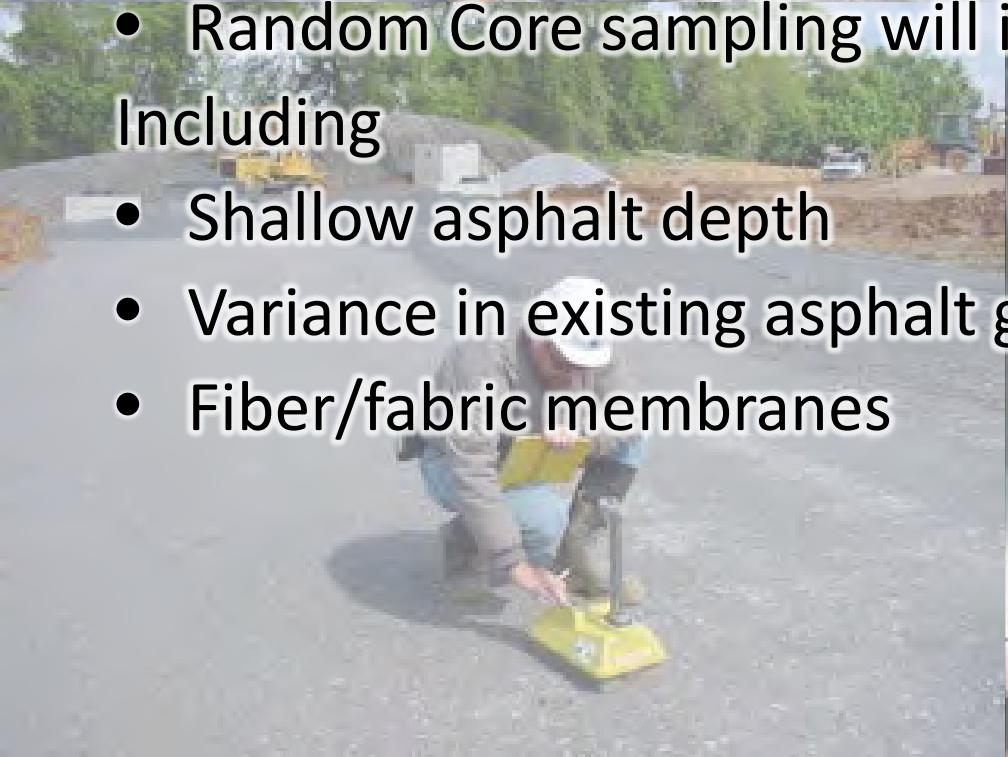
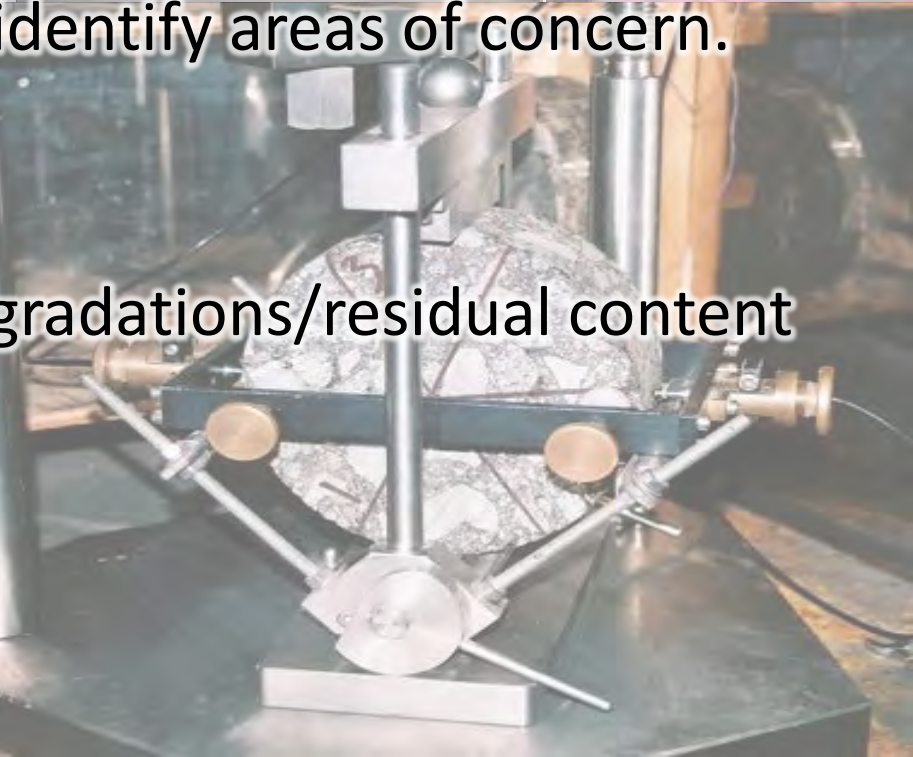
Existing Road Condition

- Large amount of Asphalt crack sealer present in some areas
- Fabric interlayer was present between overlays
- Previously chip sealed
- Roadways had been narrowed from multiple overlays

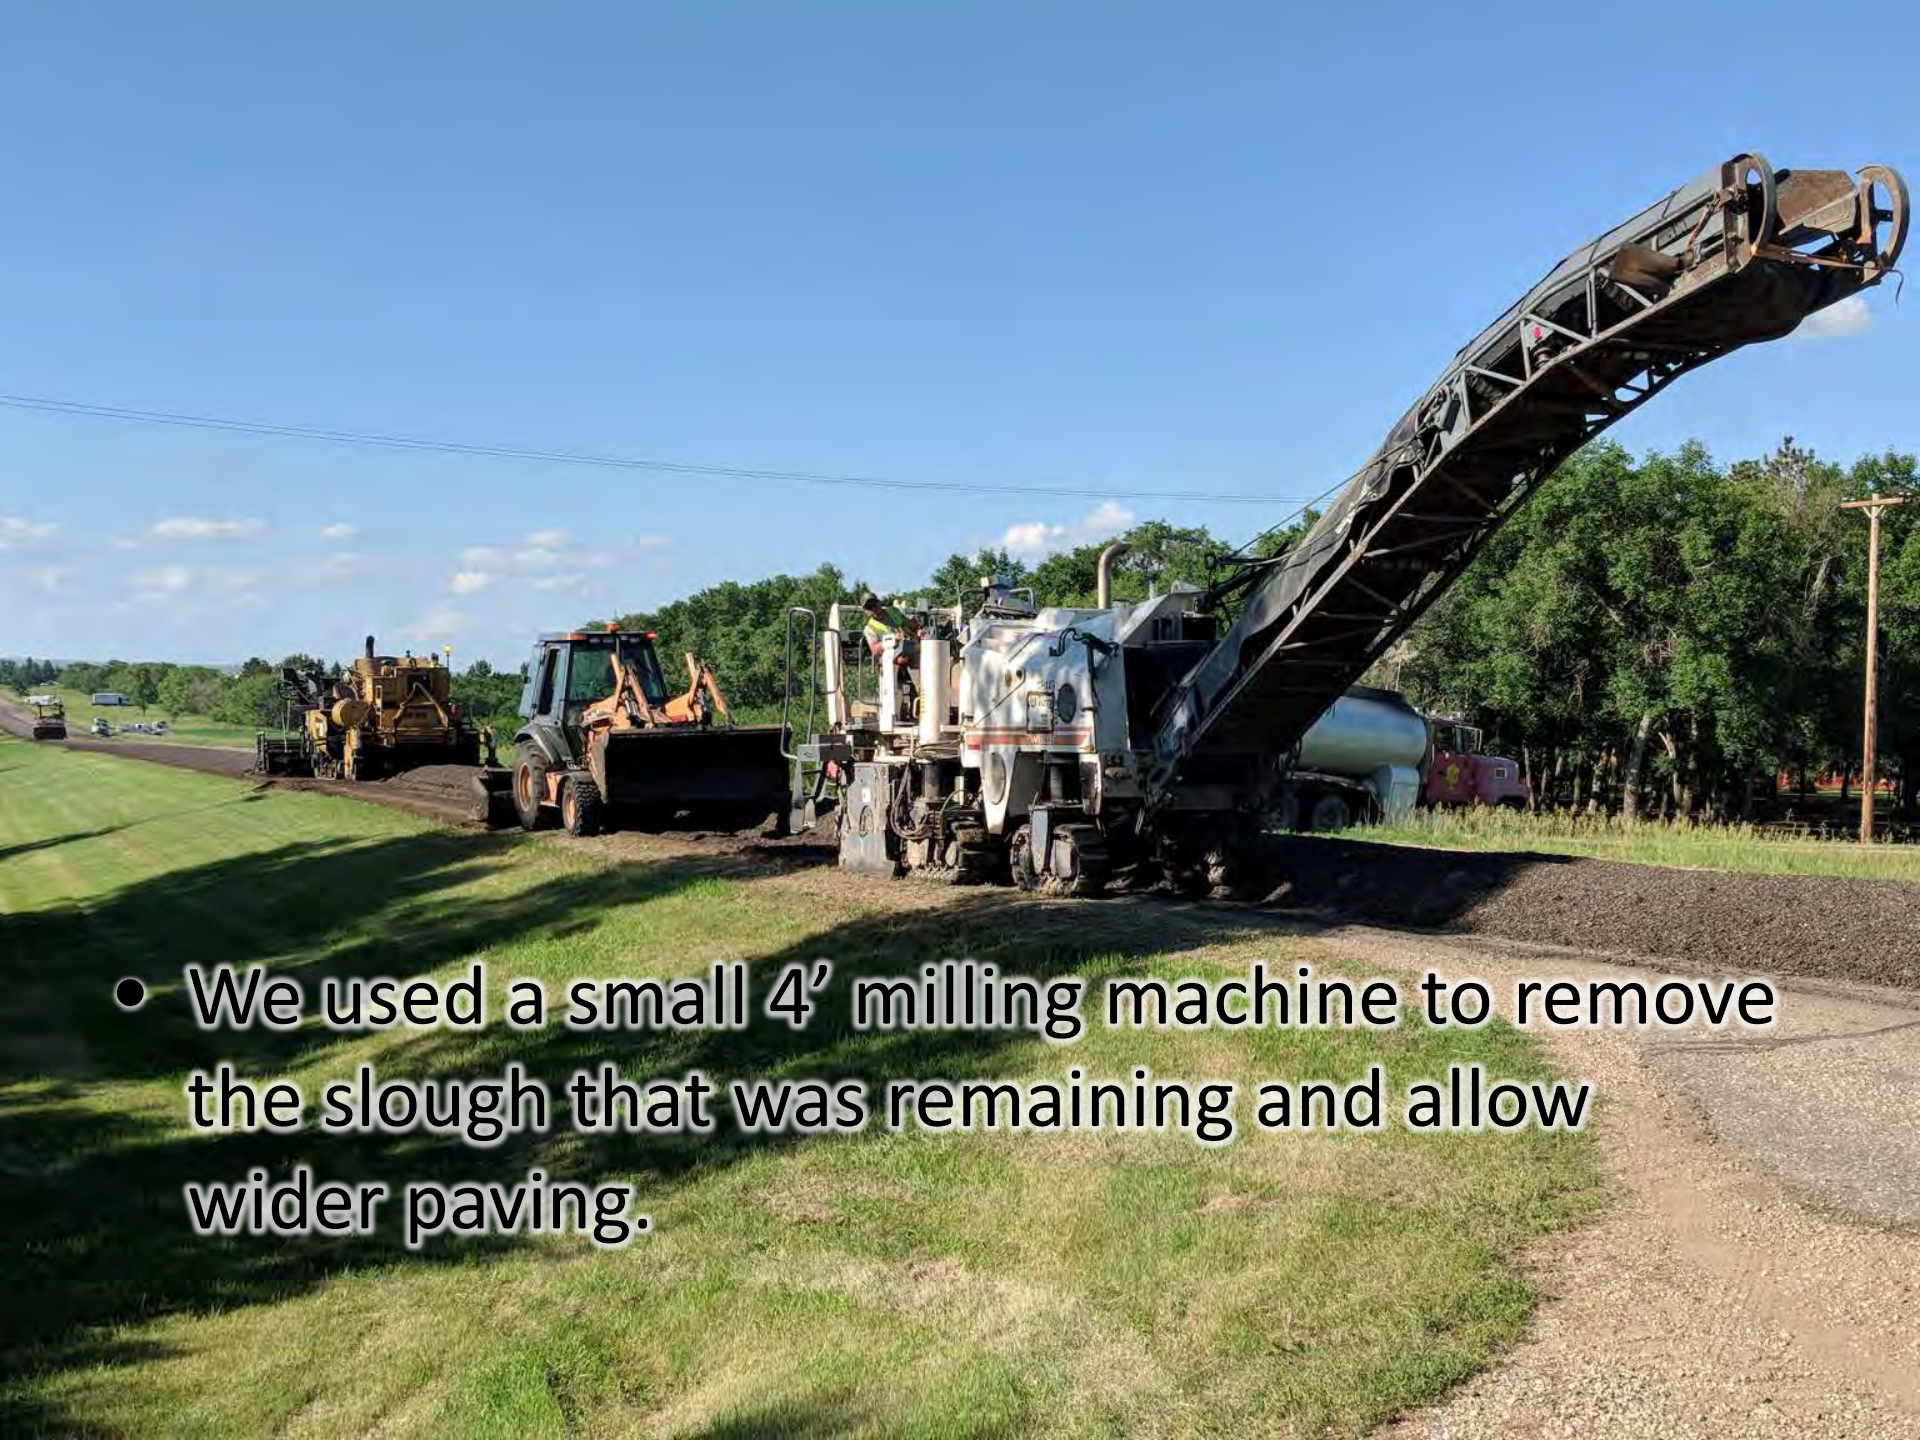
-  
- The milling machine was not wide enough to get some of the existing slough material.

- We used a small 4' milling machine to remove the slough that was remaining and allow wider paving.

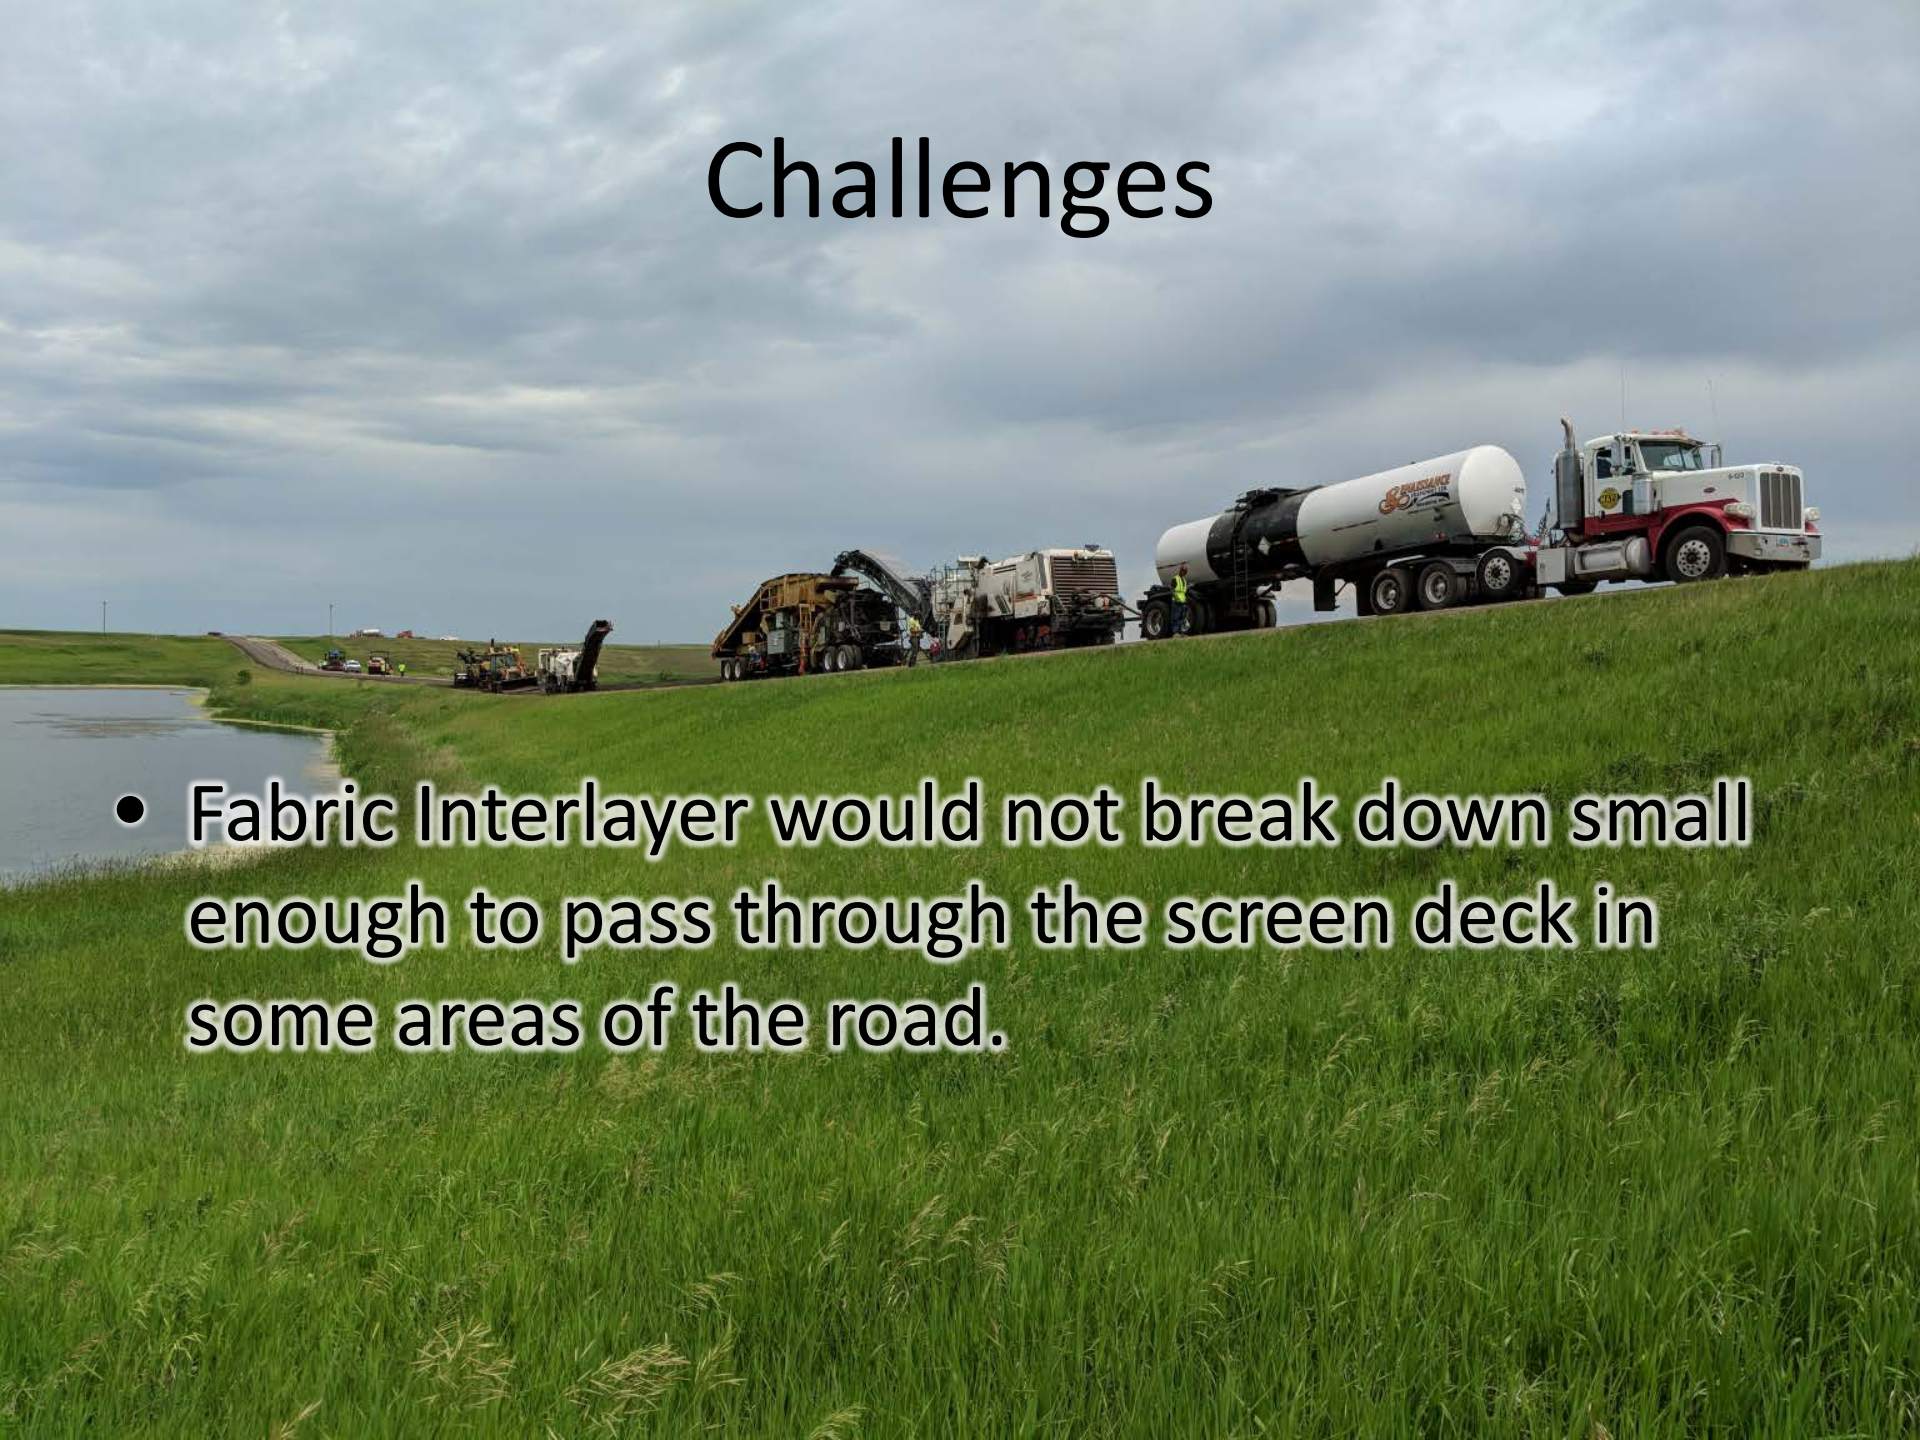
- Fabric Interlayer would not break down small enough to pass through the screen deck in some areas of the road.

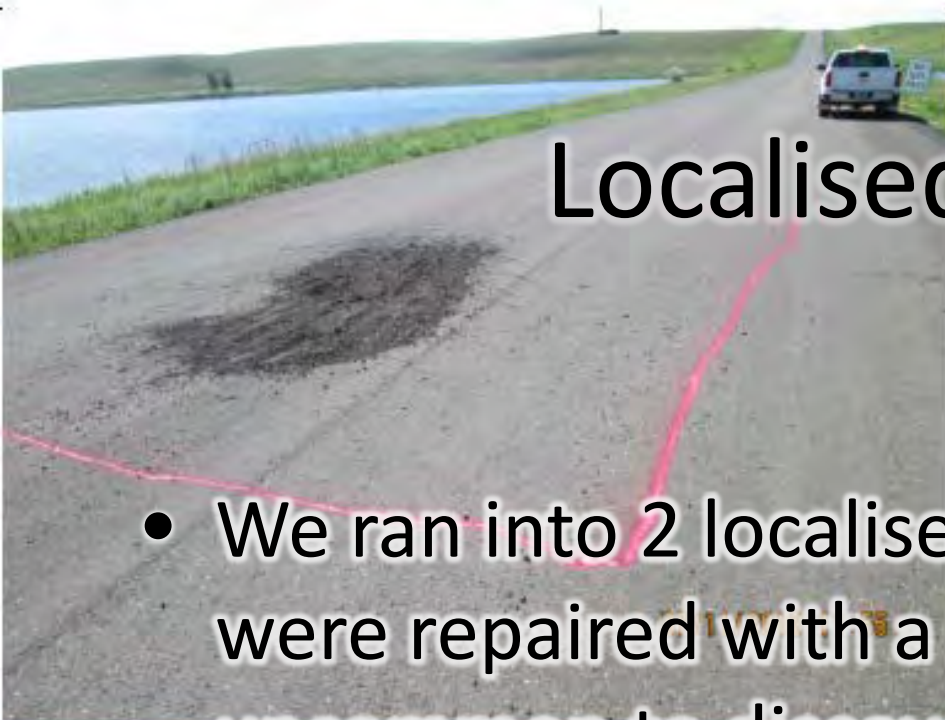
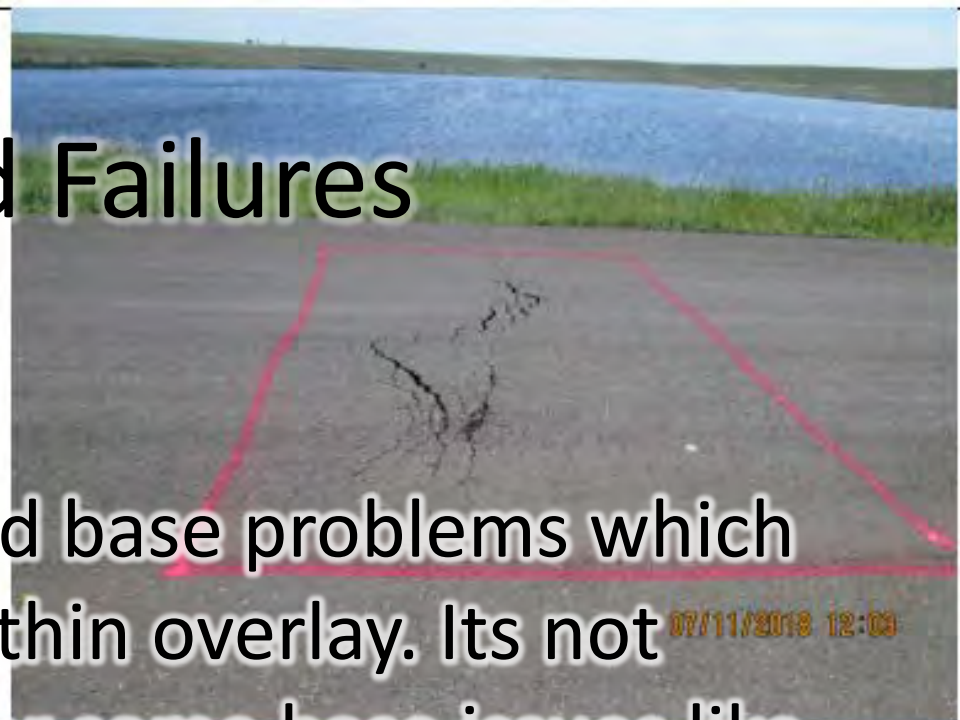
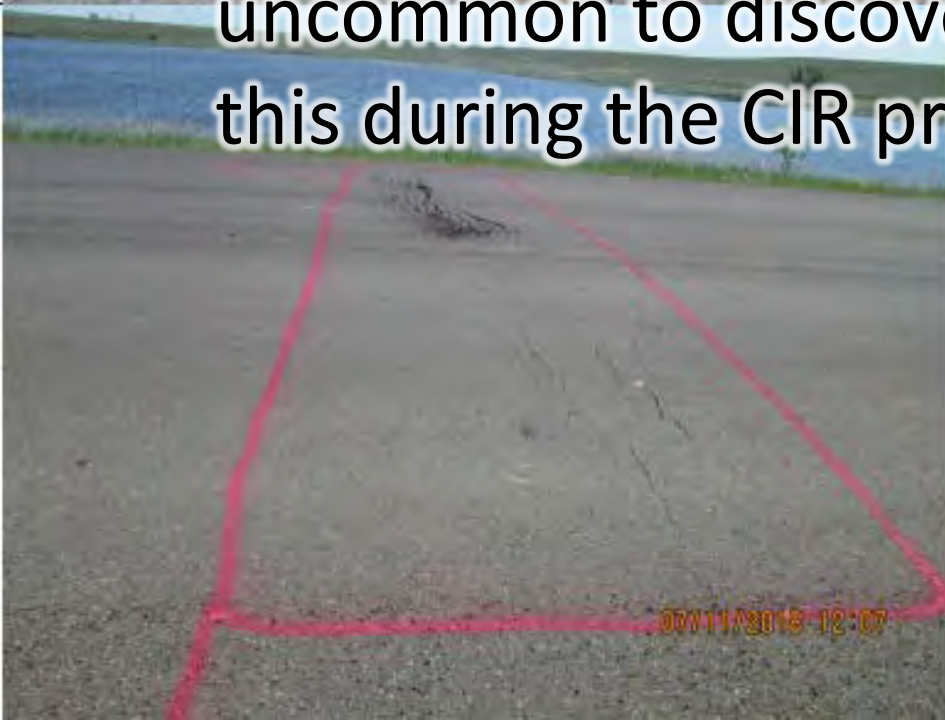
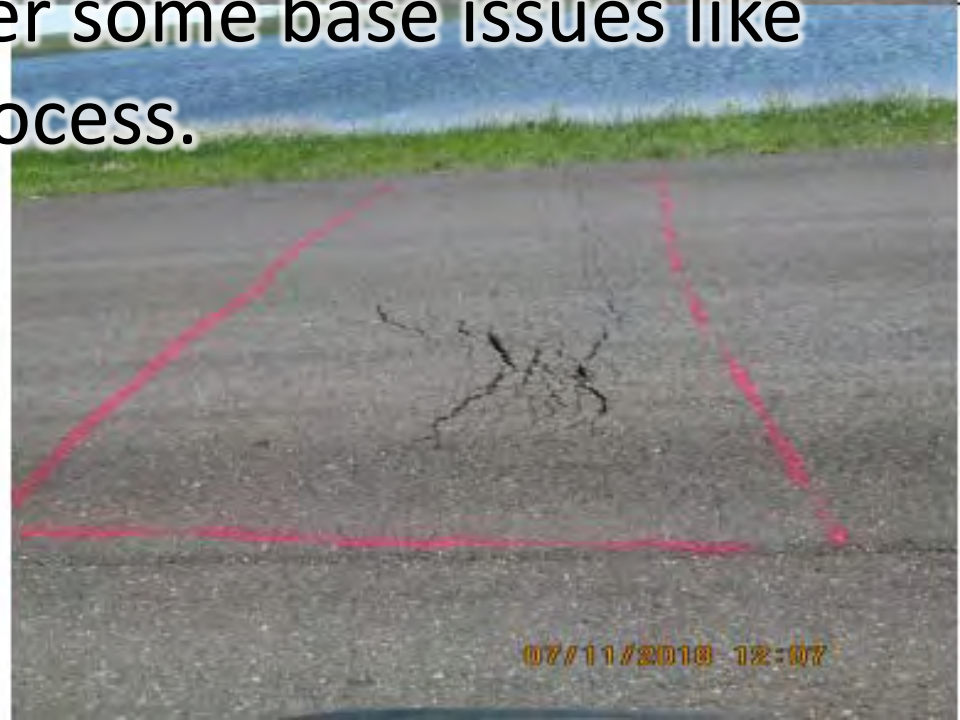
Sub cut

- We ran into 2 localised base problems which were repaired with a thin overlay. Its not uncommon to discover some base issues like this during the CIR process.
