NTSB Investigative Process Office of Highway Safety

Shawn Currie

Multivehicle Crash Mt. Pleasant Township, Pennsylvania

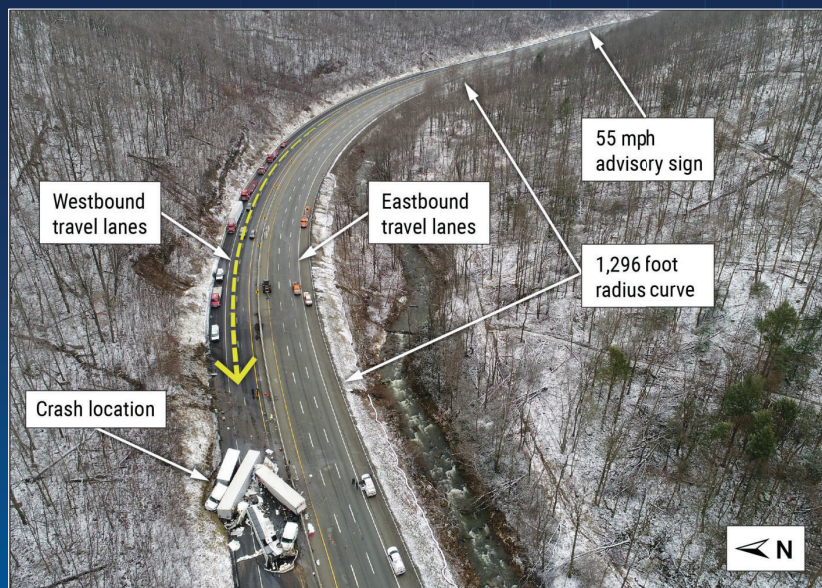
Crash Scene

- Vehicles at final rest
- Left-hand curve
- East and westbound lanes
- 55-mph warning sign

Source: Pennsylvania State Police – NTSB overlay

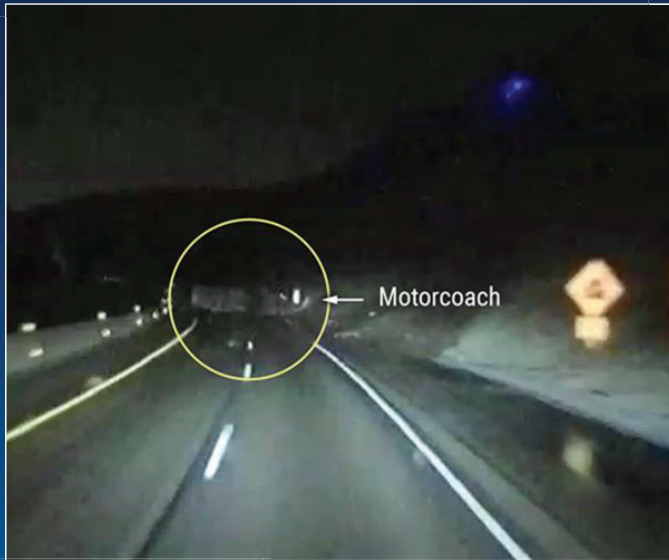
Overtaken Motorcoach

Source: FedEx forward-facing video, annotated by NTSB

- Initial position of rest was blocking both travel lanes and shoulders
- Entered curve at 77 mph
- Light braking upon entering curve decreased speed to 70 mph
- After brakes released vehicle speed changes not associated with braking or throttle occurred
- Speed changes consistent with vehicle yawing from excessive steering inputs
- Sufficient roadway traction existed for normal travel

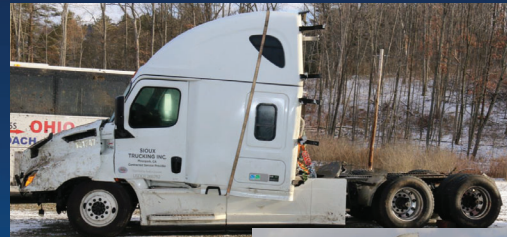
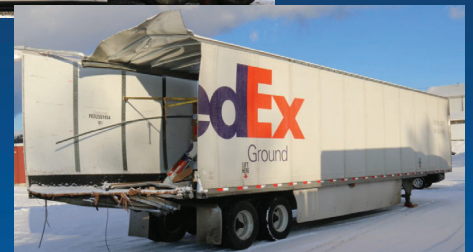
FedEx Combination Unit

2018 Freightliner Cascadia

2019 53' Hyundai Translead semitrailer

- Traveling through curve at 53 mph in right lane
- Had been passed by motorcoach 79 seconds before the two collided
- Driver responded about 5 seconds before impact
- Driver steered left and braked, impacted motorcoach at about 21 mph

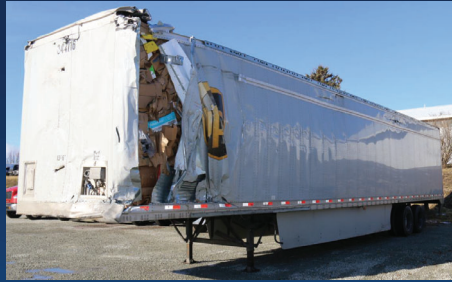
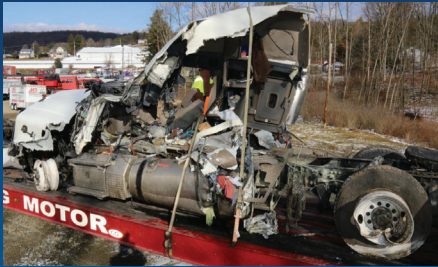
UPS-1 Combination Unit

2018 Freightliner Cascadia

2018 53' Stoughton semitrailer

- Entered curve at 71 mph, traveling in left lane
- Evidence that driver braked and swerved to the right
- Tractor collided with right rear of FedEx trailer
- Average speed 67 mph during preceding two hours of travel on turnpike

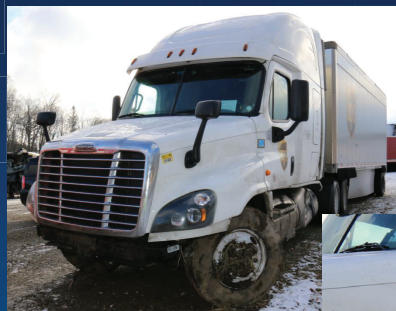
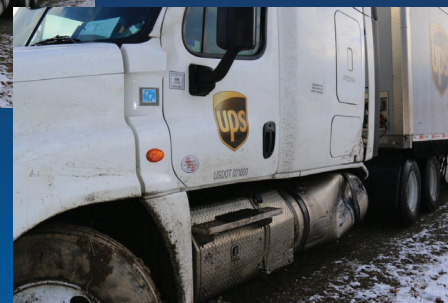
UPS-2 Combination Unit

- Entered curve at 69 mph, traveling in right lane
- Driver braking lightly to control speed
- Driver observed UPS-1 impact, increased braking and swerved toward right shoulder
- Average speed 65 mph during preceding 2.5 hours of travel on turnpike

2018 Freightliner Cascadia
2020 28.5' Stoughton semitrailer

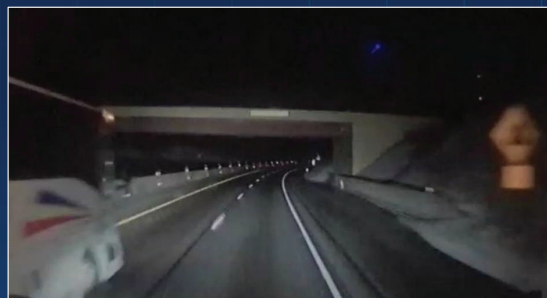
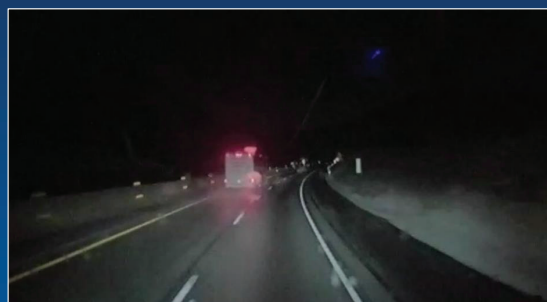
Onboard Video Event Recorders

- FedEx truck video system provided key information:
 - Motorcoach speed and lane position when passing
 - Position and visibility of overturned motorcoach on roadway
 - FedEx driver reacted quickly to hazard
 - FedEx truck speed and crash severity

Source: FedEx forward-facing video

- Forward- and inward-facing video event recorder system on the FedEx truck provided valuable information
- Video event recorder systems can provide key safety information about crash circumstances
- Video event recorder systems can be proactively used to improve driver performance
- What we propose:
 - One recommendation to the National Highway Traffic Safety Administration
 - One recommendation to the Federal Motor Carrier Safety Administration
 - One reiteration to the American Bus Association, United Motorcoach Association

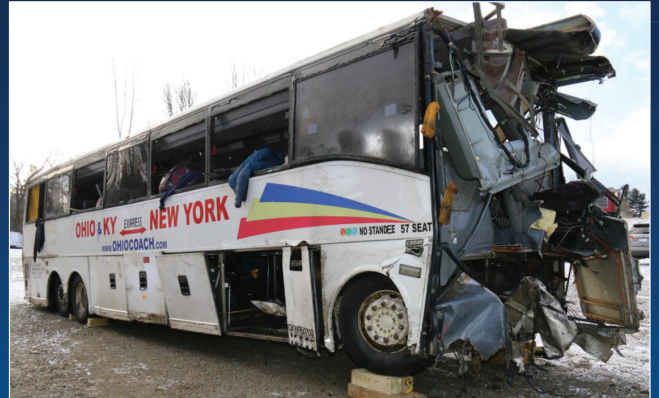
Lack of Data on Motorcoach

- Cause of motorcoach initial loss of control
- Driver performance including steering inputs and fatigue
- Engagement of engine brake

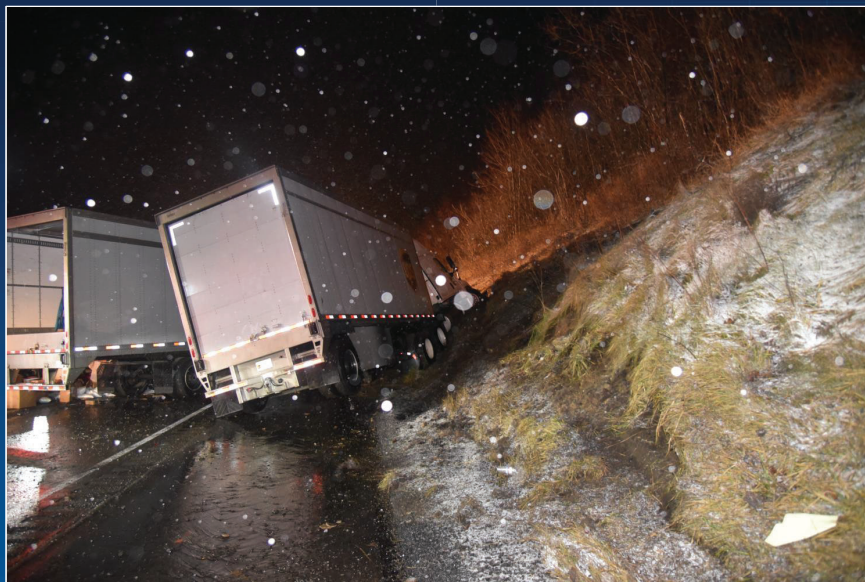
Environmental Conditions

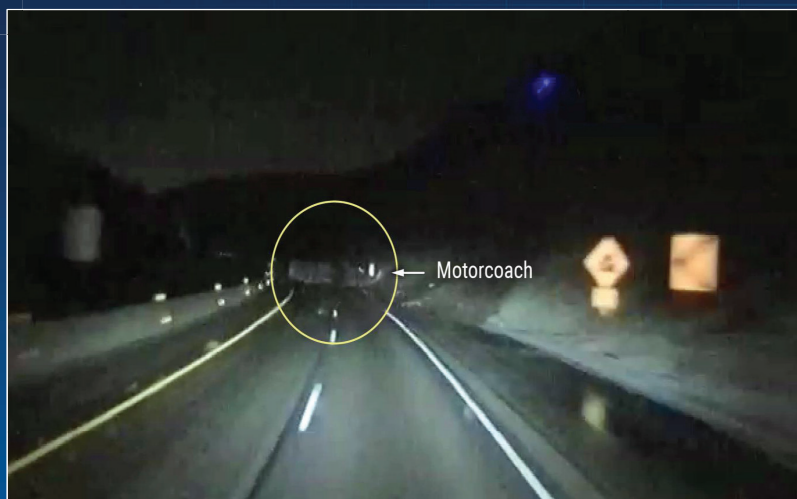
FedEx Driver Response

- FedEx truck entered curve at 53 mph
- Driver steered to left, applied brake
- Driver reacted within 0.3 seconds
- FedEx truck slowed to 21 mph

Source: FedEx truck forward-facing video, annotated by NTSB

- FedEx driver reduced speed on wet roadway, reduced crash severity
- UPS-1 driver's initial speed too fast for wet roadway conditions
 - Driver's braking attempt failed to reduce speed before impact
 - Contributed to severity of crash from impact speed
- UPS-2 driver had visual cues to warn of collisions ahead

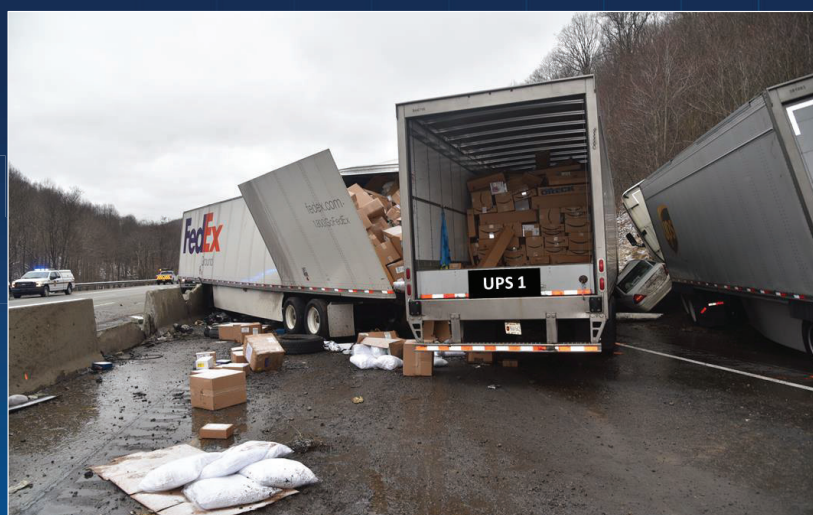
UPS-1 Driver Response

- UPS-1 entered curve at 71 mph
- FedEx truck had begun slowing
- Driver applied brakes, steered right
- UPS-1 collision occurred at 56 mph

Source: Pennsylvania State Police, annotated by NTSB

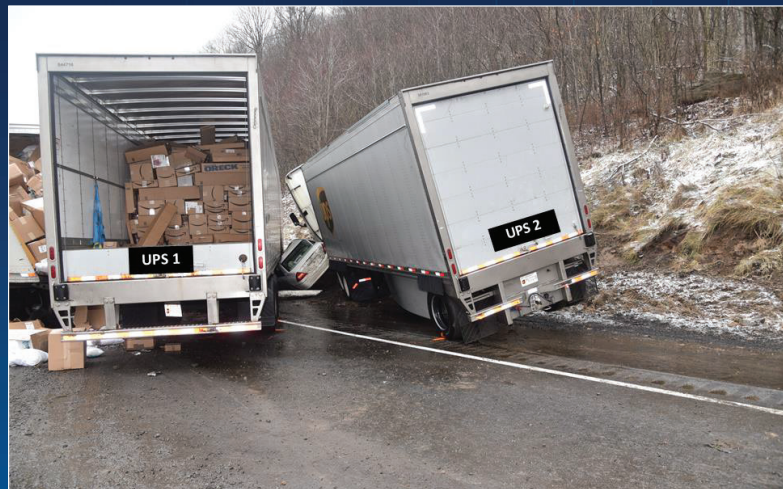
UPS-2 Driver Response

- UPS-2 entered curve at 69 mph
- UPS-2 3–5 seconds behind UPS-1
- Driver observed UPS-1 collision
- Driver applied brakes, steered right
- UPS-2 came to rest next to sedan

Source: Pennsylvania State Police, annotated by NTSB

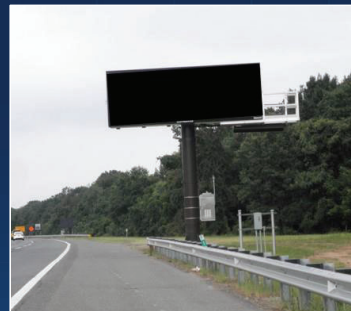
Signage

- 38 signs installed along westbound lanes
- 5 dynamic message signs
- “Curves ahead” advisory speed sign with flashing beacons
 - Warn motorists to reduce speed to 55 mph, particularly at night
- Connected vehicle technology
 - Harrisburg Connected Project

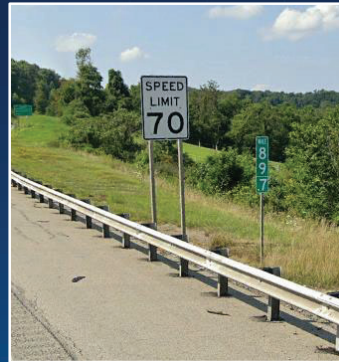
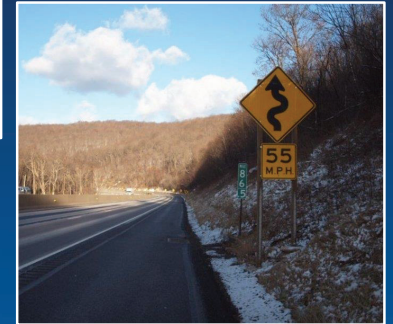
Speed Limits

- Regulatory 70 mph speed limit
 - Maximum speed on highway section, established by law, and is enforceable
 - 1,054 miles of straight sections
- Advisory 55 mph speed sign
 - Recommended safe speed for all vehicles, not enforceable
- 150 horizontal curves (51 miles) for advisory speeds of 55, 60, 65 mph

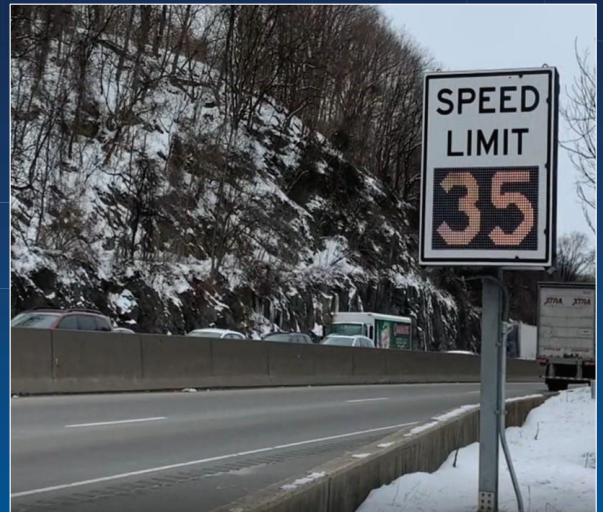
What We Found: *Variable Speed Limit Signs*

- Effective countermeasure to speeding
 - Dynamically resetting regulatory speed limit
 - Response to changing roadway conditions
 - Speed limit is enforceable
- PDOT installed variable speed limit signs on I-76
- May have prevented the crash

Source: Pennsylvania Department of Transportation

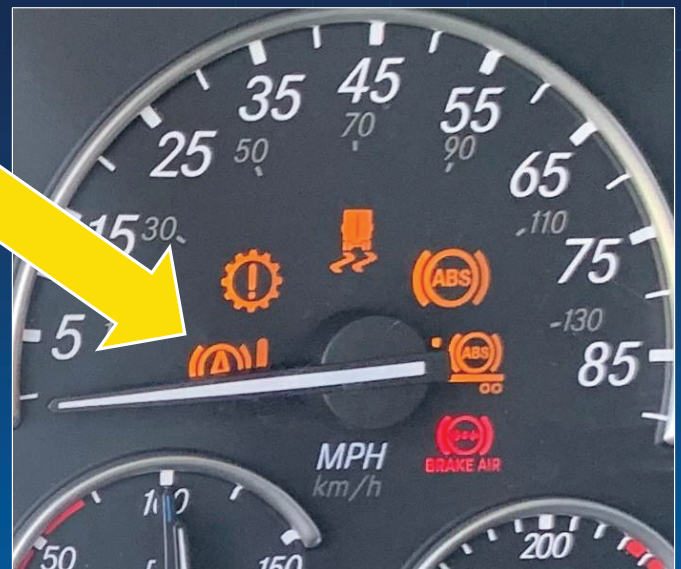
Maintenance Issues

- UPS Truck 1 – misaligned radar sensor
- Error code and warning since June 2019
 - Detected by Penske in July 2019
 - Noted several times on maintenance records
 - No Driver Vehicle Inspection Report (DVIR) entry by driver

- Penske
 - Places vehicle with Forward Collision Avoidance System defects out of service
 - Lessor receives notification email
 - Between May 2020 and December 2021, over 6,300 vehicles affected
- UPS
 - Changed driver training
 - Changed check ride form to account for advanced safety systems

- Maintaining the full functionality of installed collision avoidance systems is critical to vehicle safety
- If drivers report defects or faults in collision avoidance system, repairs can be made more readily, improving safety
