149th Avenue NW

Burleigh County Awards Project

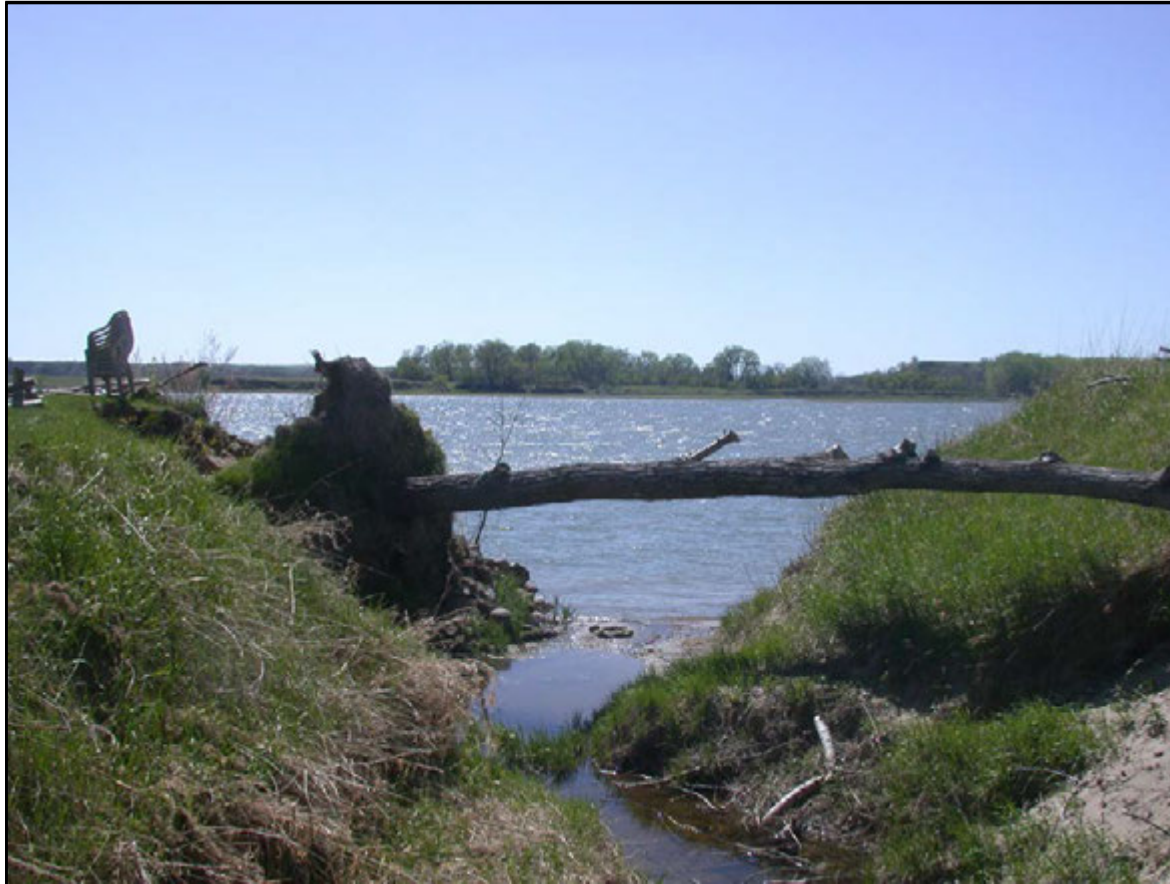
Project Design – Storm Sewer and Open Channel

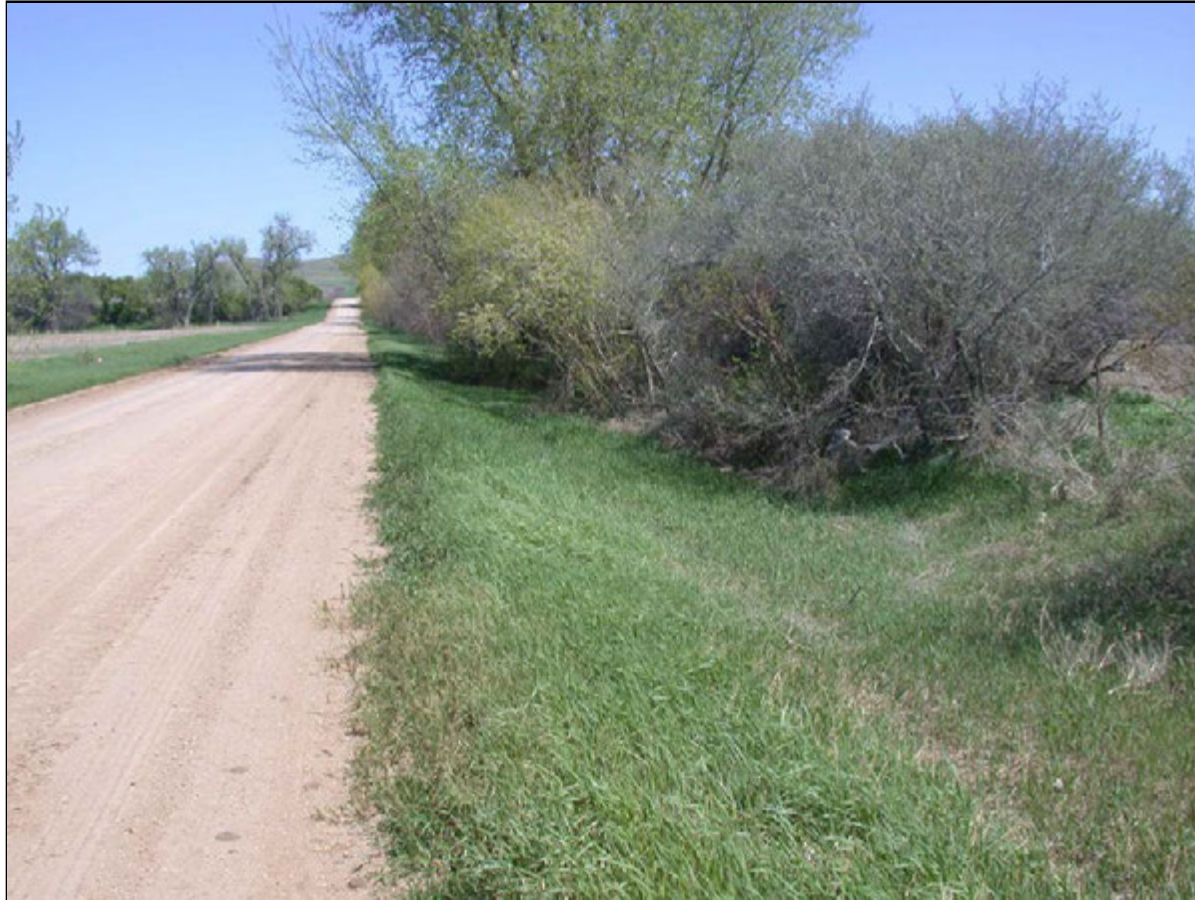
Project Design – Roadway Considerations

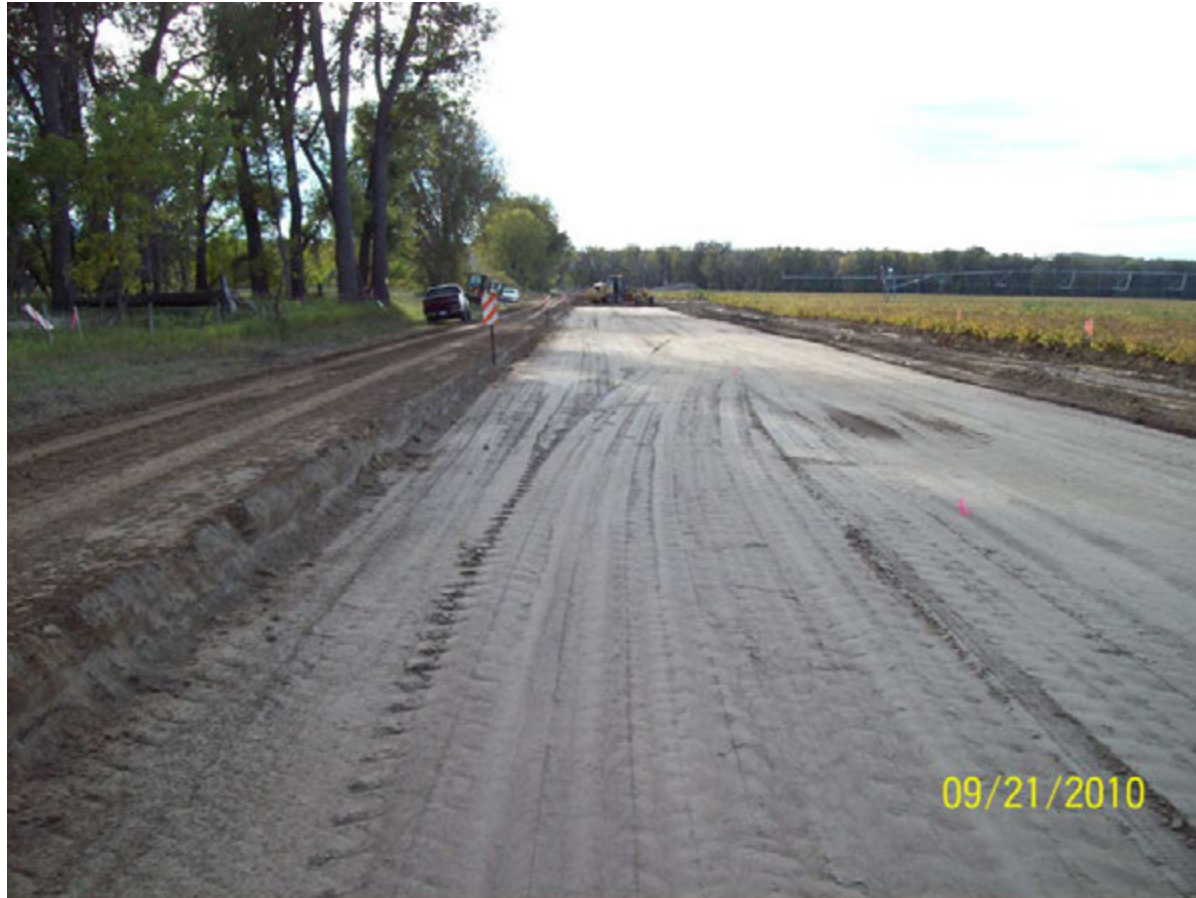
Construction-Road

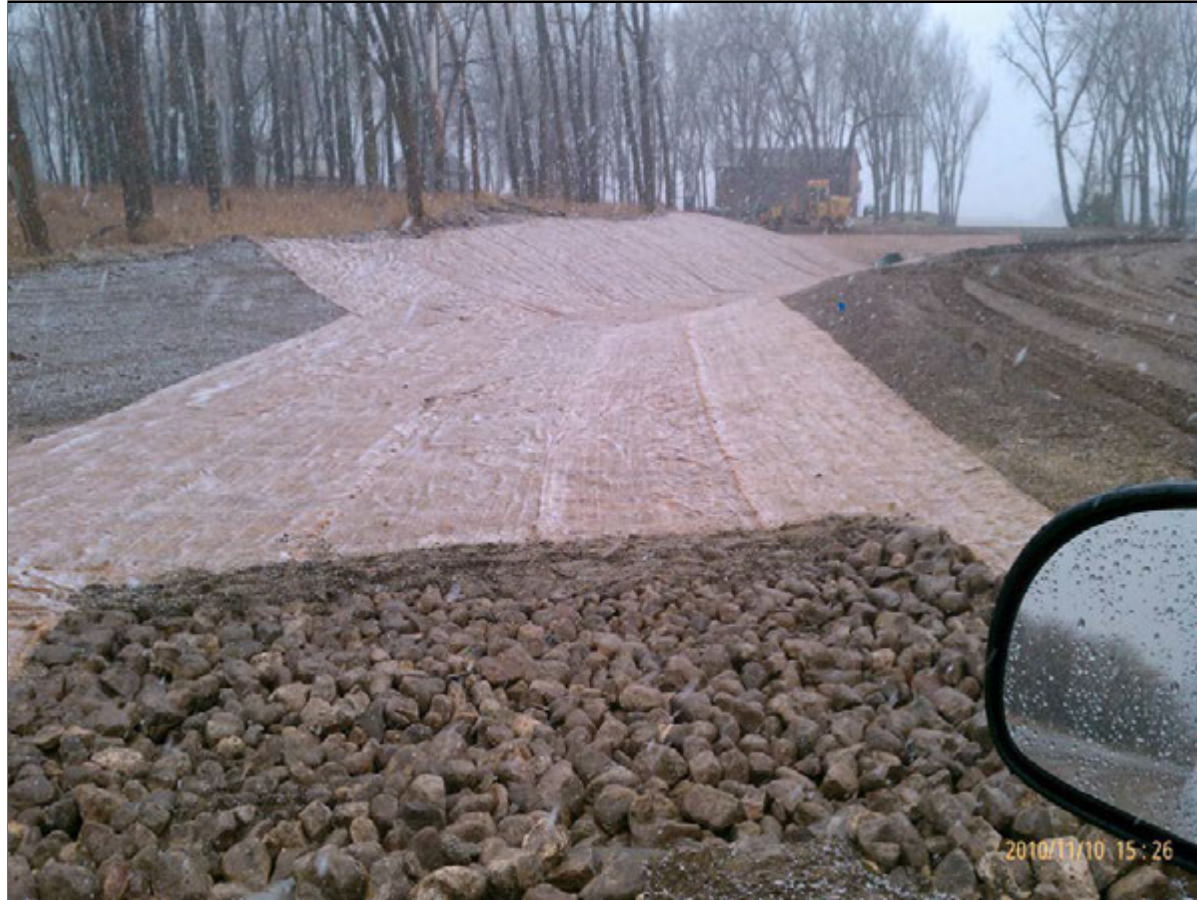
Construction-Storm

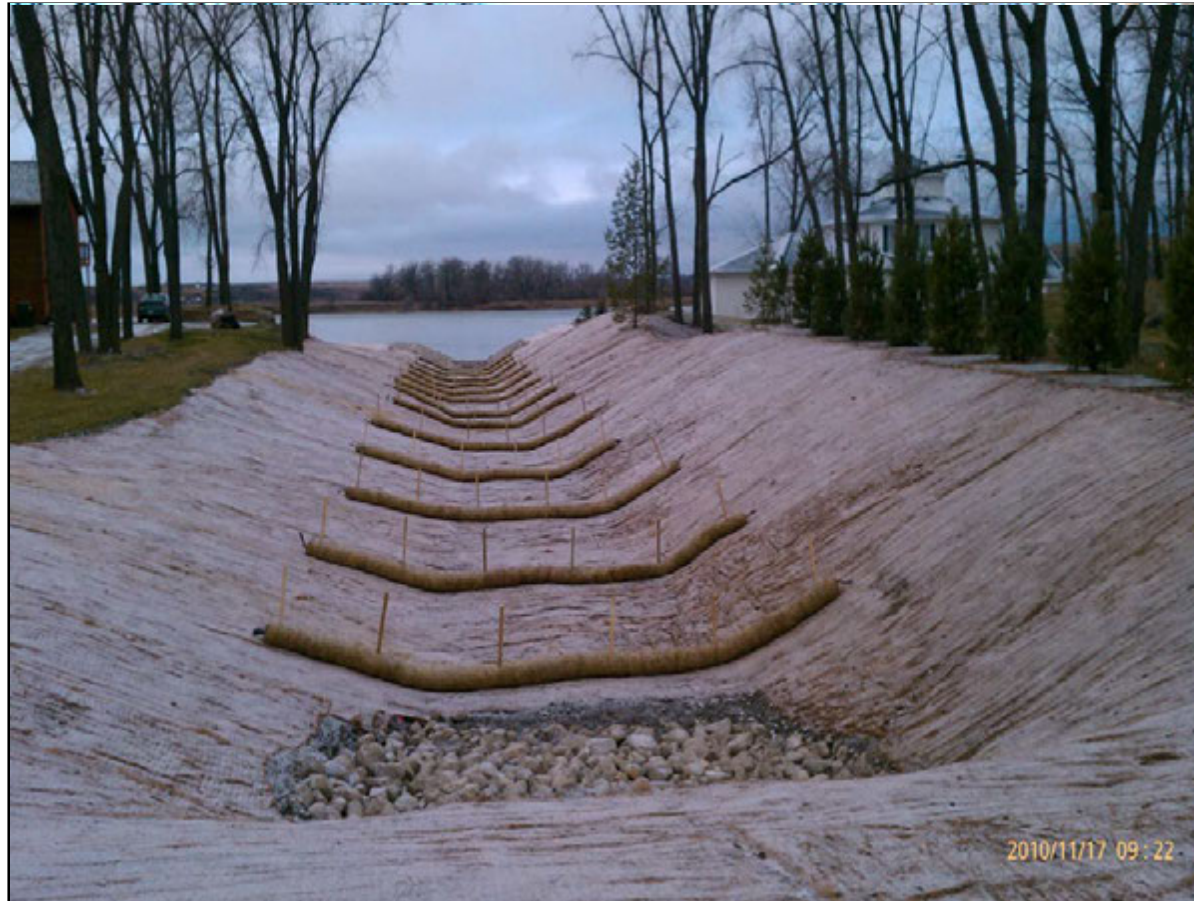
Construction-Ditch Channel

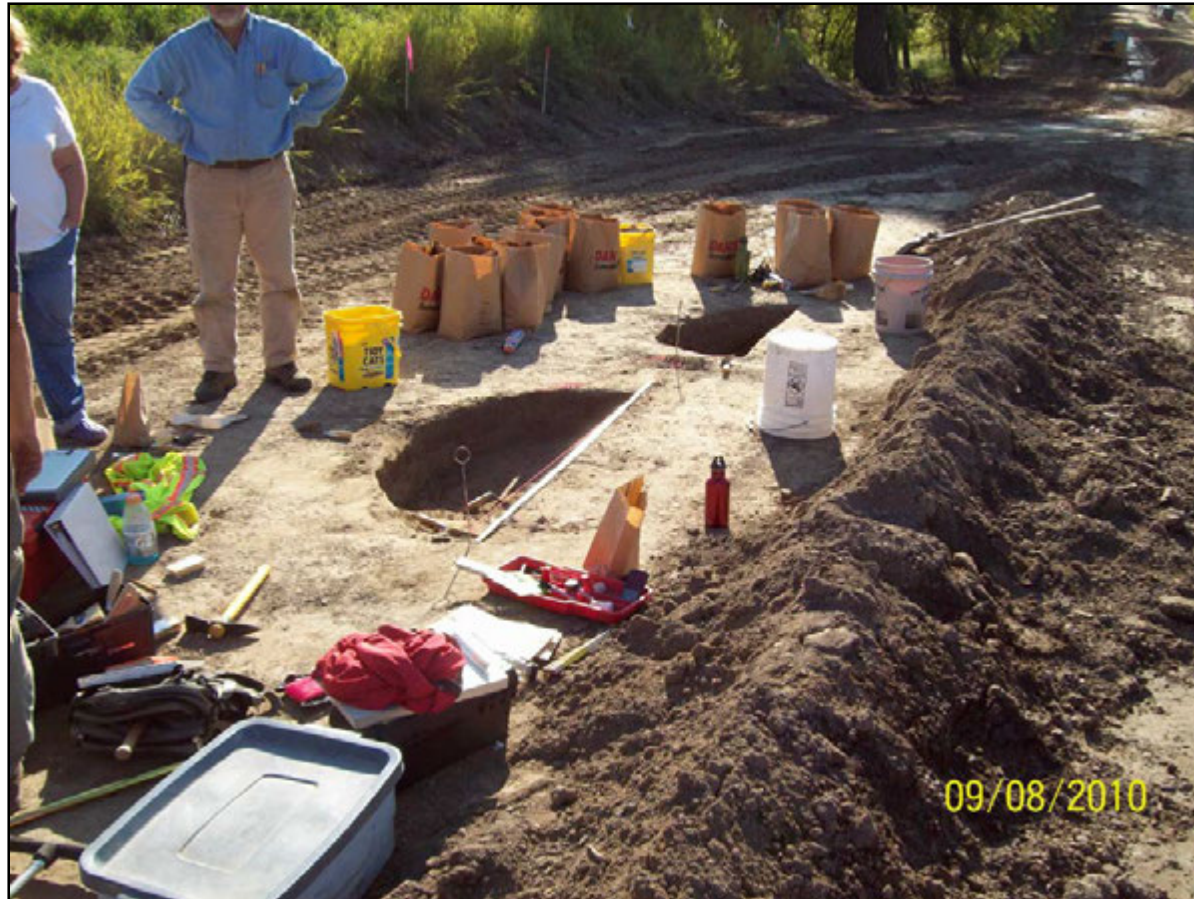
Construction-Cultural Impacts

- Reroute overland flow through storm sewer so erosion is minimized in cultural area.
- Excavate in smallest area possible.
- Construct road within limits of cultural area. Fill acceptable as long as it ties into existing.
- Equipment cannot park and material cannot be stored in cultural area.
- Officers patrolling area to protect artifacts.

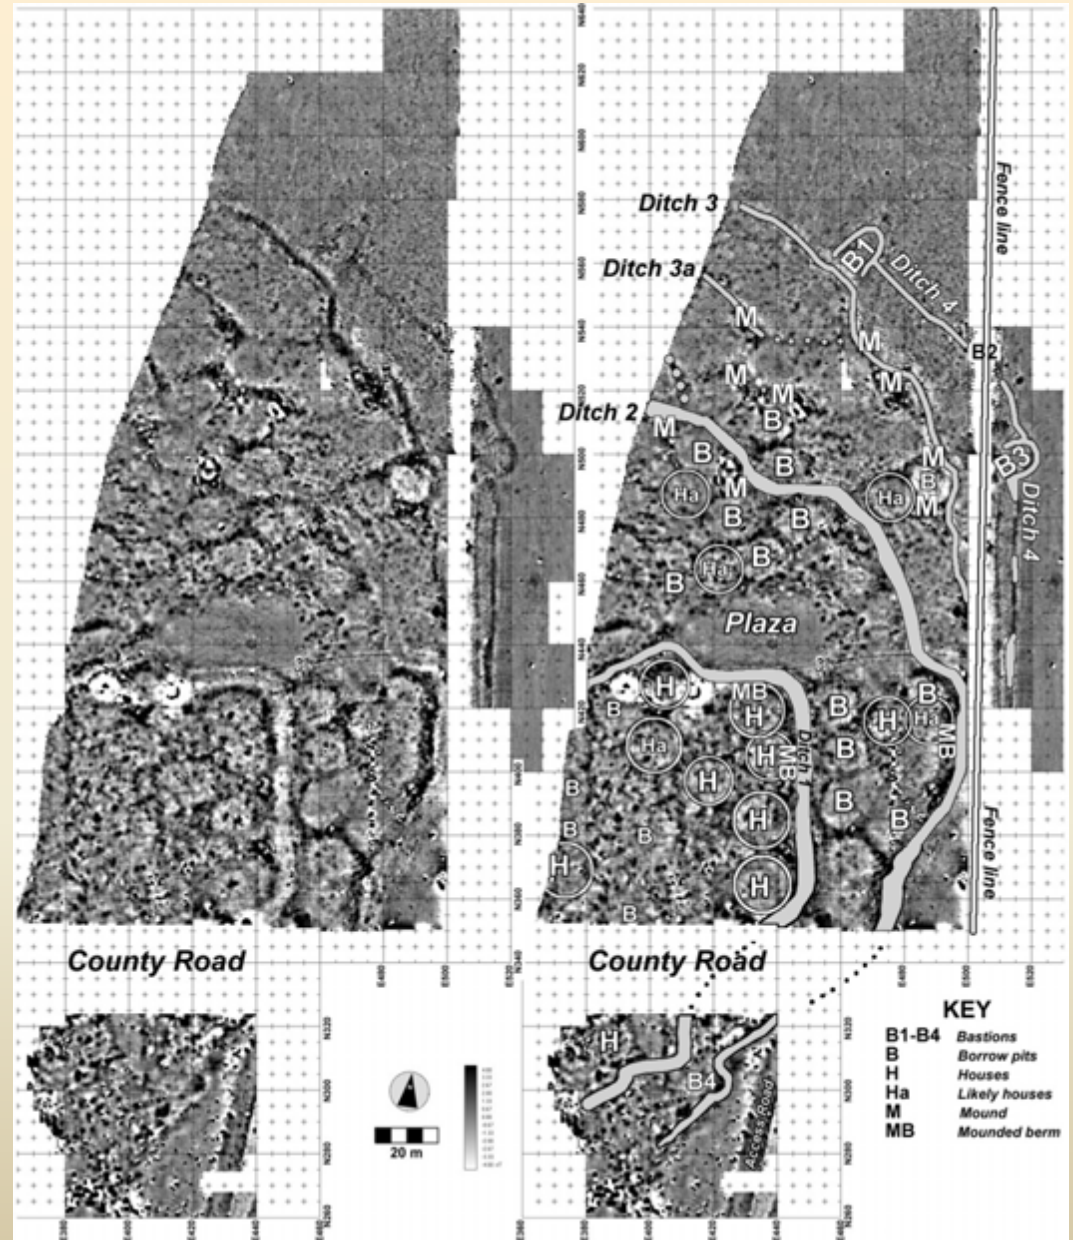
2006-2007 Geophysical Surveys at Larson

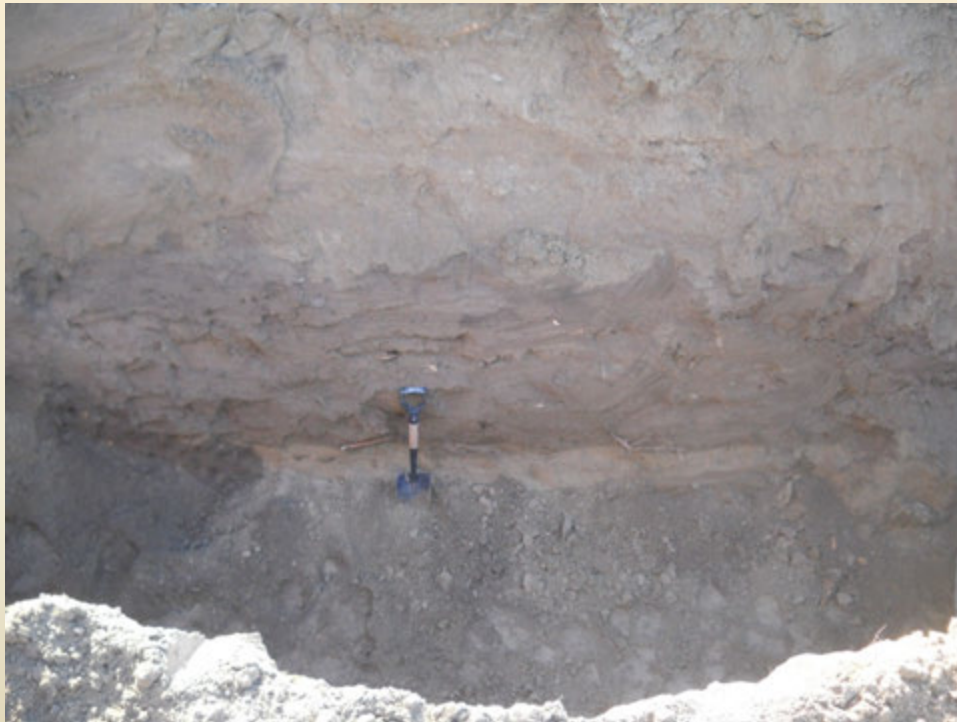
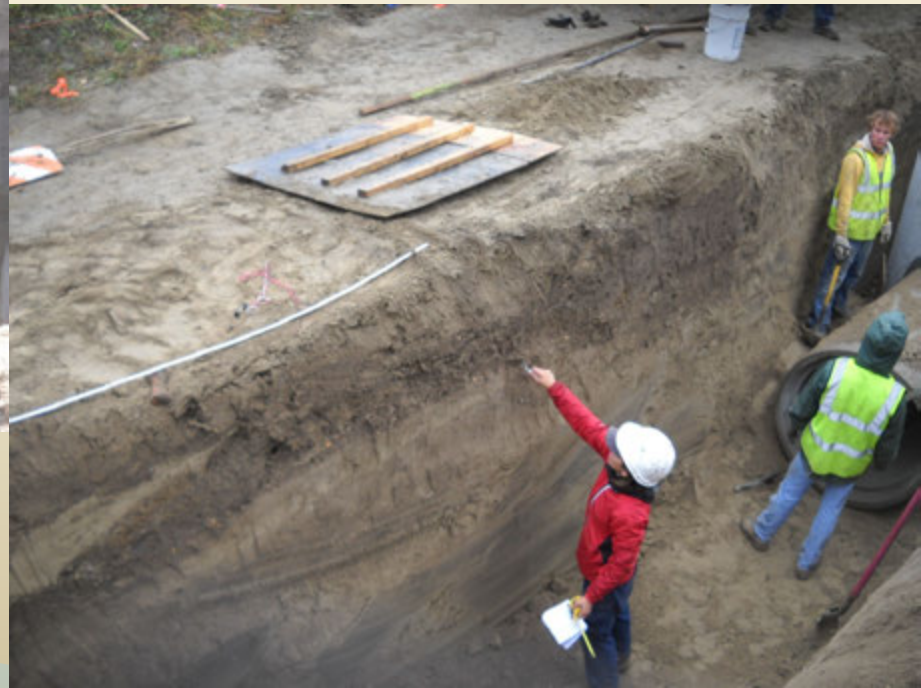
Fortification ditches
