Bridge 101

2019 County Roads Conference

Bryon Fuchs, PE

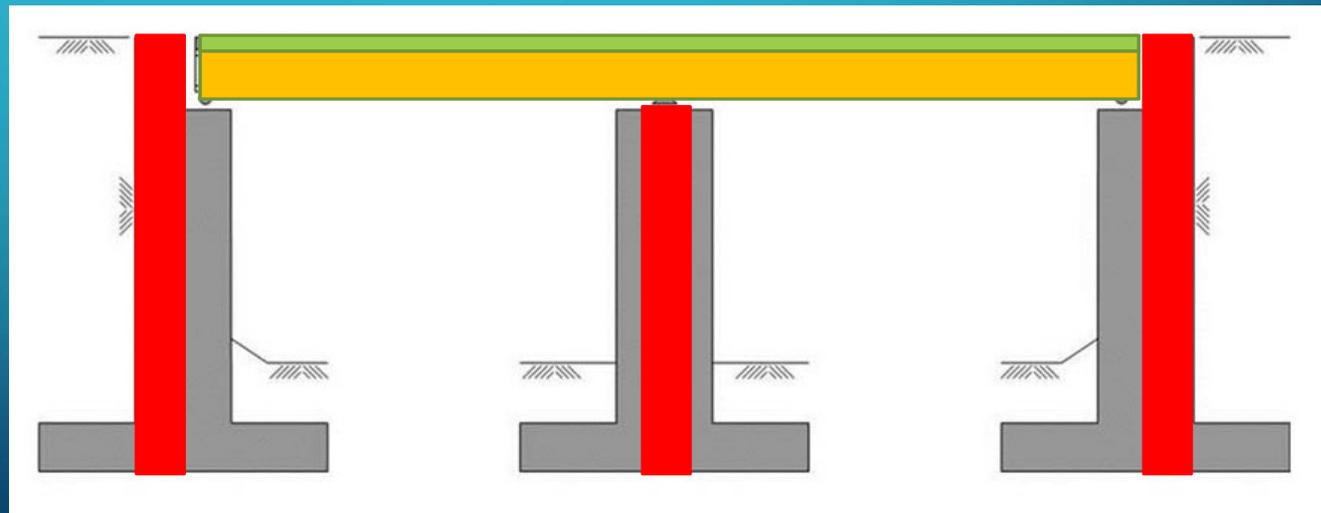
- Three Major Bridge Components
 - Deck
 - Superstructure
 - Substructure

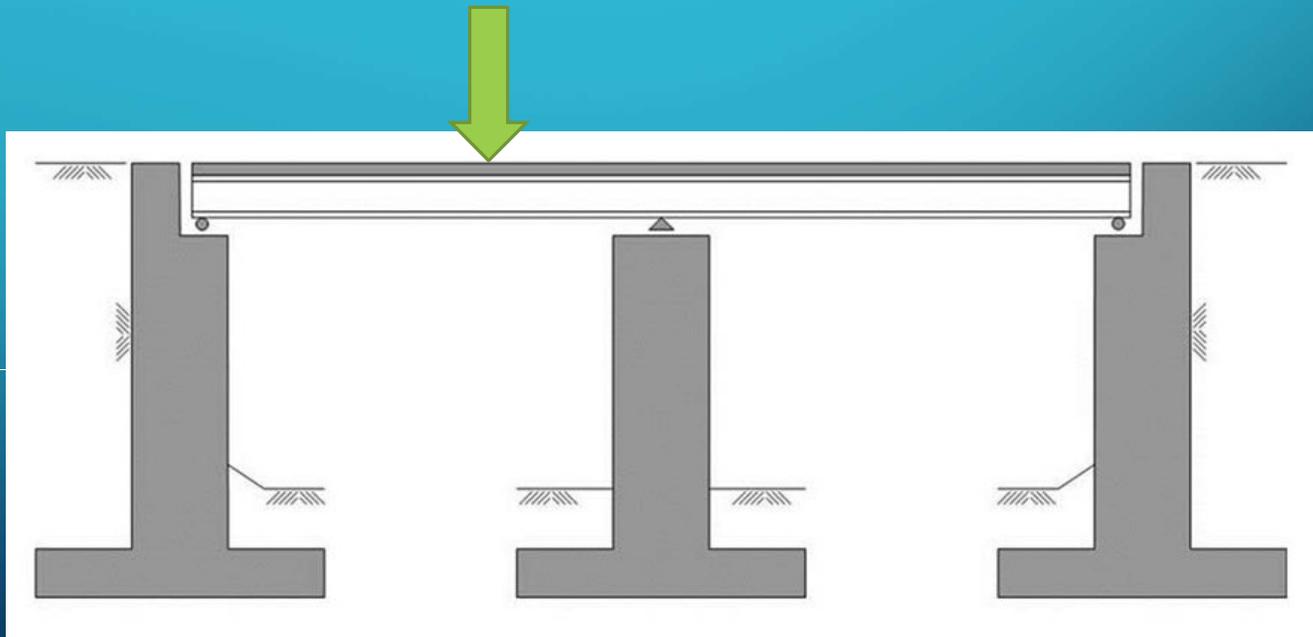
DECK

- Portion of the bridge that you drive on

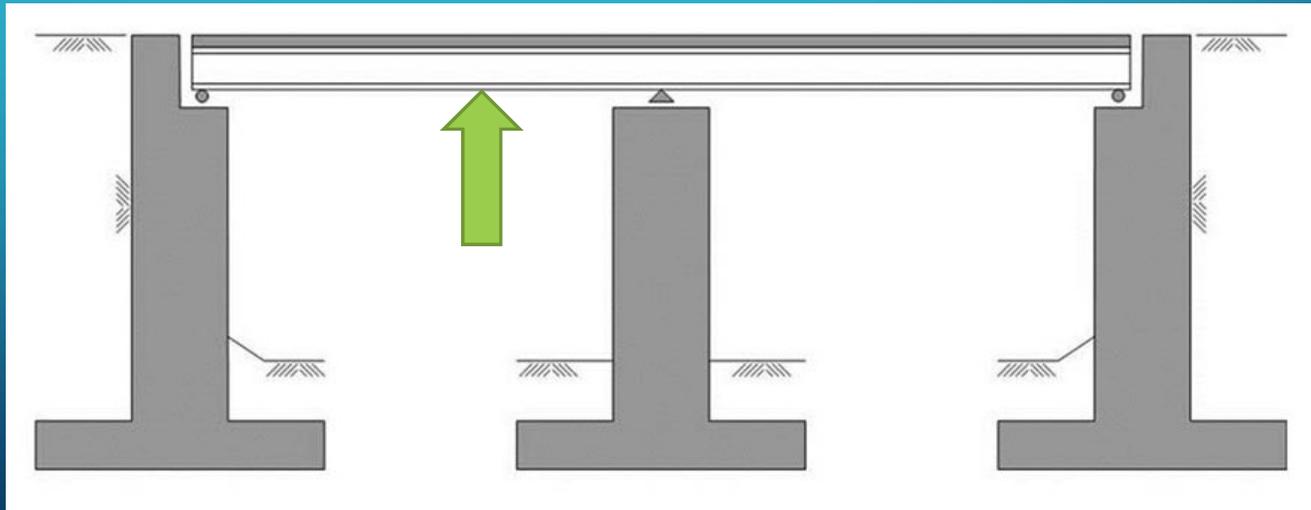
SUPERSTRUCTURE

- Portion of the bridge that lies directly below and supports the deck
 - Beams, girders, truss, arch

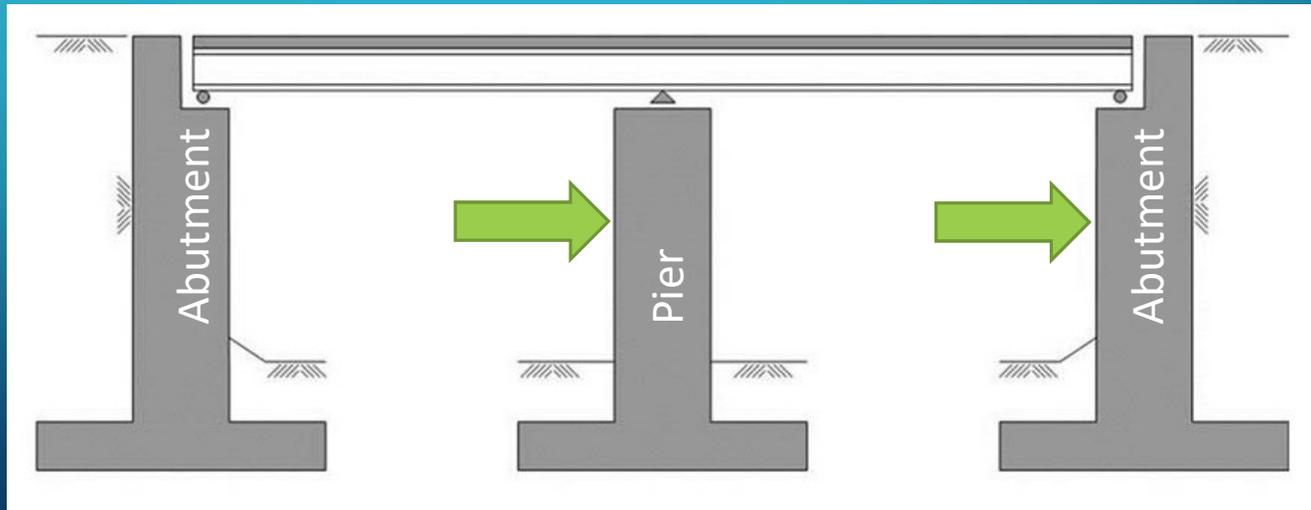
SUBSTRUCTURE

- Portion of the bridge that supports the deck and superstructure.
 - Abutments, piers

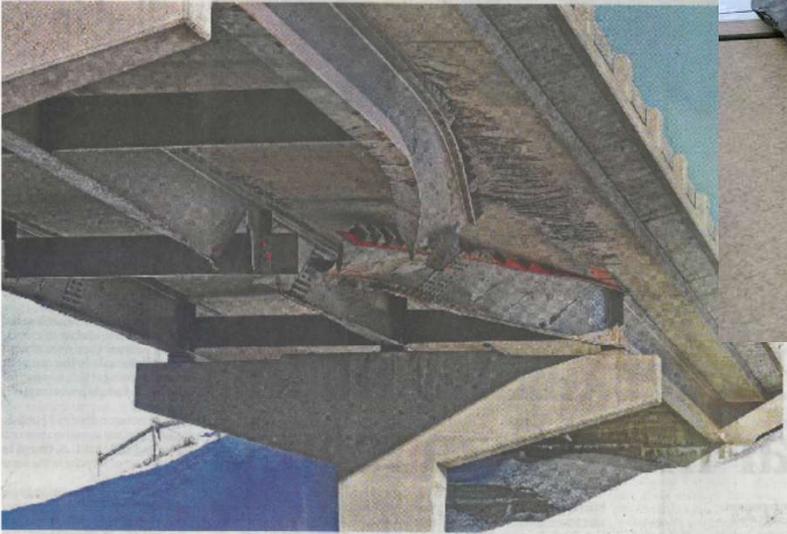
Truck crashes into bridge

Truck with an oversize load struck the underside of a bridge over Interstate 94 near mile marker 129 on Wednesday, leaving extensive damage to the underside of the overpass near McKenzie. The bridge, closed indefinitely until repairs can be made, carried local traffic on 275th Street Northeast in rural Bismarck.

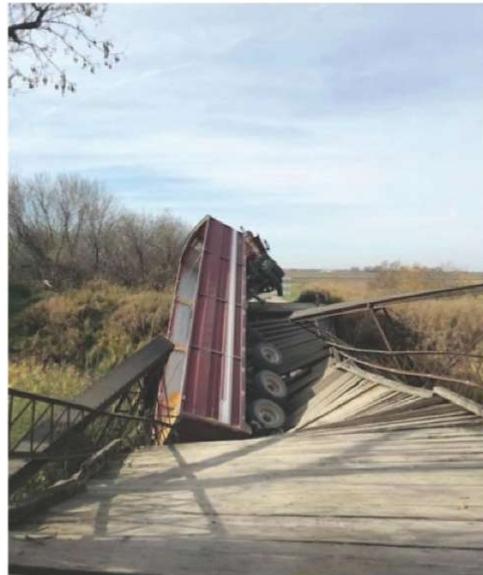
Bridge in rural N.D. collapses under weight of truck

FOREST RIVER, N.D. - A semi driver is lucky to be safe after a bridge caved while crossing it.

The truck appears to have been hauling grain when the bridge gave out, causing the cab of the truck to be caught in the air.

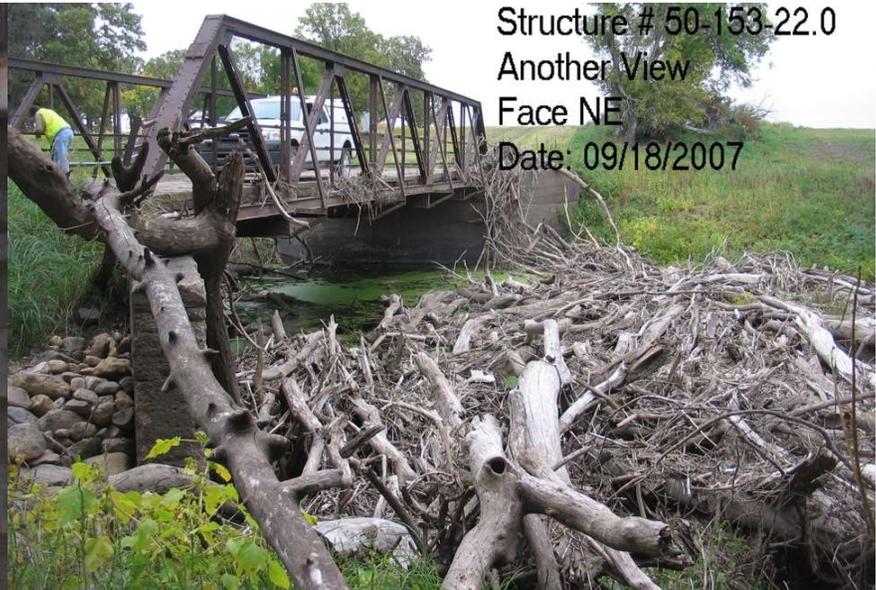
Structure # 50-153-22.0
Another View
Face NE
Date: 09/18/2007
