SDDOT/SDLTAP Surface Gravel Study Project Update

Lessons Learned Thus Far

Focus of Test Project

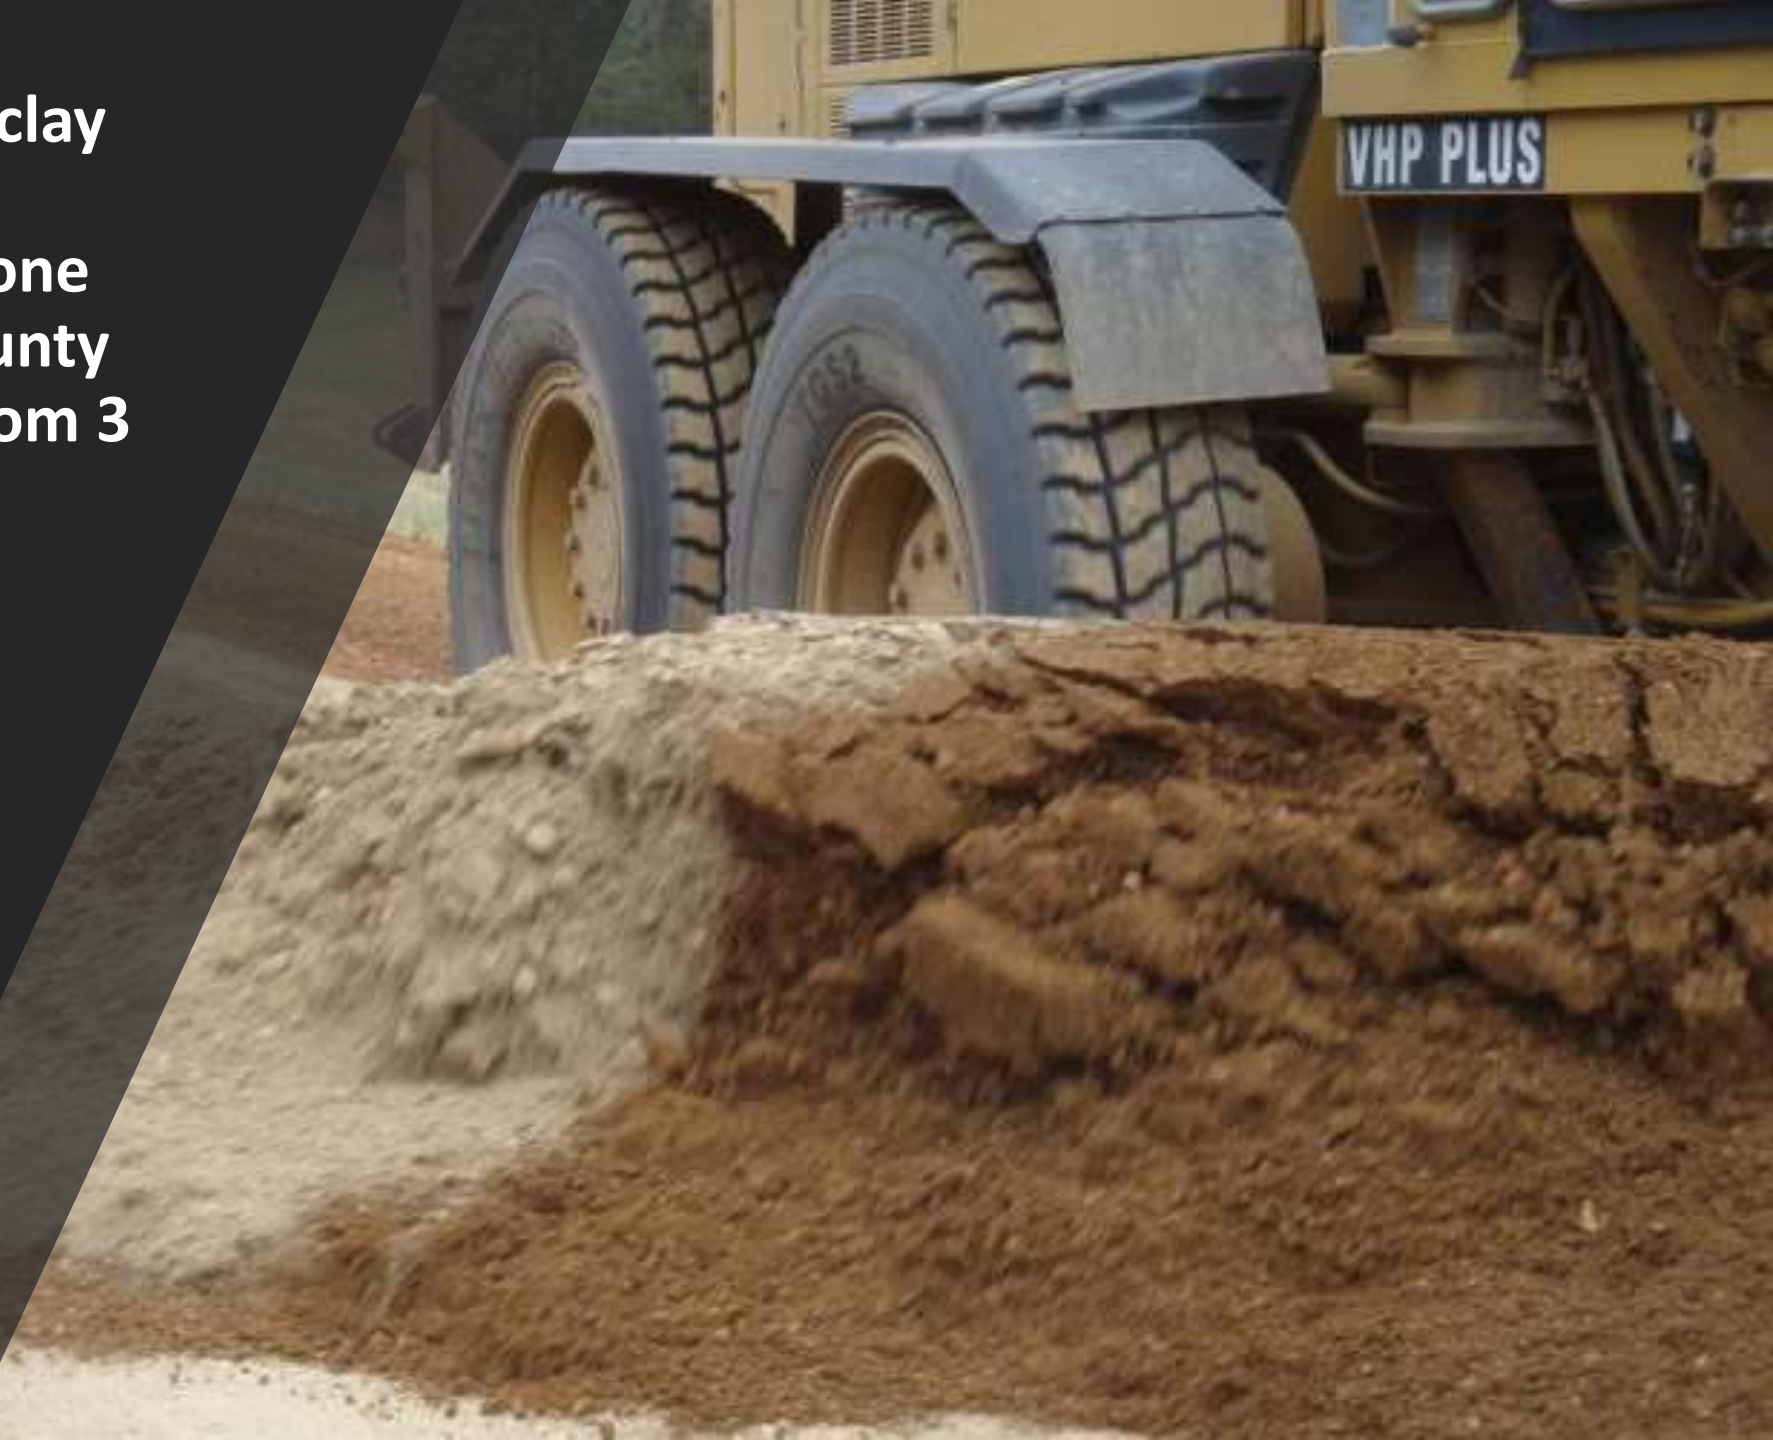
**Road mixing natural clay
to get the modified
surface gravel was done
on the Brookings County
Section – raised PI from 3
to 7**

One of the biggest challenges was finding gravel that meets the modified SDDOT Specification: “Shall have minimum plasticity index (PI) of seven”. (Even higher minimum was considered in project planning)

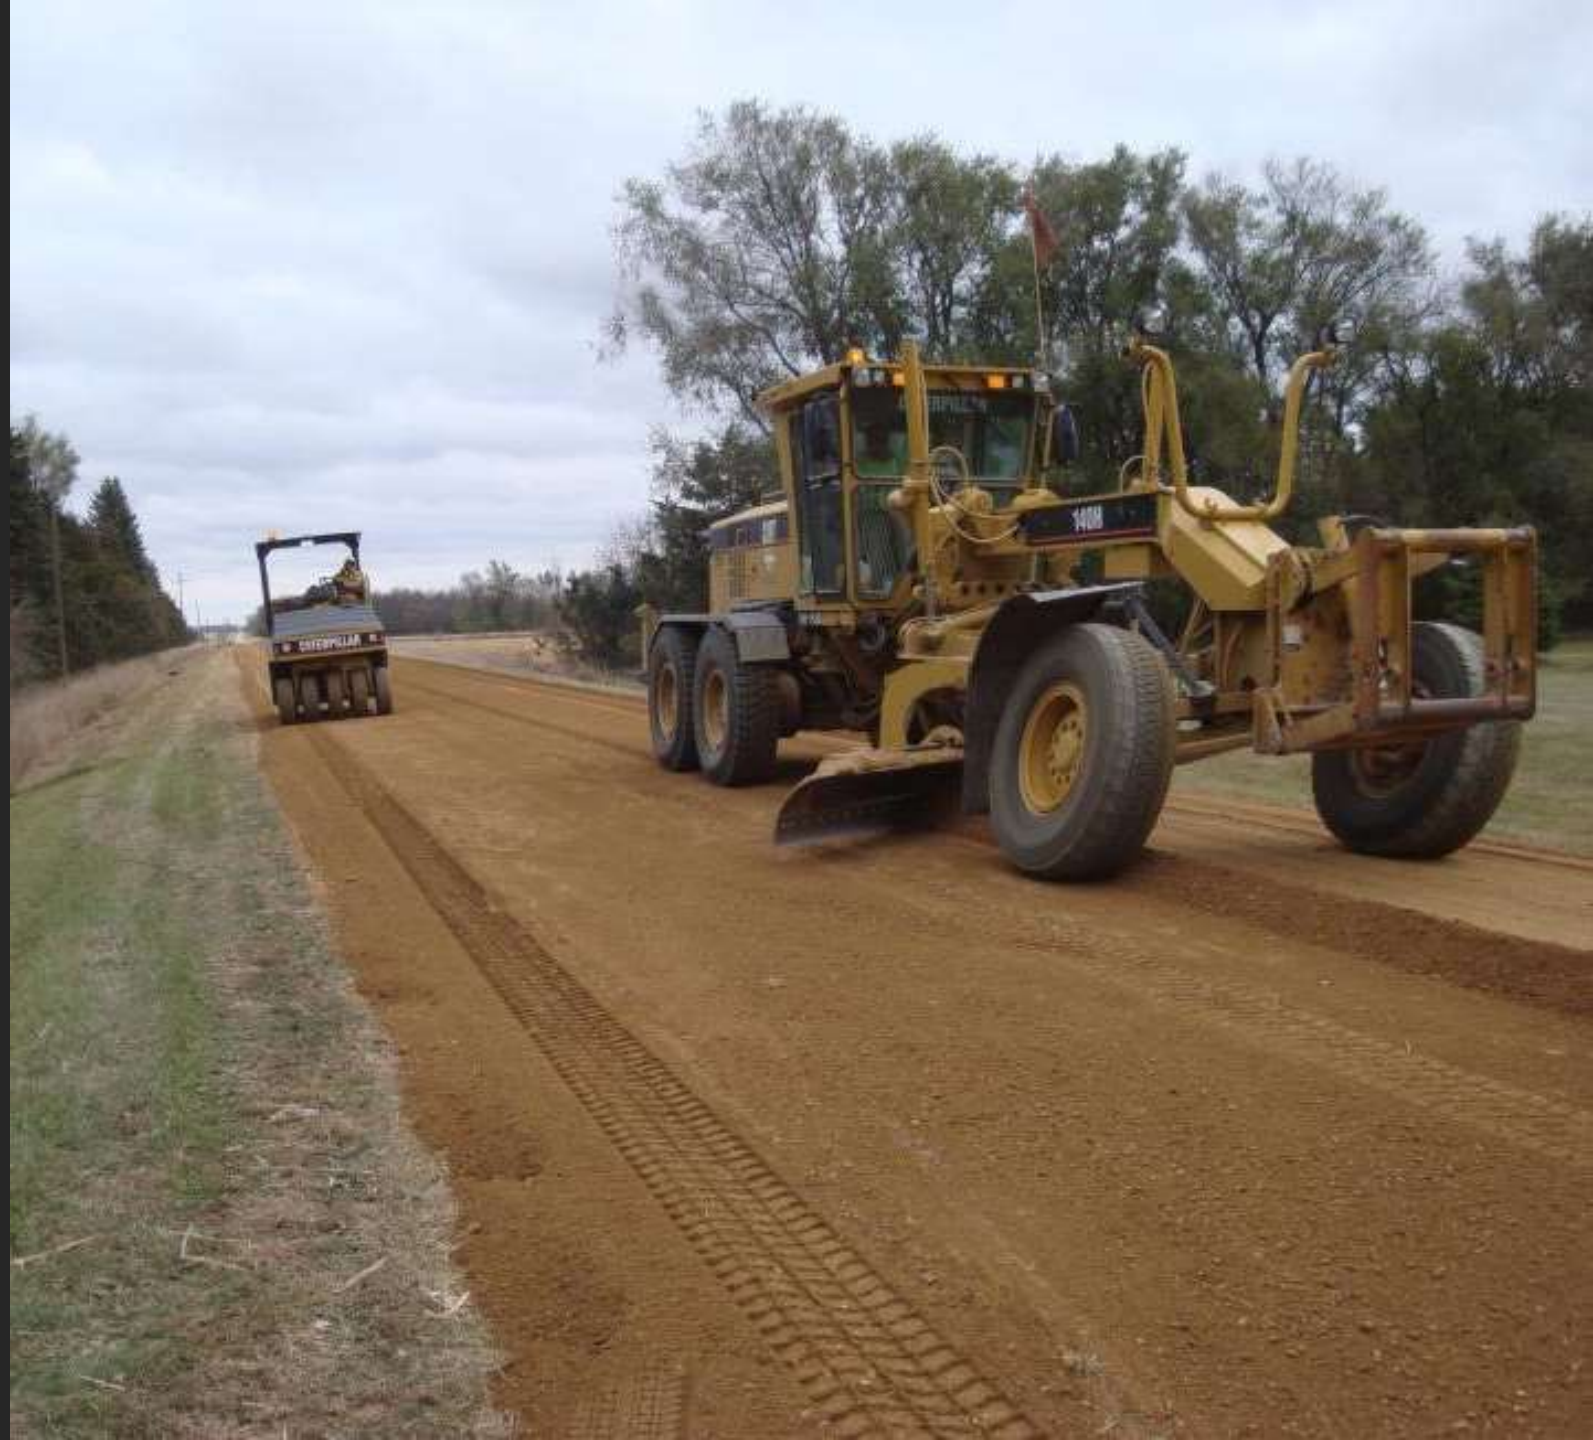
**Final finish on
the Brookings
Modified
Gravel Section**

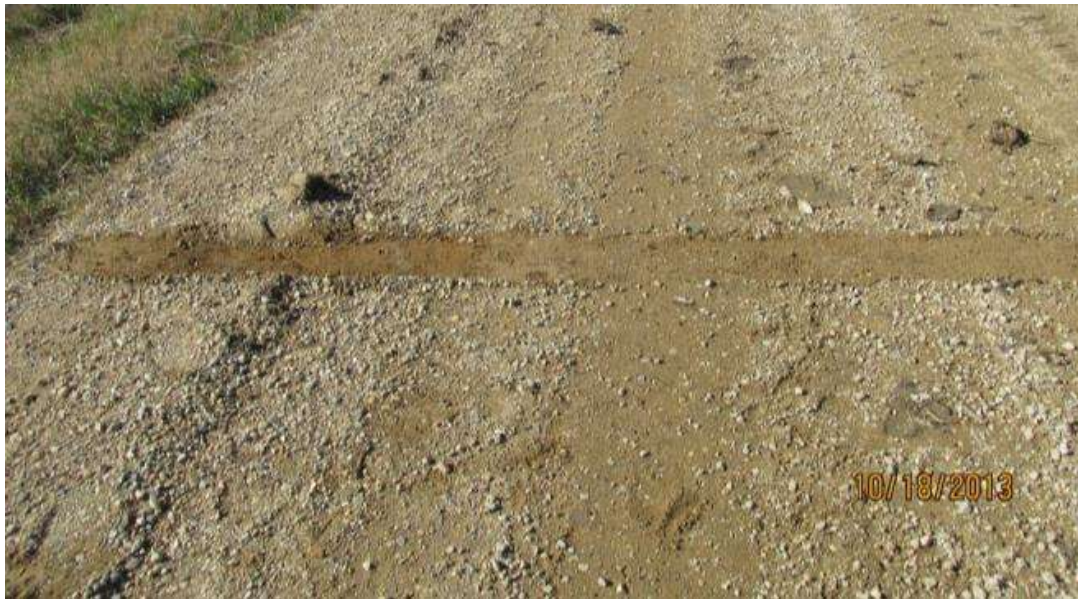
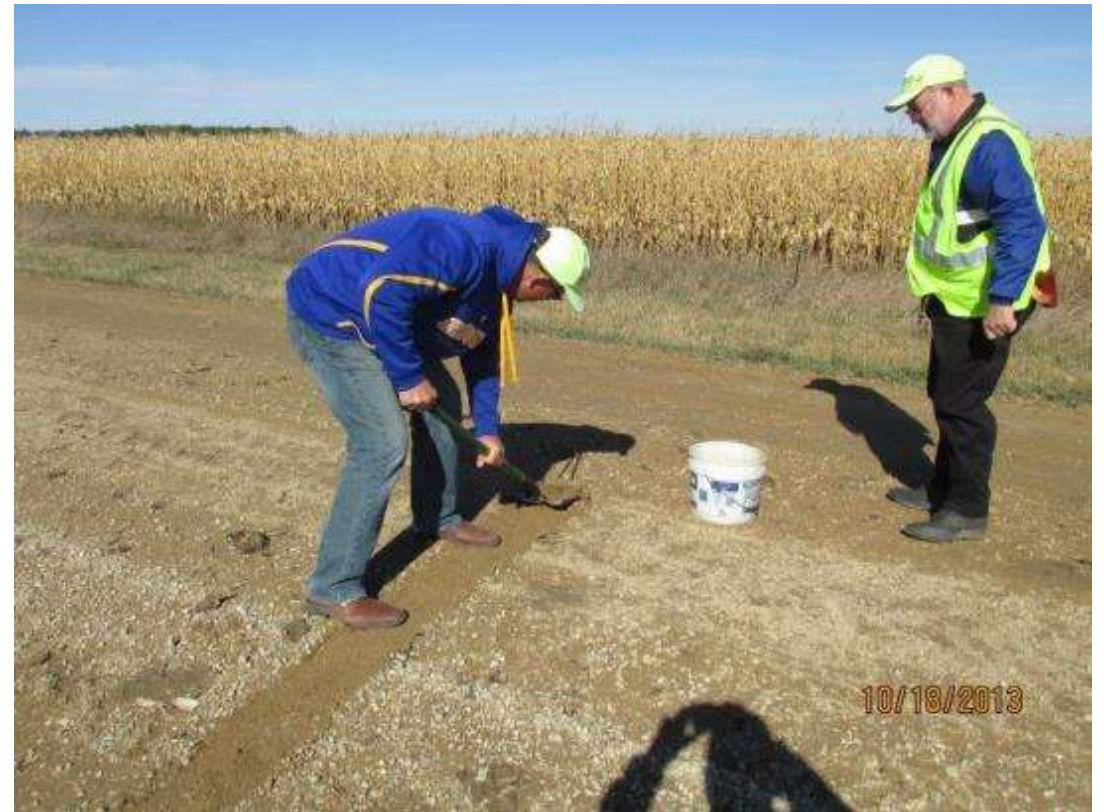
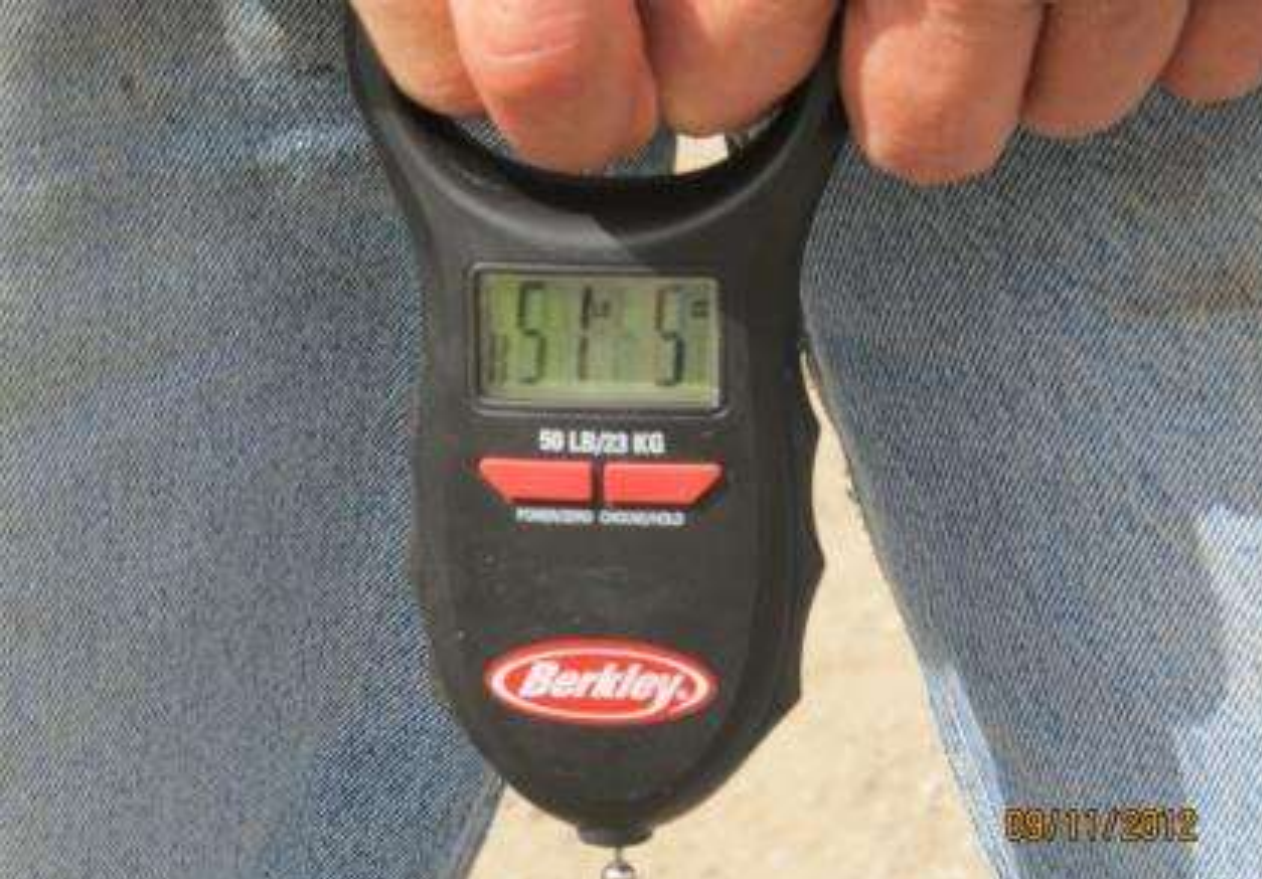
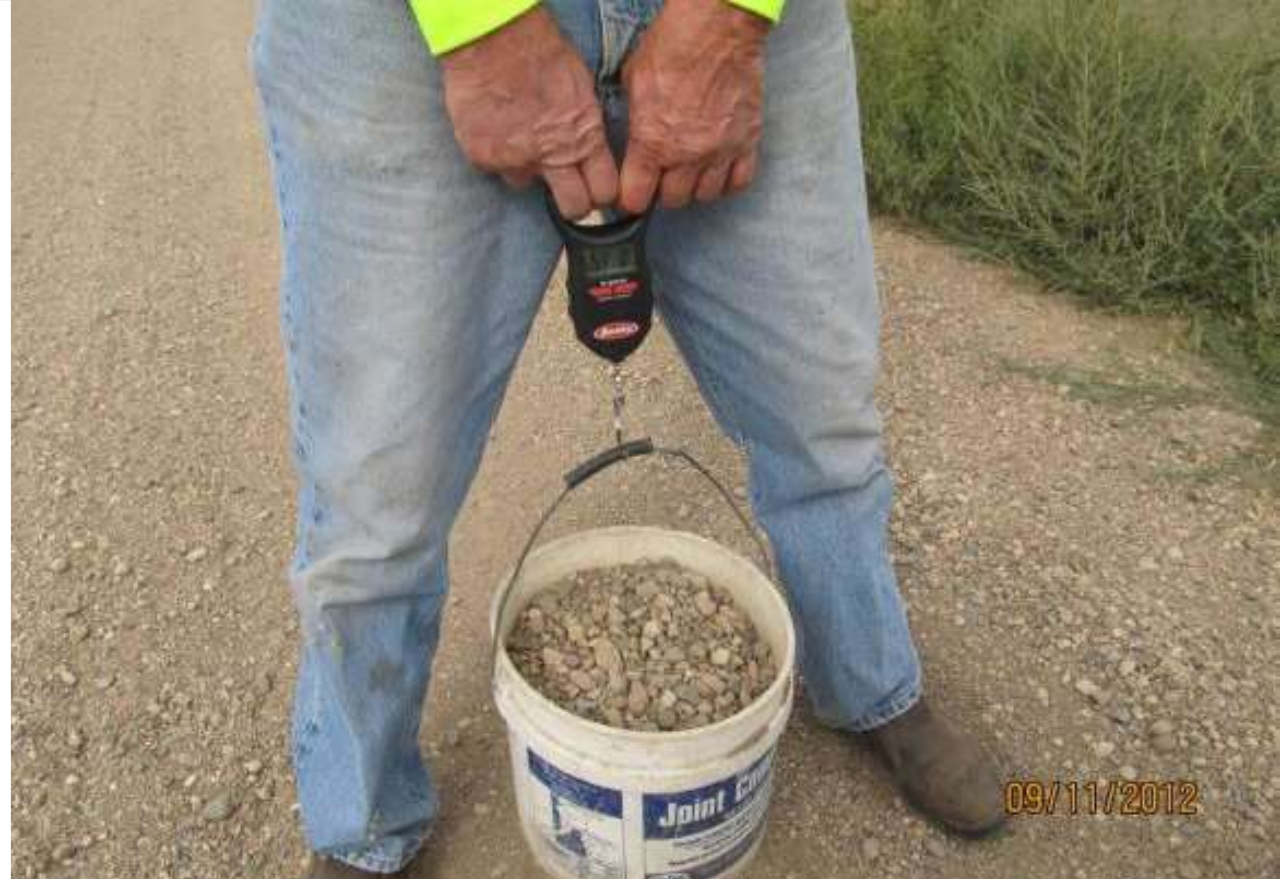
The float test (loose aggregate)

Simply remove loose aggregate from a 10 inch cross section, weigh it and convert that to a one-mile section

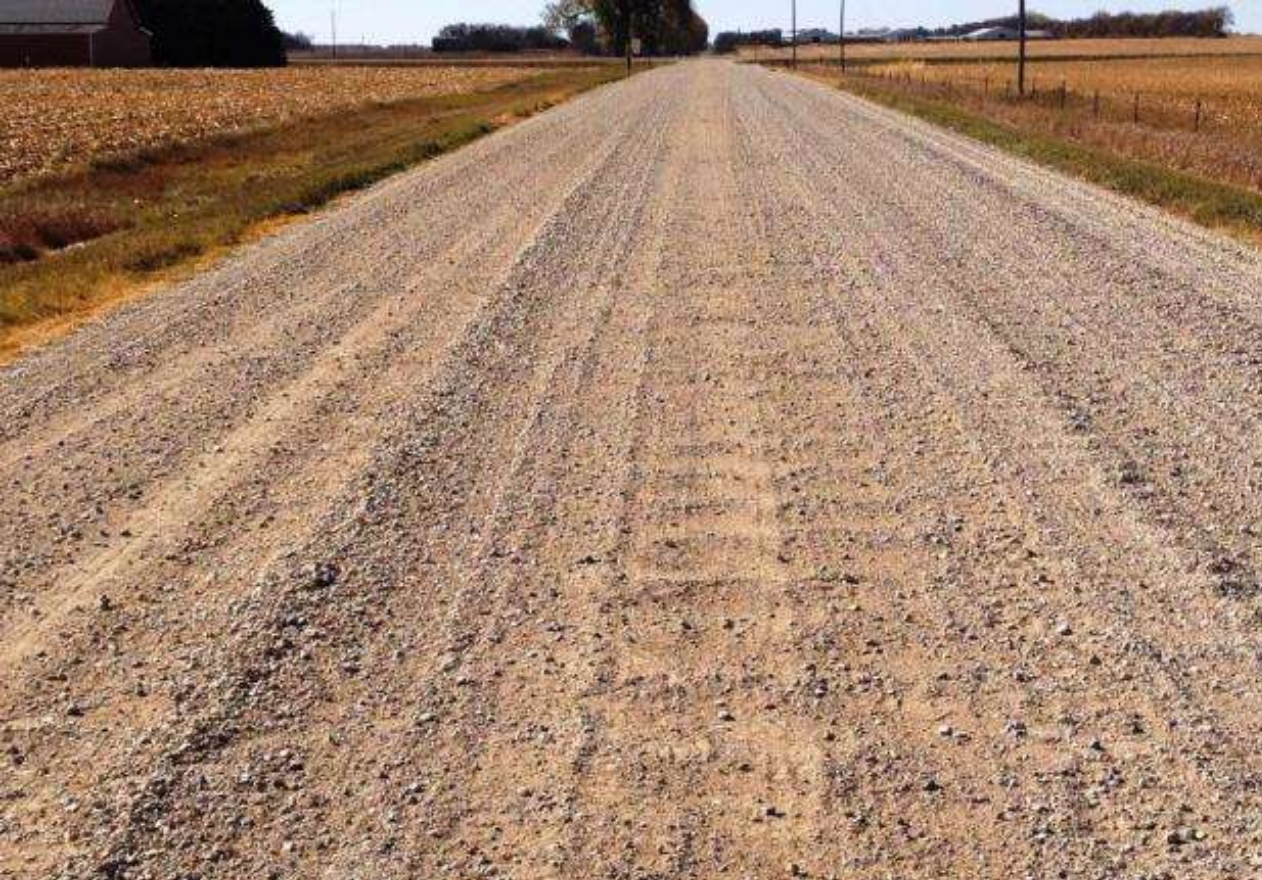
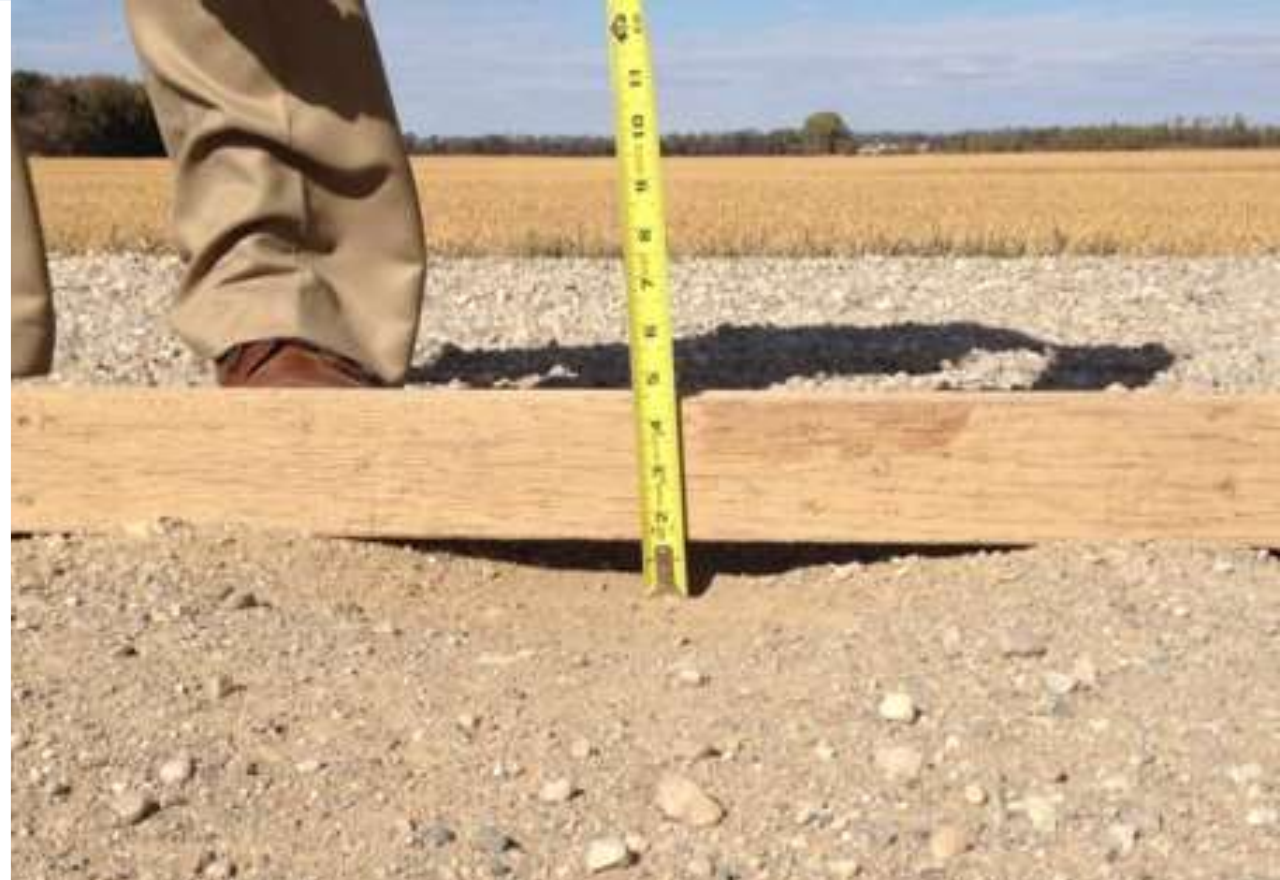
Change in top-width is measured on traveled way – hinge point to hinge point

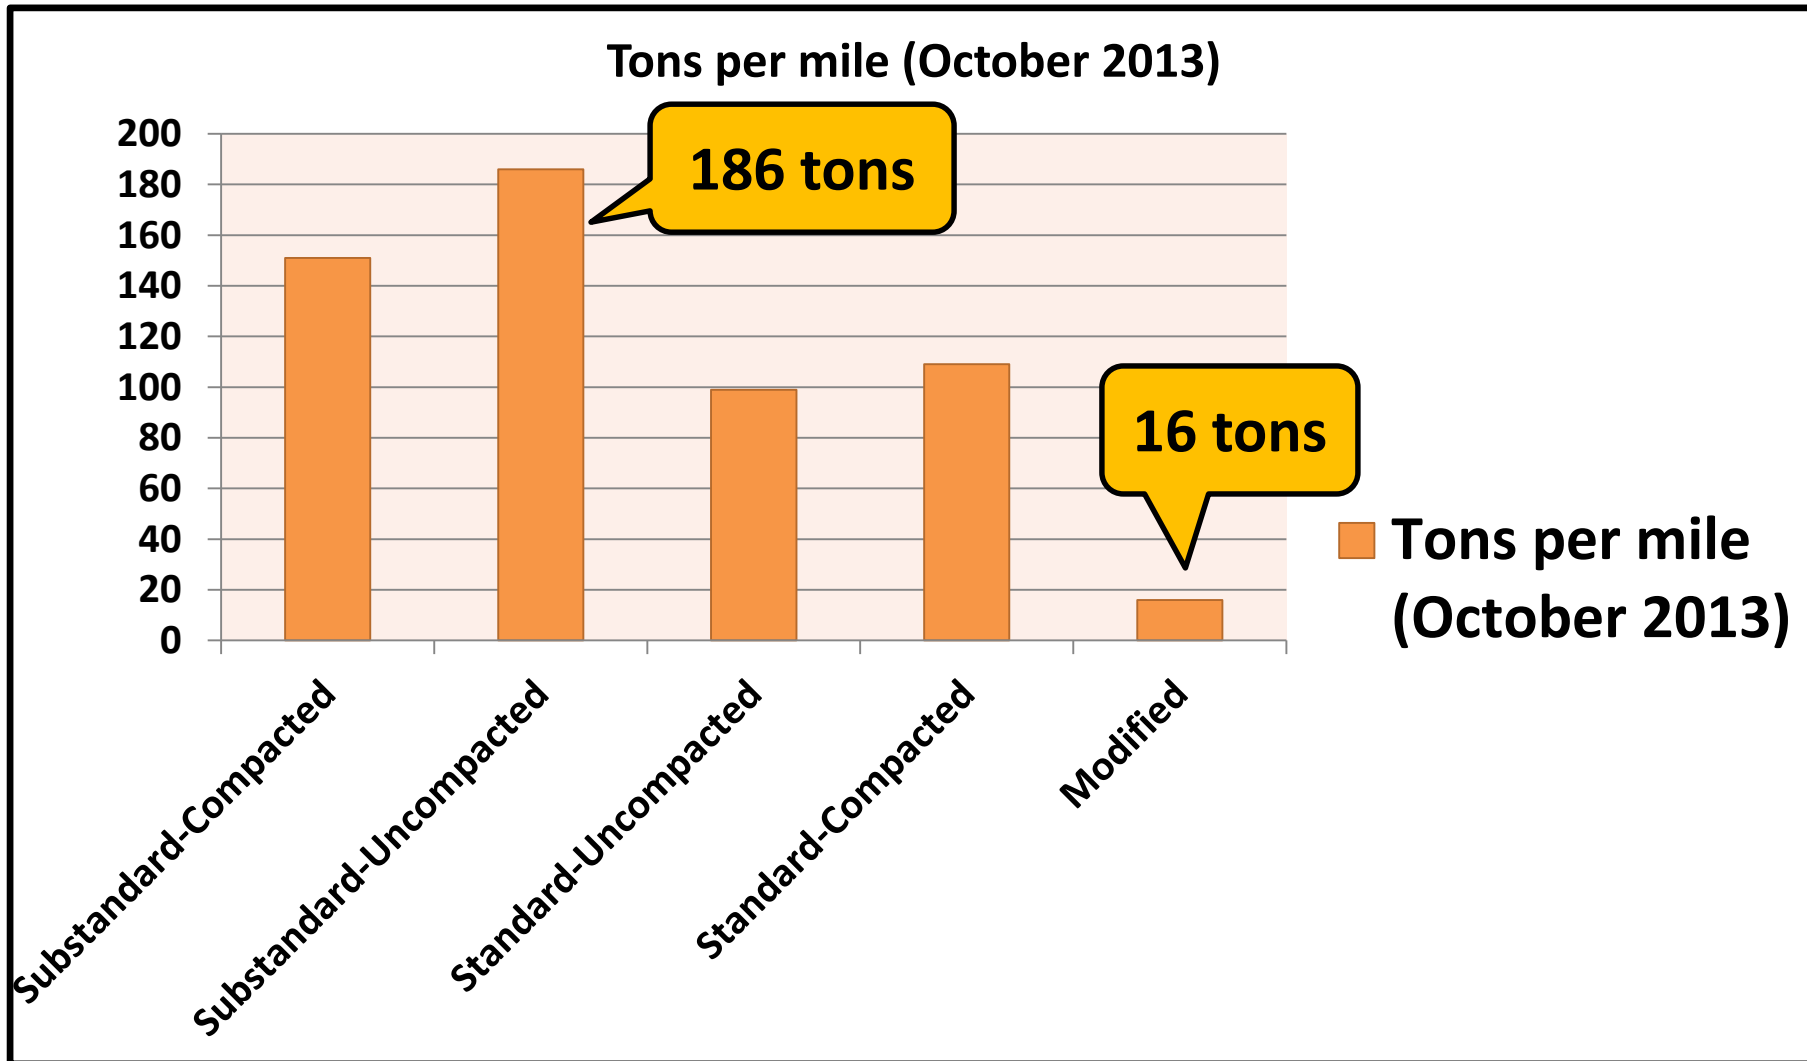
Brooking Section – Loose aggregate 2013

Note: trends are the same, but much more moisture was received during the 2013 maintenance season compared to 2012.

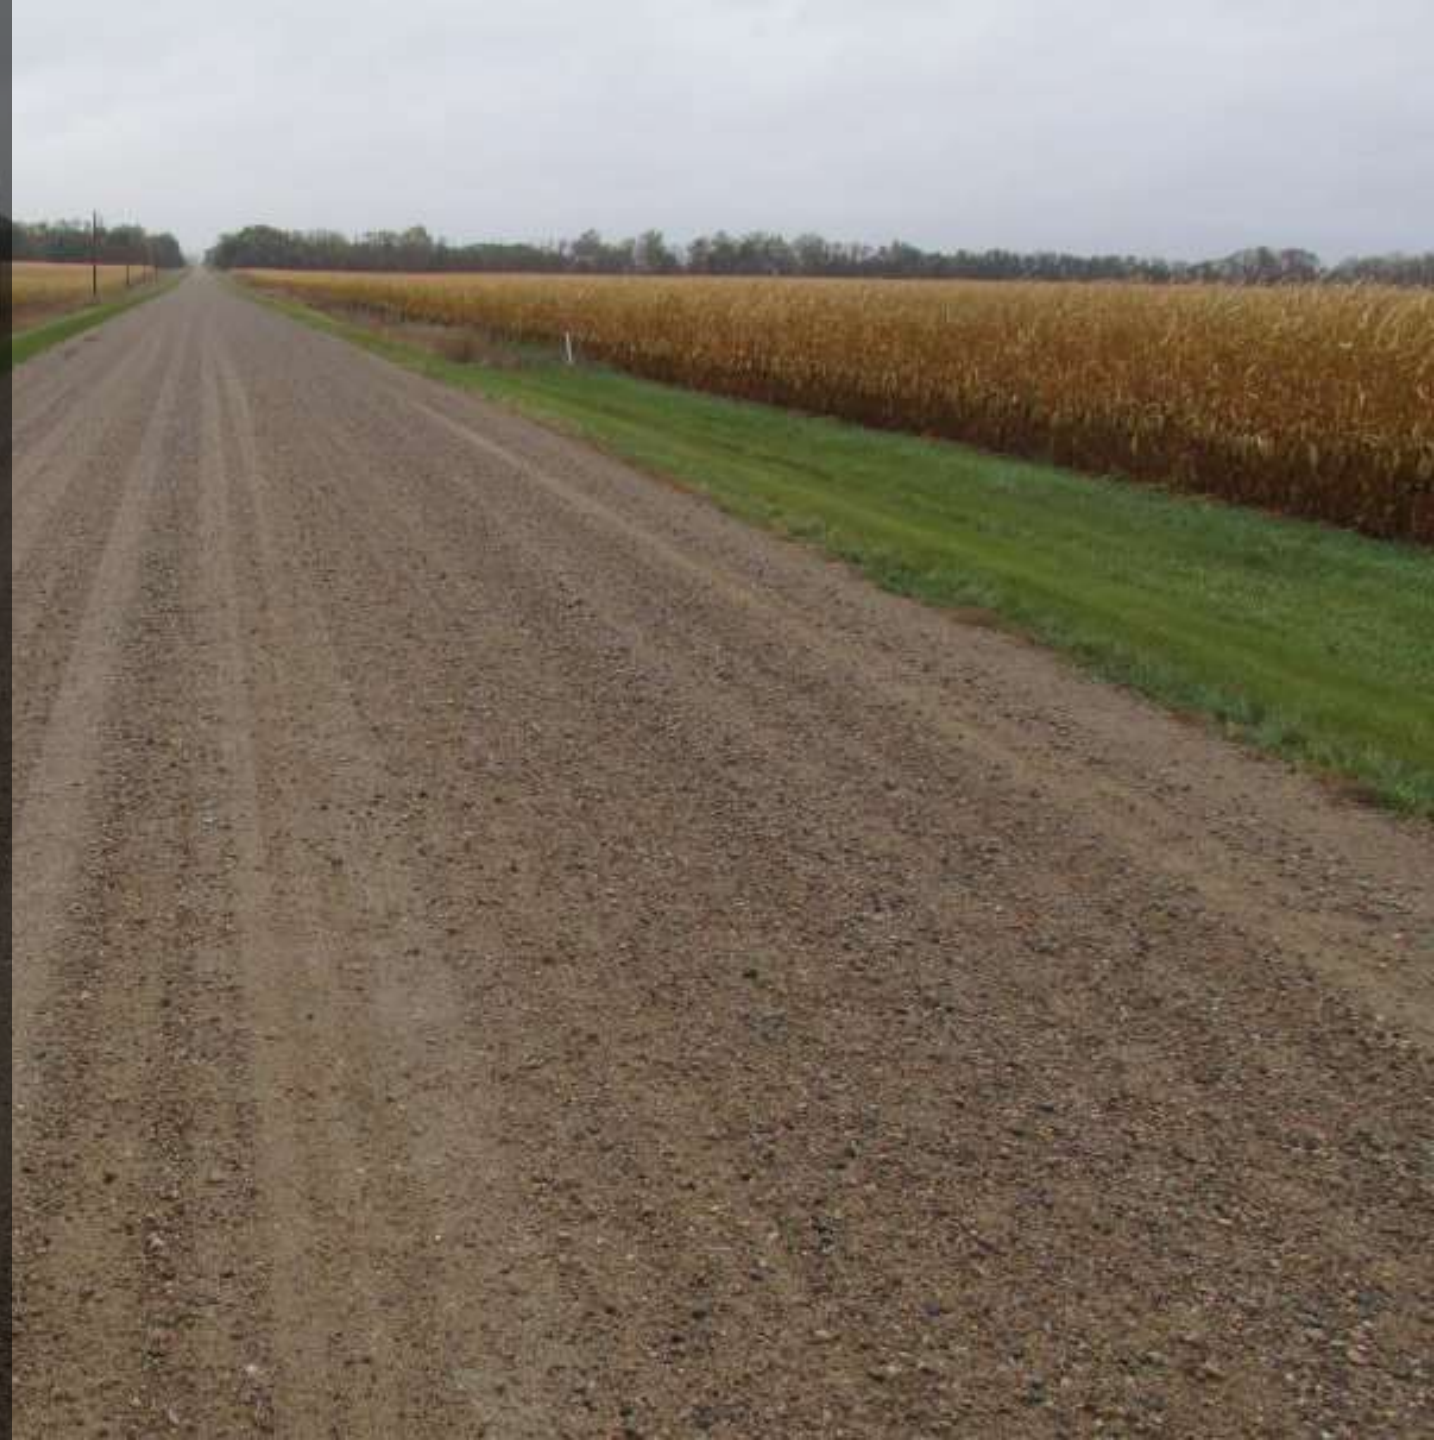
**Substandard
section –
aggregate has
moved outward
nearly 4 ft since
construction**

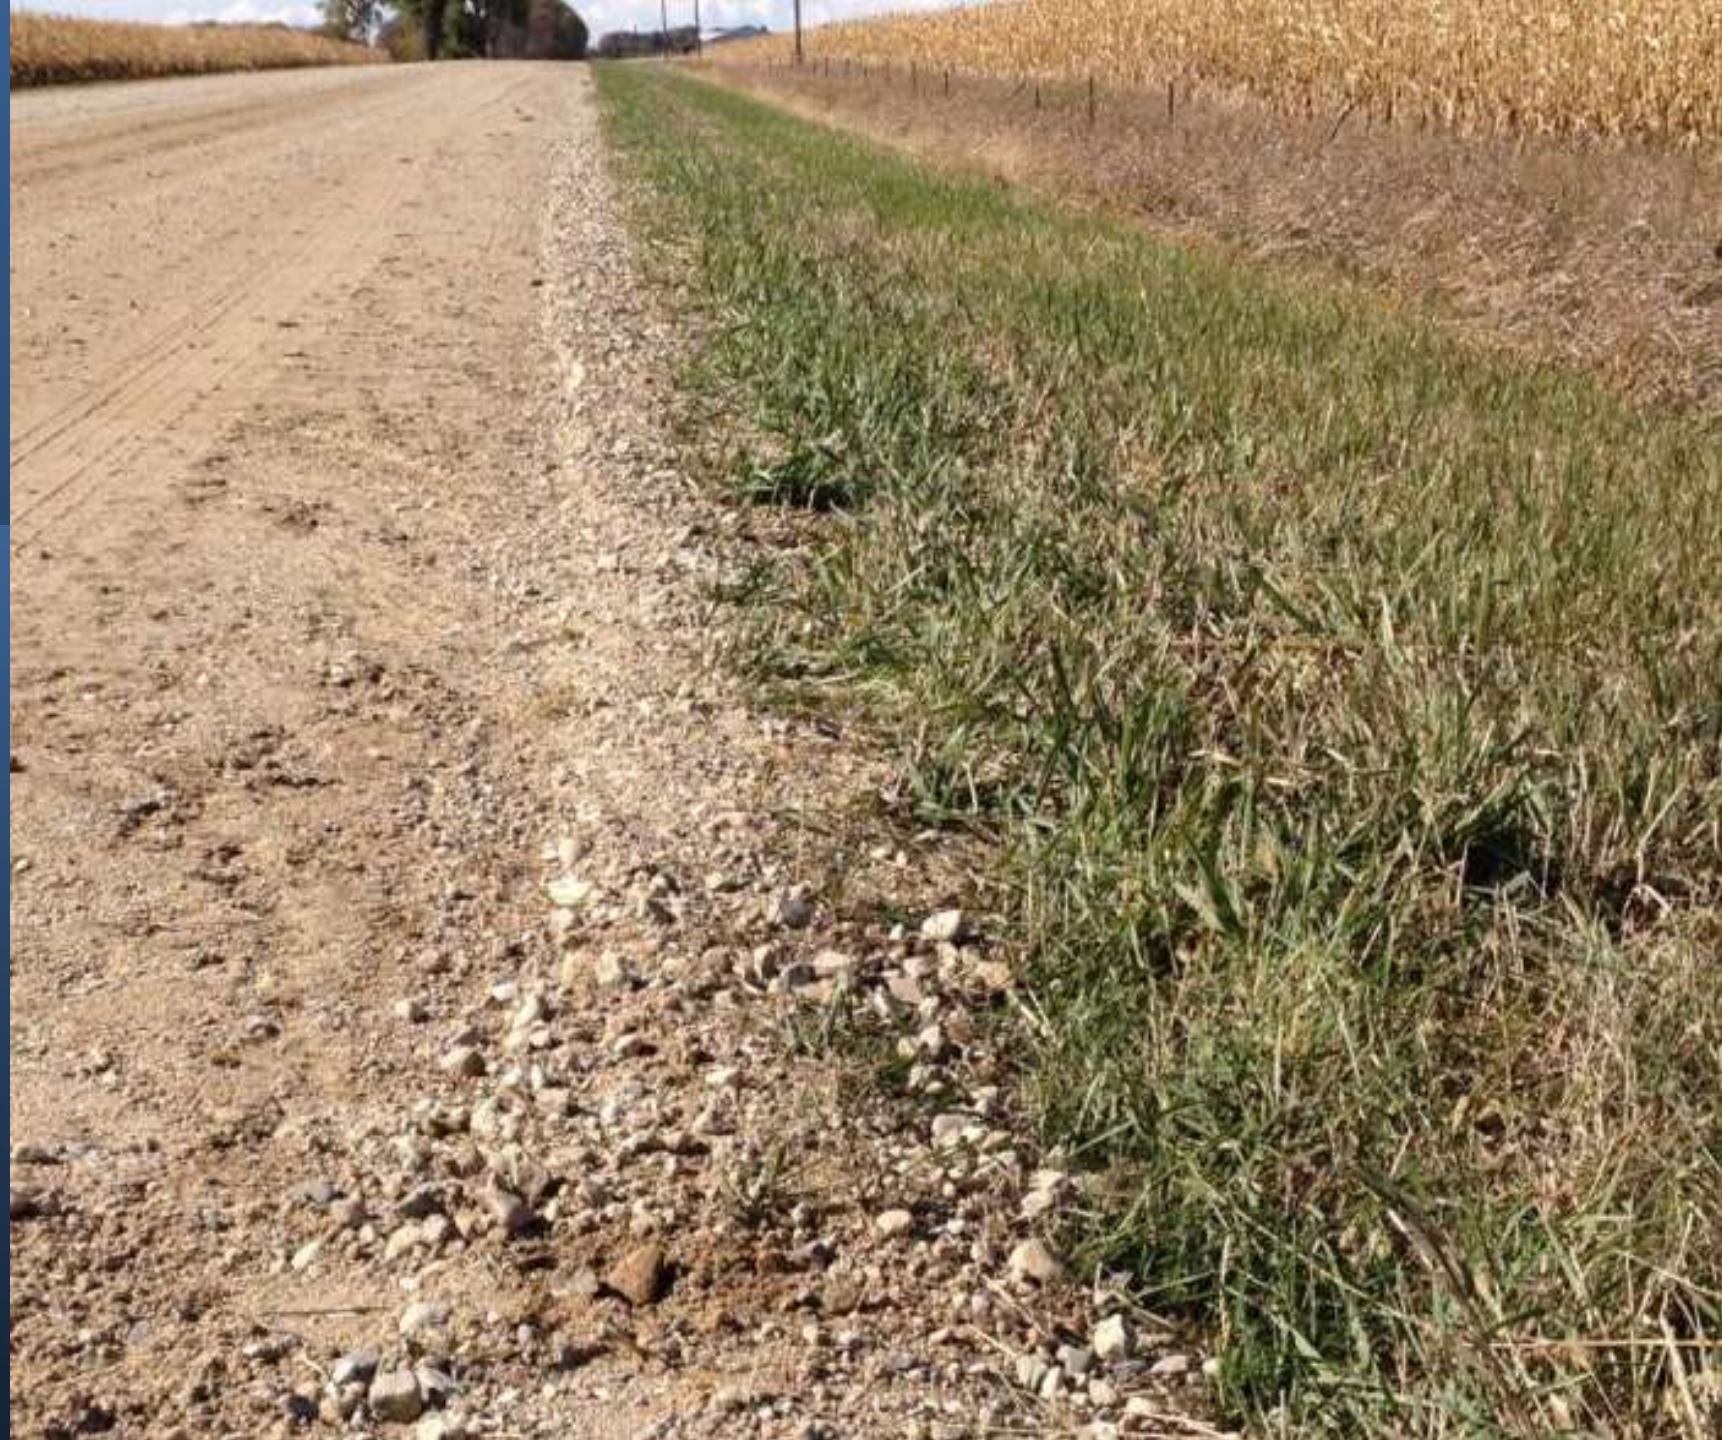
**Modified
section has
moved outward
only six inches
since
construction**

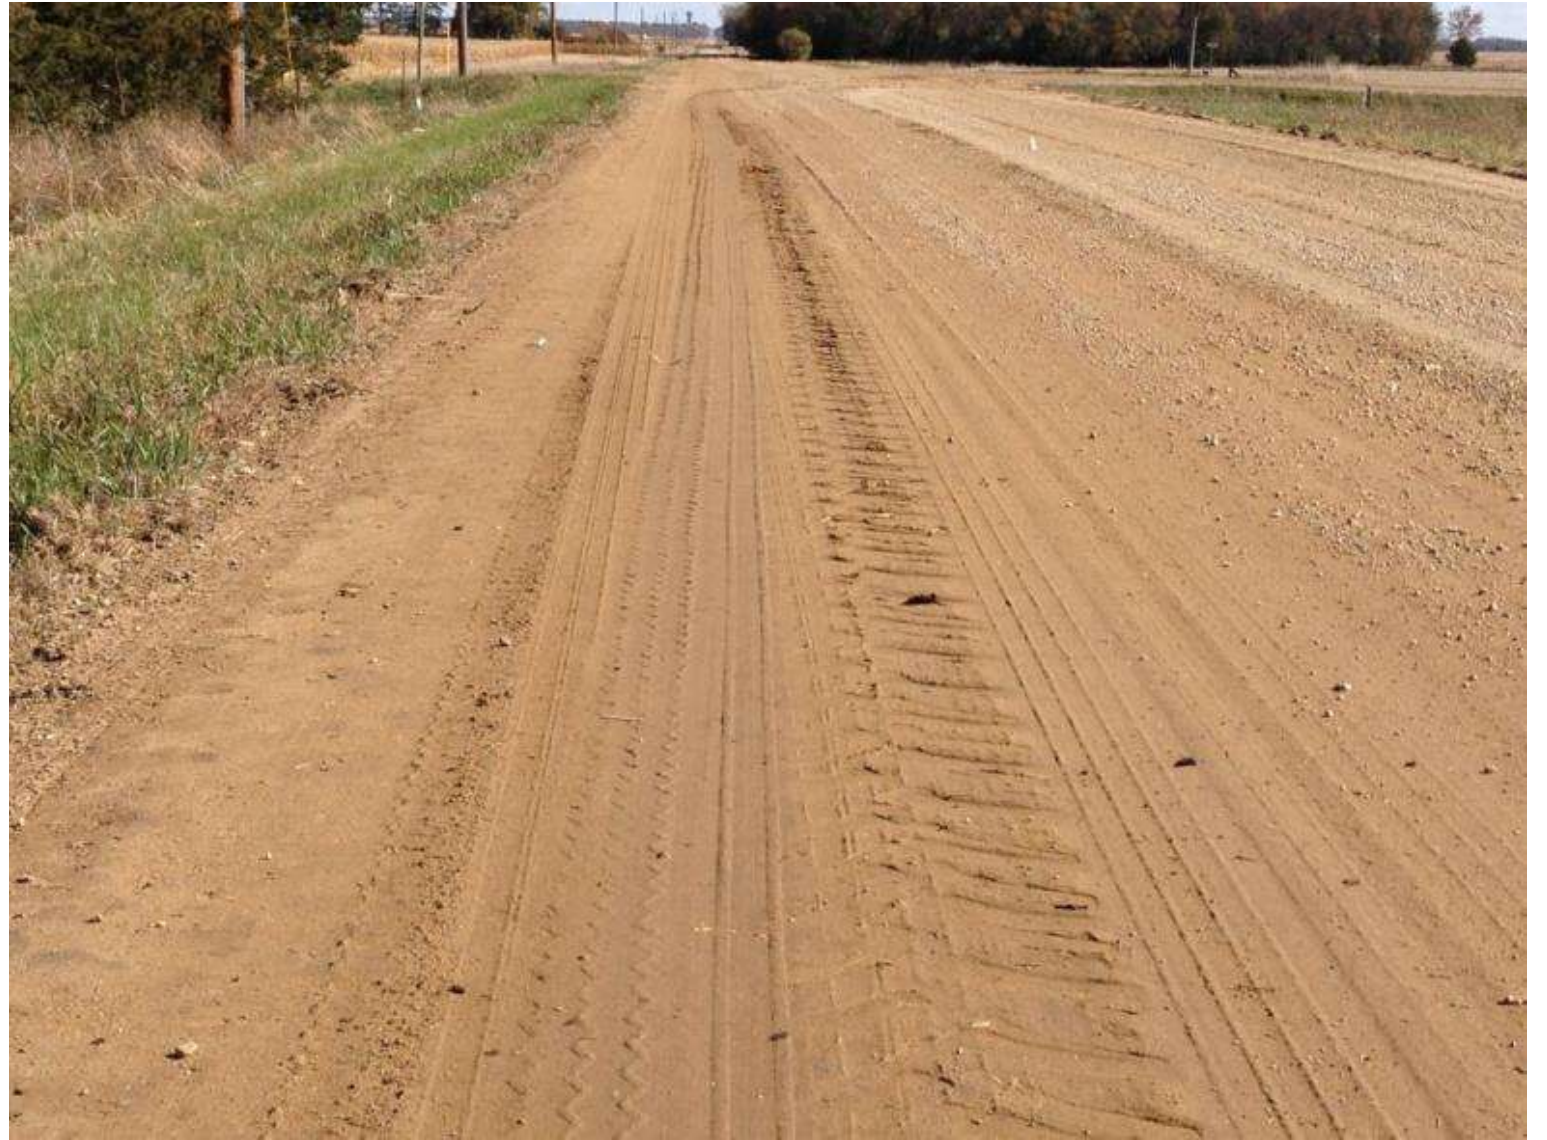
**View of
Substandard
section –
10-18-13**

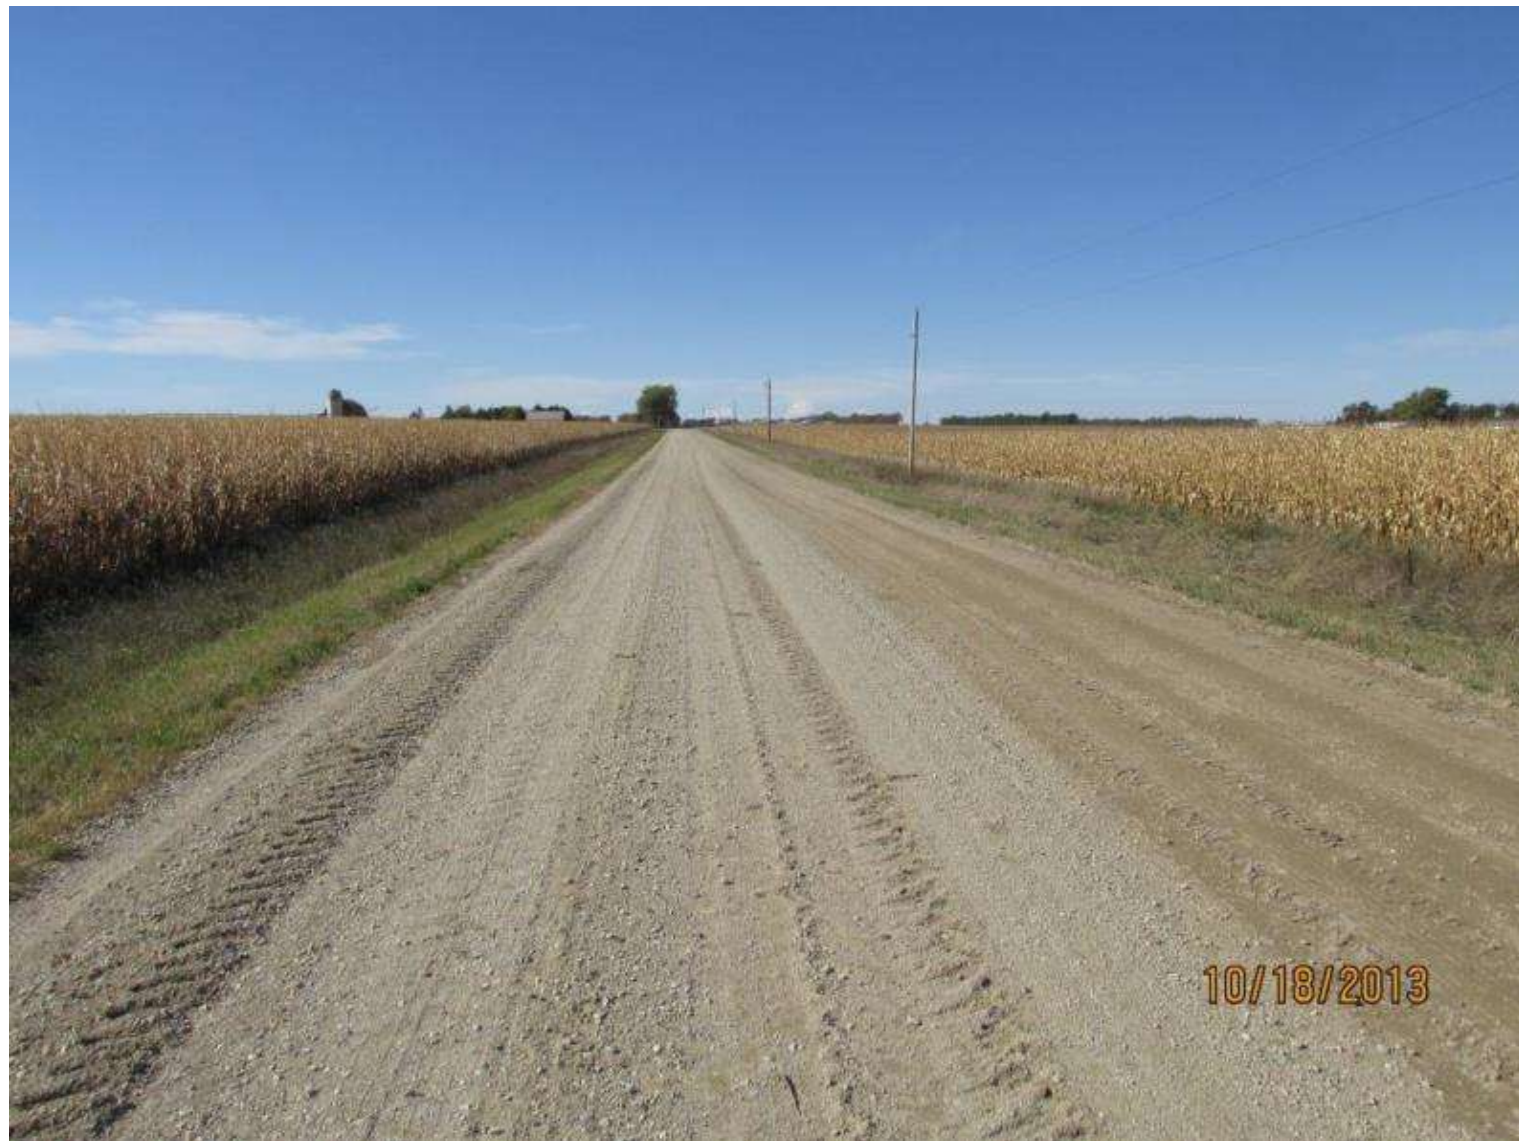
**View of
Modified
section –
10-18-13**
