SDDOT/SDLTAP Surface Gravel Study Project Update

Lessons Learned Thus Far

Focus of Test Project

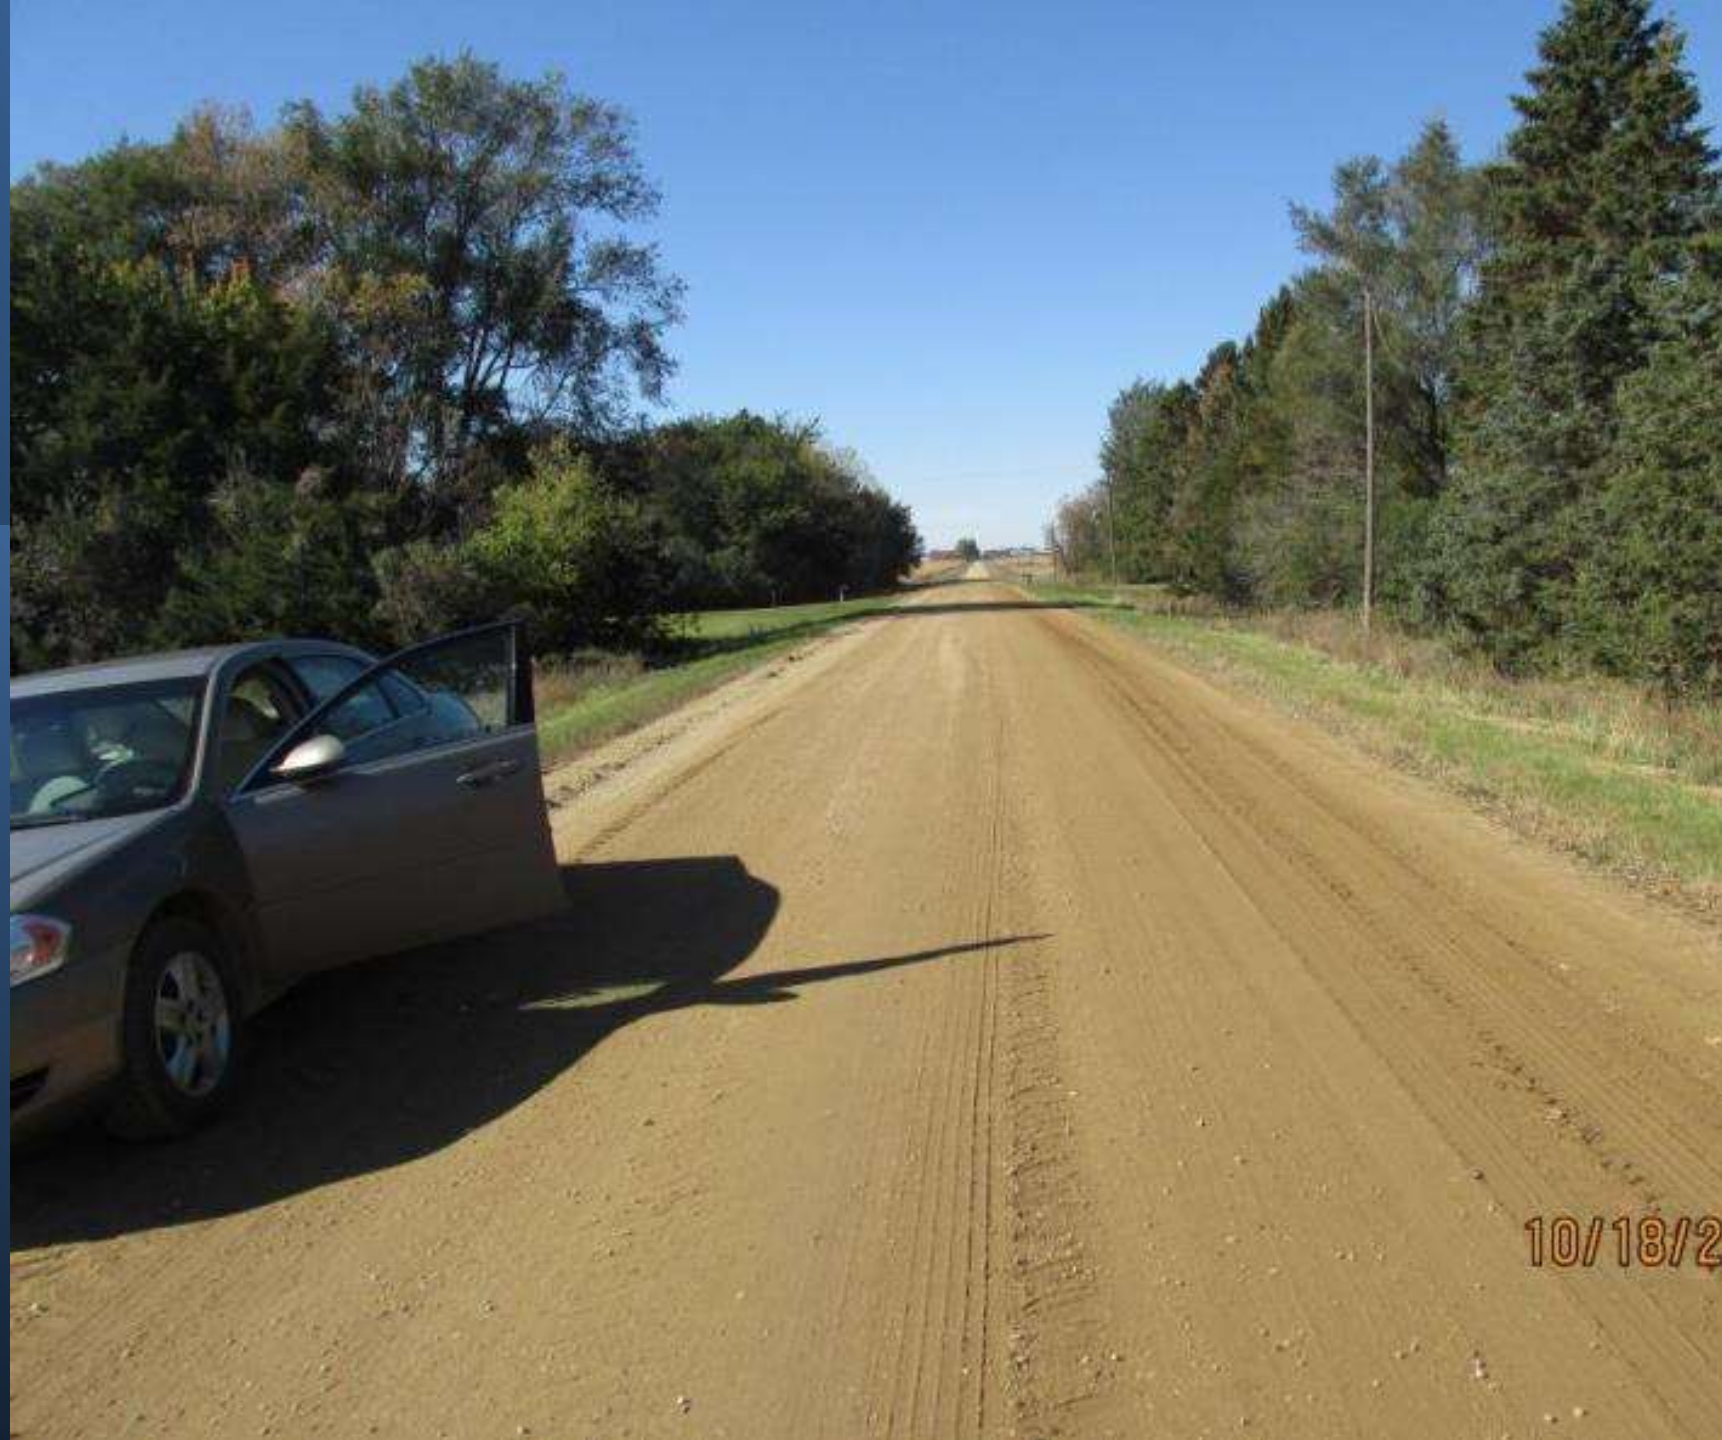
**Does the
modified
section rut in
wet weather?
Virtually no
rutting ever
observed.**
