MOUNTAIN-PLAINS CONSORTIUM

MPC 24-541 | A.D. Sorensen and J. Jiang

STATIC AND DYNAMIC
EXPERIMENTAL
EVALUATION OF
PRECAST COLUMNS WITH
GROUTED SPLICE SLEEVE
CONNECTORS

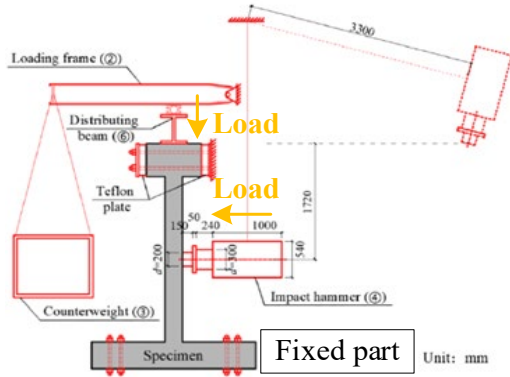
(a) Pull-out test [39]

(b) Push-over test [40]

(c) Pendulum impact test [35]

(d) Drop hammer impact test [36]

Figure 2.1 Test setups and loading methods.

Pull-out testing is a direct method for measuring maximum tensile strength and identifying failure modes of GSS connections (i.e., coupler, rebar, and grout). Tensile force is mainly transferred through bonds between the rebar, grout, and sleeve. A pull-out testing machine includes a fixed part and a movable part, both of which clamp the ends of rebars, then apply a controlled tensile load or cyclic load on the moving end, as presented in Figure 2.1 (a). Throughout the testing process, the applied load and the displacement at the movable end are continuously monitored and recorded. Post-test analysis includes GSS failure modes, tensile strength of the GSS connection, and required anchorage length for the bond ability of GSSs.

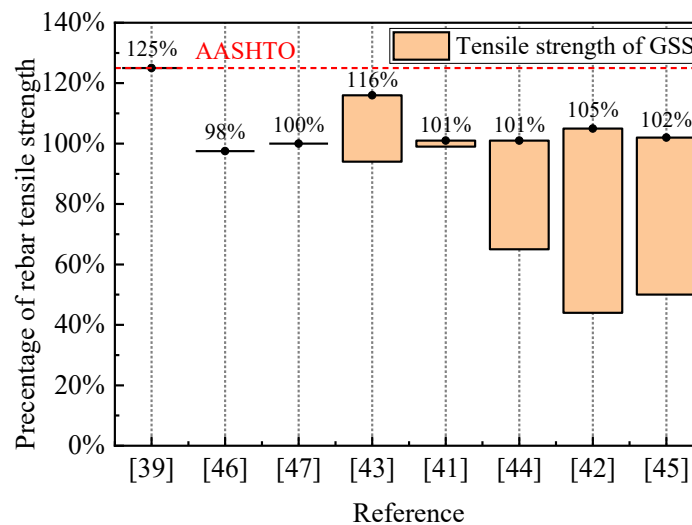
Figure 2.3 Summary of tensile strength of GSSs

Reference	Percentage of rebar tensile strength
Lu et al. (2019) [39]	125%
Haber (2013) [46]	97.5%
Liu et al. (2020) [47]	100%
Zheng et al. (2020) [43]	94%–116%
Henin et al. (2015) [41]	99%–101%
Guo et al. (2022) [44]	65%–101%
Li et al. (2022) [42]	44%–105%
Zhang et al. (2022) [45]	50%–102%

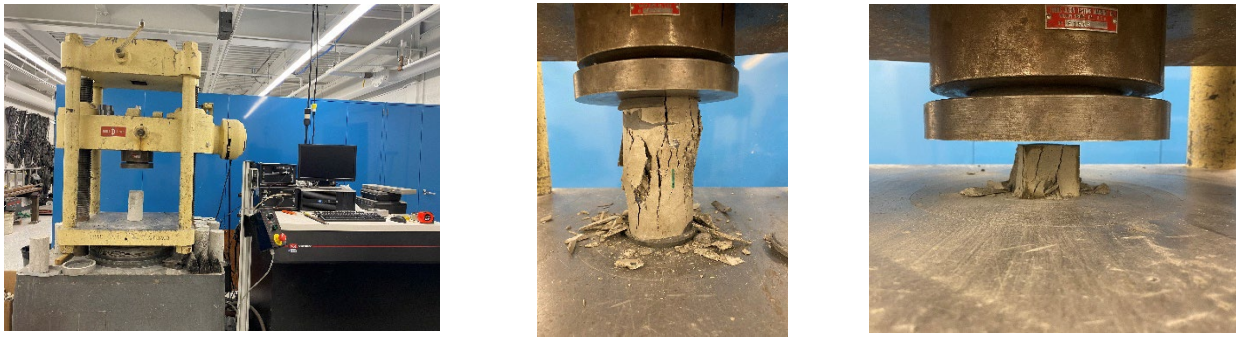
(a) Tinius Olsen compression machine (b) 4 in. × 8 in. cylinder (c) 2-in. cube

Figure 3.3 Details of compression test

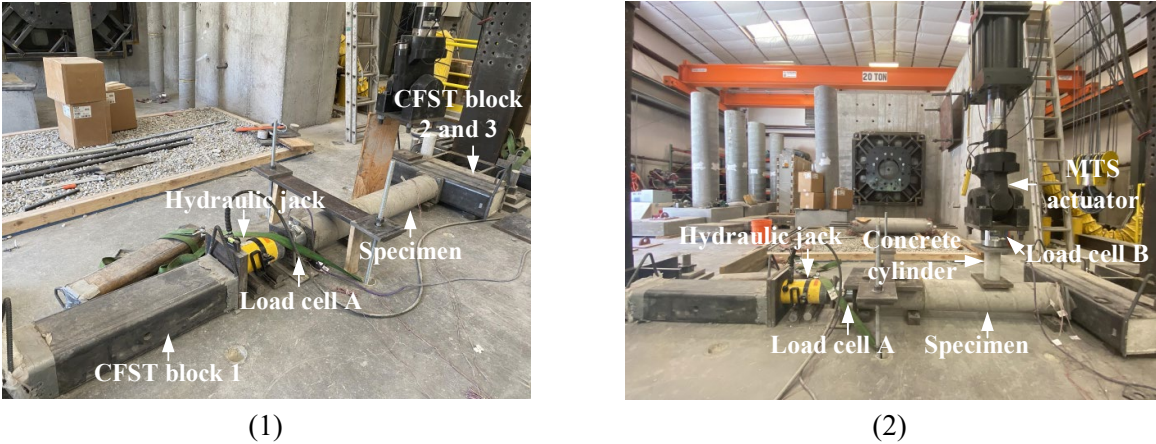
(a) Pictures of test setup

Figure 3.6 Static test setup: (1) axial compression loading stage; (2) multi-step lateral ramp loading stage

In this experiment, specimens are placed horizontally inside a steel frame that provides rigid constraints in both horizontal and vertical directions, as shown in Figure 3.6. The axial load application system is comprised of a cylindrical hydraulic jack with a load capacity of 120 kips, a load cell, three concrete-filled steel tube (CFST) blocks that are used to transfer the reaction force from the frame, and several steel plates for distributing the load uniformly across the tested element and reducing localized stresses. Note that these blocks and plates feature 1.5-inch diameter central holes to accommodate the pass-through of the rebars. The lateral loading system includes an MTS actuator with a 5-inch displacement range and a 120-kip maximum load capacity, a load cell, a cylinder for load transfer, and multiple steel plates. To replicate the actual boundary conditions of a bridge pier, three steel bearings are positioned: one under the left side of the footing part, one at the left side of the footing-column interface, and one under the right side of the pier part, as shown in Figure 3.6 (a.2). In addition, to prevent the footing portion from flexural deformation during the lateral loading stage, a longitudinal plate with the same length as the footing portion and a transverse steel plate with anchor holes on both sides are sequentially placed on the specimens. Two high-strength steel rods are secured using top and bottom plates, which are bolted to the top transverse plate and the bottom base ground, respectively.

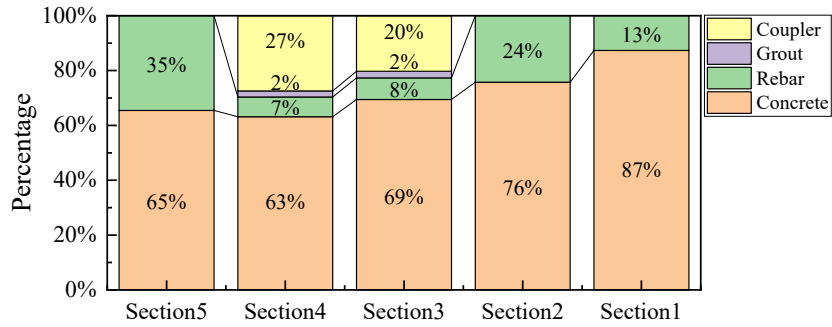
(a) In the ideal condition

(b) In GSS-F

(c) In GSS-C

$$P_i = \left(E_i \cdot A_i / \sum E_i \cdot A_i \right) \cdot (\text{Total load} - P_{cp}) \quad \text{Eq. 7}$$
