MPC 24-569 | W. Davis and P. Heyliger

MONITORING  
TRANSPORTATION  
STRUCTURE INTEGRITY  
LOSS AND RISK WITH  
STRUCTURE-FROM-  
MOTION

# **Monitoring Transportation Structure Integrity Loss and Risk with Structure-From-Motion**

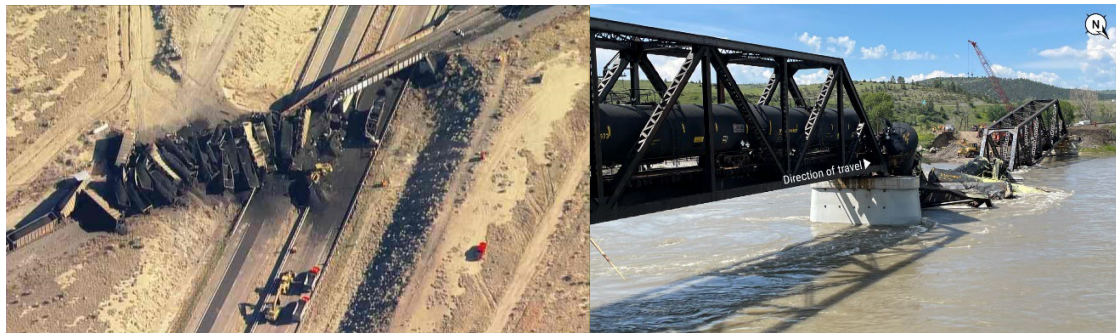
**Figure 1.1** Two significant derailment failures: Left: 30 BNSF rail cars hauling coal near Pueblo, Colorado, derailed on October 15, 2023, causing extensive damage and one death on I-25 below the bridge (photo courtesy of KVDR); right: 16 rail cars, 15 of which had hazardous material, derailed on June 24, 2023, at Reed Point, Stillwater County, Montana (photo NTSB). In the former case, the tracks had been inspected on the day of the accident.

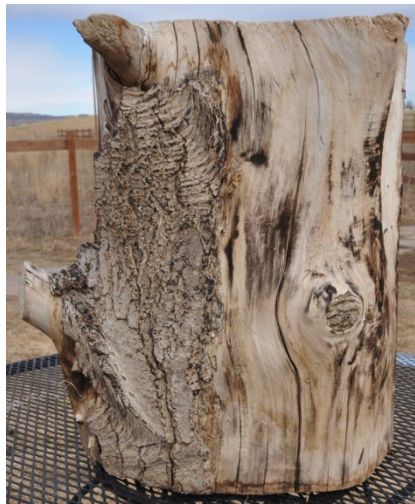
**Figure 2.1** An image of a tree stump used for imaging and inspection models. This structure was selected because of the wide variety of crack shape and size, the large amount of surface change over the object, the fact that the cracks change size over time as the moisture concentration changes, and the safety of the imaging environment.

To start this project, tests were performed on small or simple objects to evaluate whether or not photogrammetry was a feasible option for broader application. For a variety of reasons, including the safety of the photographer around transportation structures, the first object used for these tests was a cracked tree stump, as shown below in Figure 2.1.

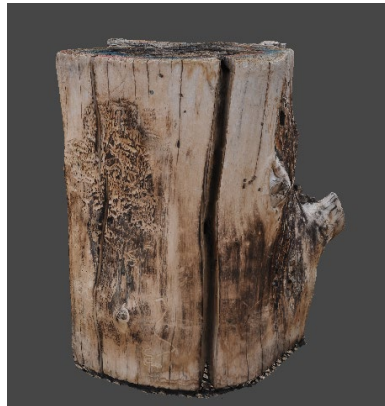
**Figure 2.2** A planar image of the rendering of the result of photogrammetry imaging of 51 planar still photos of the cracked stump.

The photos of the stump were taken on an overcast day, which provided even lighting to achieve the best results. After the photos were taken, they were uploaded to and processed in Agisoft MetaShape, a photogrammetry software package. A planar image generated by MetaShape is shown in Figure 2.2, but it is important to note that this is just a single view of a three-dimensional object that can be viewed from any angle or height.

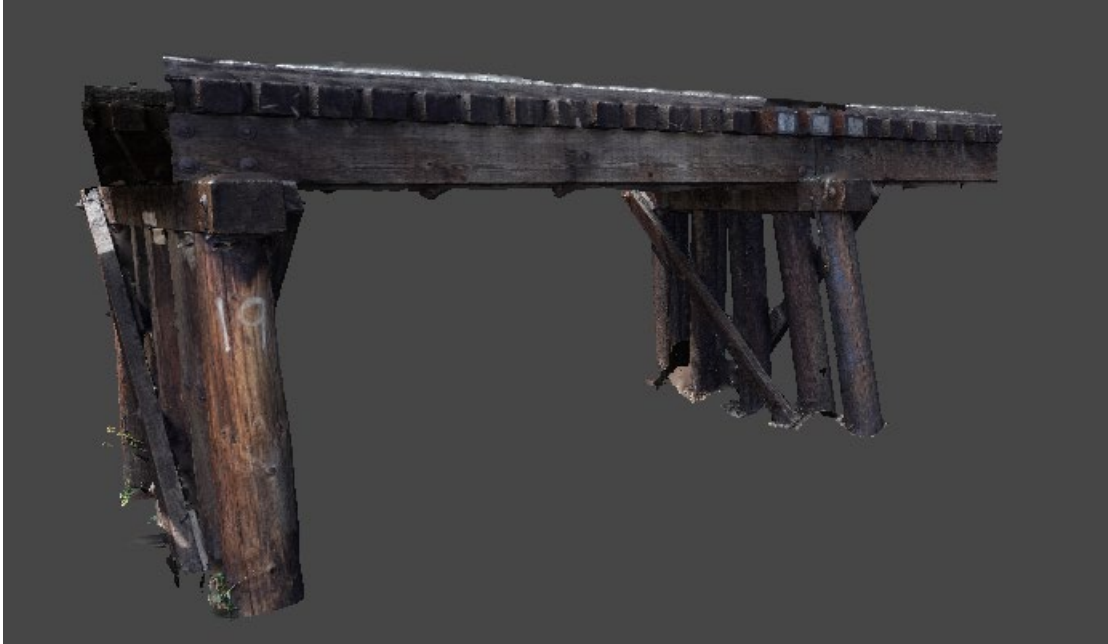
**Figure 2.8** Final SfM image of railroad bridge in northern Fort Collins. This is a two-dimensional capture of the full three-dimensional model that can be viewed from any angle or orientation/height.

The next more complex structure chosen for applying this methodology was an old, rotting railroad bridge in north Fort Collins. This bridge is no longer in use but was once capable of bearing a tremendous amount of weight. A very similar process was used to model and analyze this structure as was used for the stump. To start, a series of photos was taken of all sides of the bridge. A total of 71 photos were taken of the bridge. These photos were then processed with MetaShape to form a 3D model in the form of an STL. A photo of the 3D model is shown in Figure 2.8.

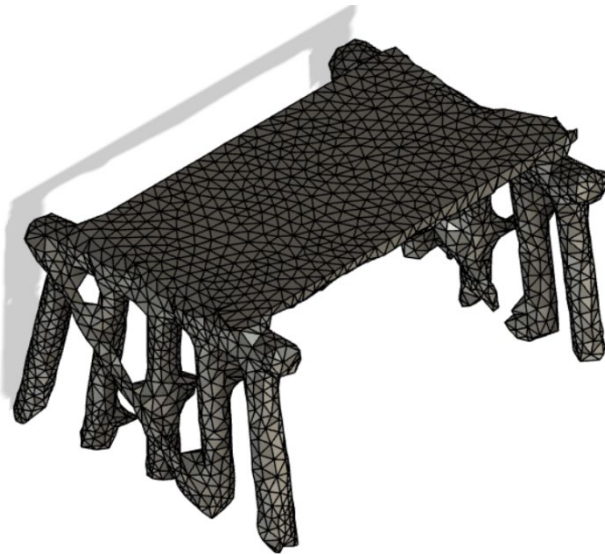
**Figure 2.9** The final three-dimensional finite element mesh of the rail bridge following several intermediate steps moving from images to final numerical model.

MeshMixer was then used to mesh the bridge and to resize and repair the mesh so that it could be imported into Fusion360. MeshMixer was also used to fill any “holes” in the model that would prevent it from being used for finite element analysis. Fusion360 was then used to further refine the model and to size the mesh to the desired saturation. We eliminate a detailed explanation of the entire process since these steps replicate what was accomplished for the introductory test case using the wooden stump. Figure 2.9 shows a photo of the completed mesh from Fusion360.

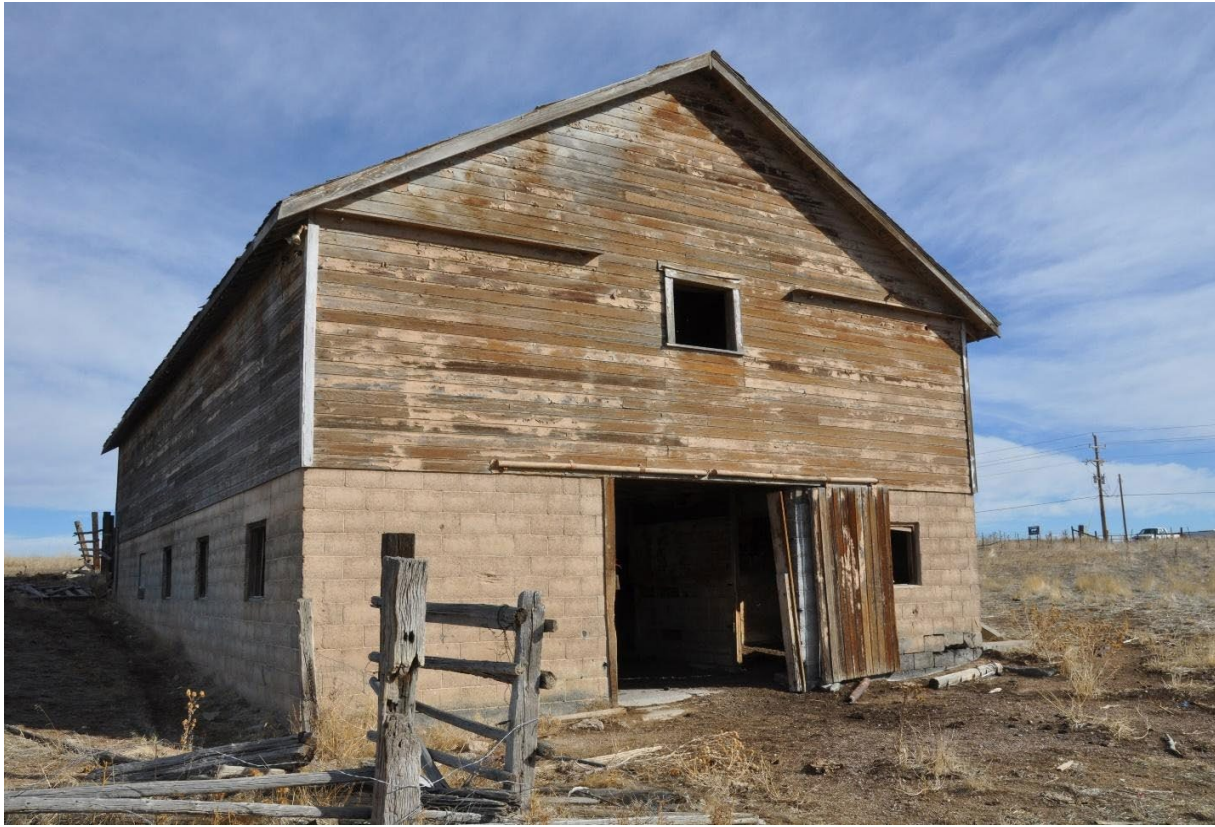
**Figure 2.11** A historic barn structure used to examine the accuracy of the SfM methodology for a relatively simple geometry.

A final test was performed on a historic barn located in Northern Colorado. This structure was selected because it had significant signs of cracks and decay, but it resembled a traditional building of four walls and a roof, as seen in Figure 2.11. This structure is able to withstand high velocity wind without issues even in its current condition.

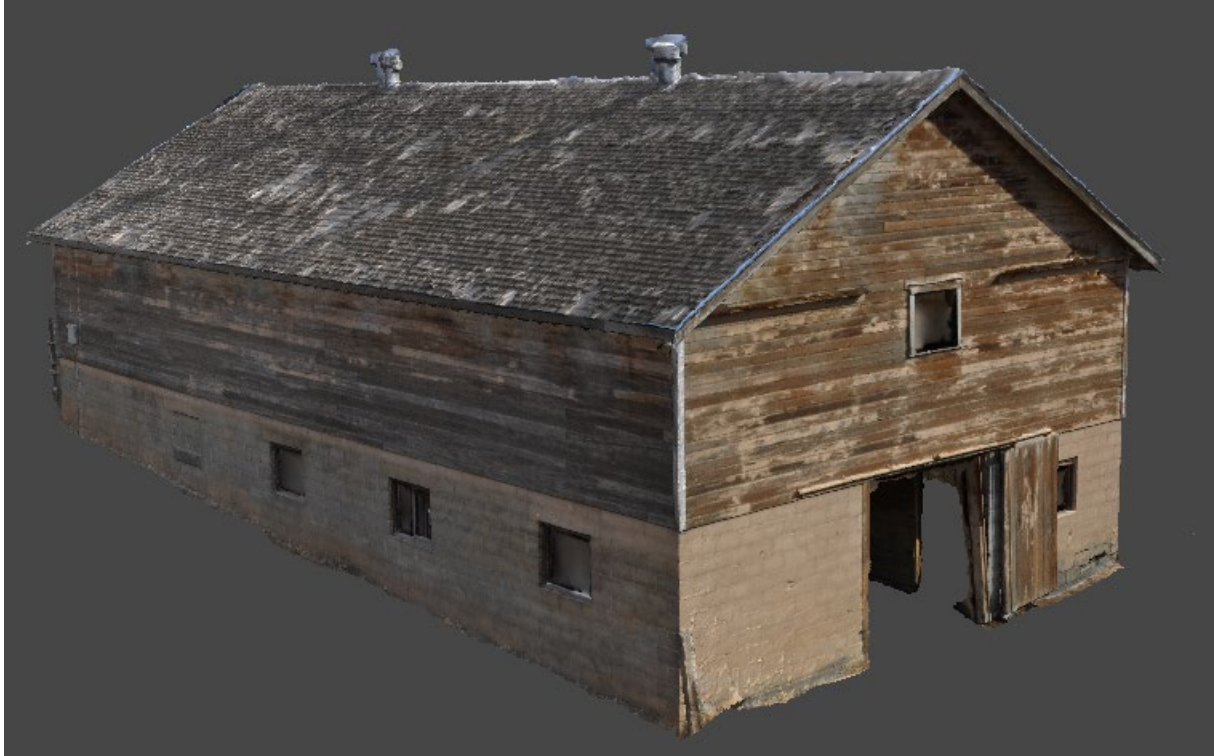
**Figure 2.12** A still shot of the rendered image from SfM software with excellent resolution for a relatively small number of still images.

A total of 126 photos were taken of all sides of the barn. These photos were then converted into a 3D STL model with the software MetaShape. This test provided some of the most visually appealing results yet because the structure is very simple and has flat, symmetric sides without much complex geometry. Figure 2.12 shows the three-dimensional model of the barn in MetaShape following processing of the point cloud.

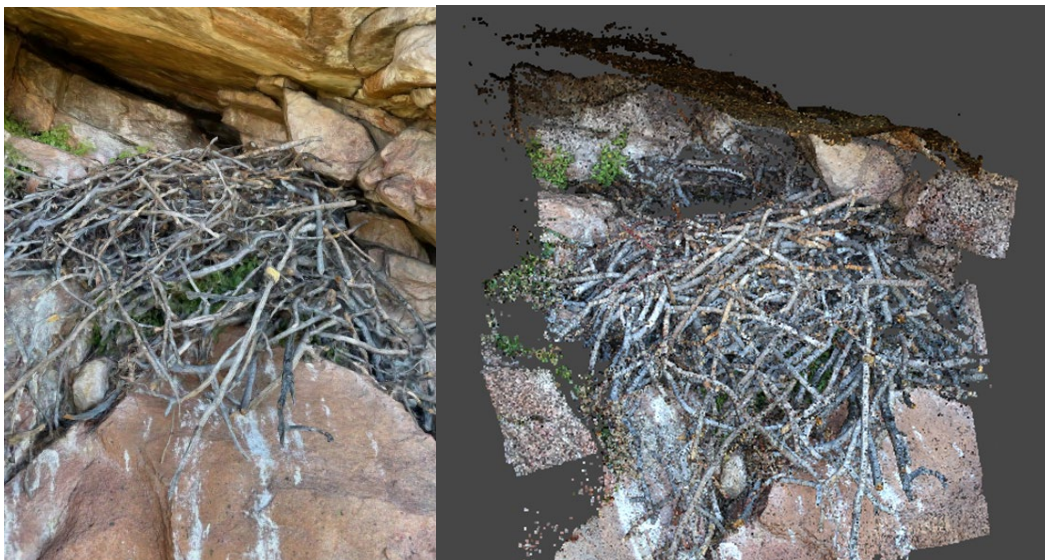
**Figure 2.18** SfM (left) and Lidar (right) based models of a raptor nest in Staunton State Park in Colorado.

We explored several other comparisons of structural representations when using SfM versus Lidar/Widar applications. Figure 2.17 shows the walls of the historic Fort Vasquez in Colorado. As a second example, we also imaged a raptor nest from Staunton State Park in Colorado using both Lidar and SfM methods. The results are shown in Figure 2.18.

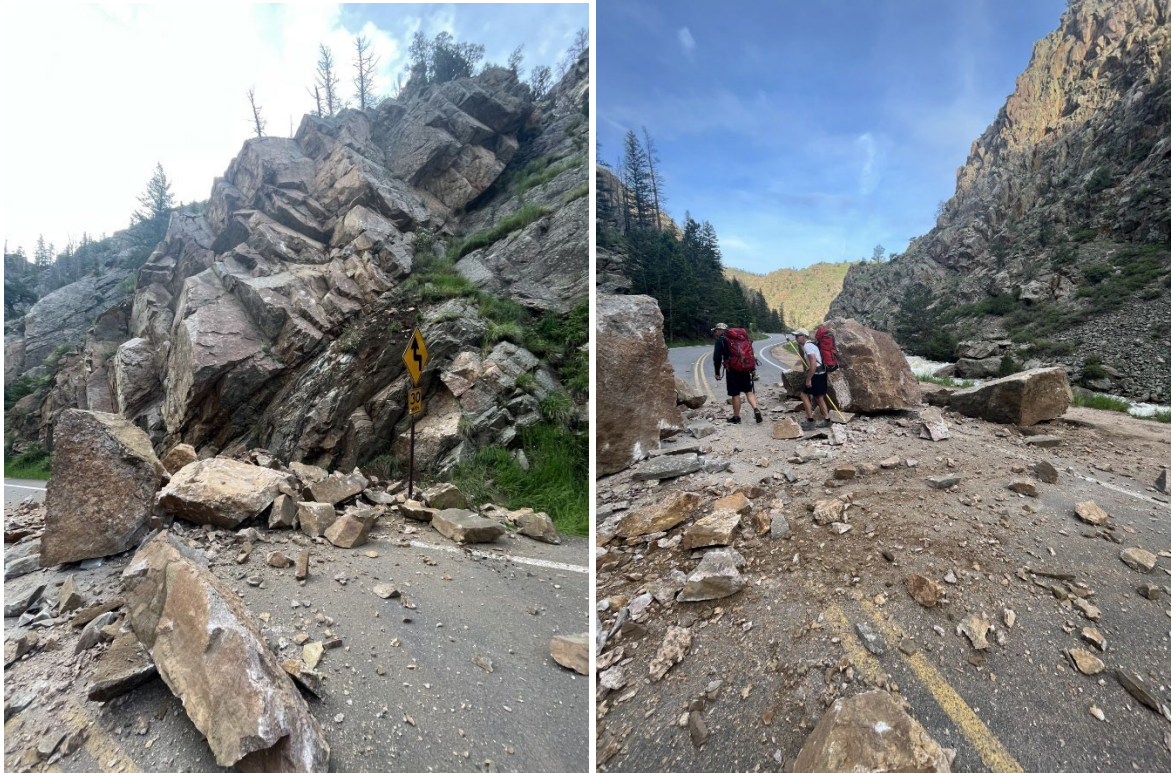
**Figure 3.1** Rockfall damage on Highway 14 on June 9, 2023, at 6 AM. The PI and colleagues (right) were on scene to investigate the level of damage and attempt to image the resulting starting and final position of the rockfall. The highway was closed for about four hours, but after an incredible response by CDOT was shortly reopened despite significant damage to the surrounding asphalt.

One type of application for which photogrammetry can eventually be applied is in tracking the process of natural hazards, including rockfall or movement of granular media. An example, seen in Figure 3.1, is a recent rockfall on Highway 14 in Colorado, where several large boulders collided with the pavement below.

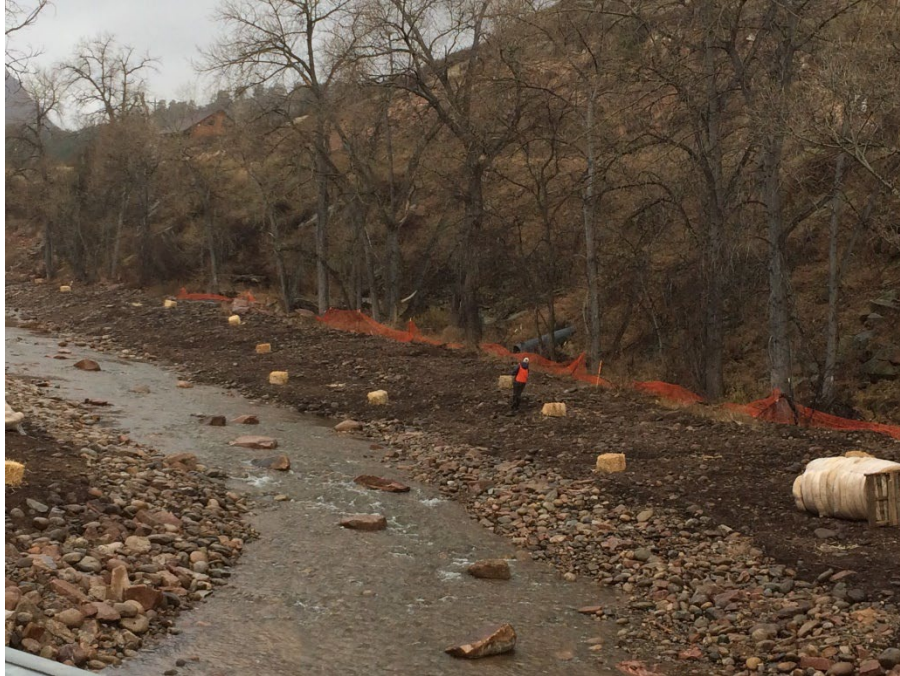
**Figure 3.2** Remediation efforts in the Saint Vrain River following wildfire damage, November 21, 2017. Bales of hay and other natural fibrous materials are being used as reinforcement along the riverbank.
