Cold In Place Recycling

Using an Emulsion Binder

Trevor Christianson
Mayo Construction Company
And
Adam Mahaney
Western Asphalt Products

Williams County Road 17

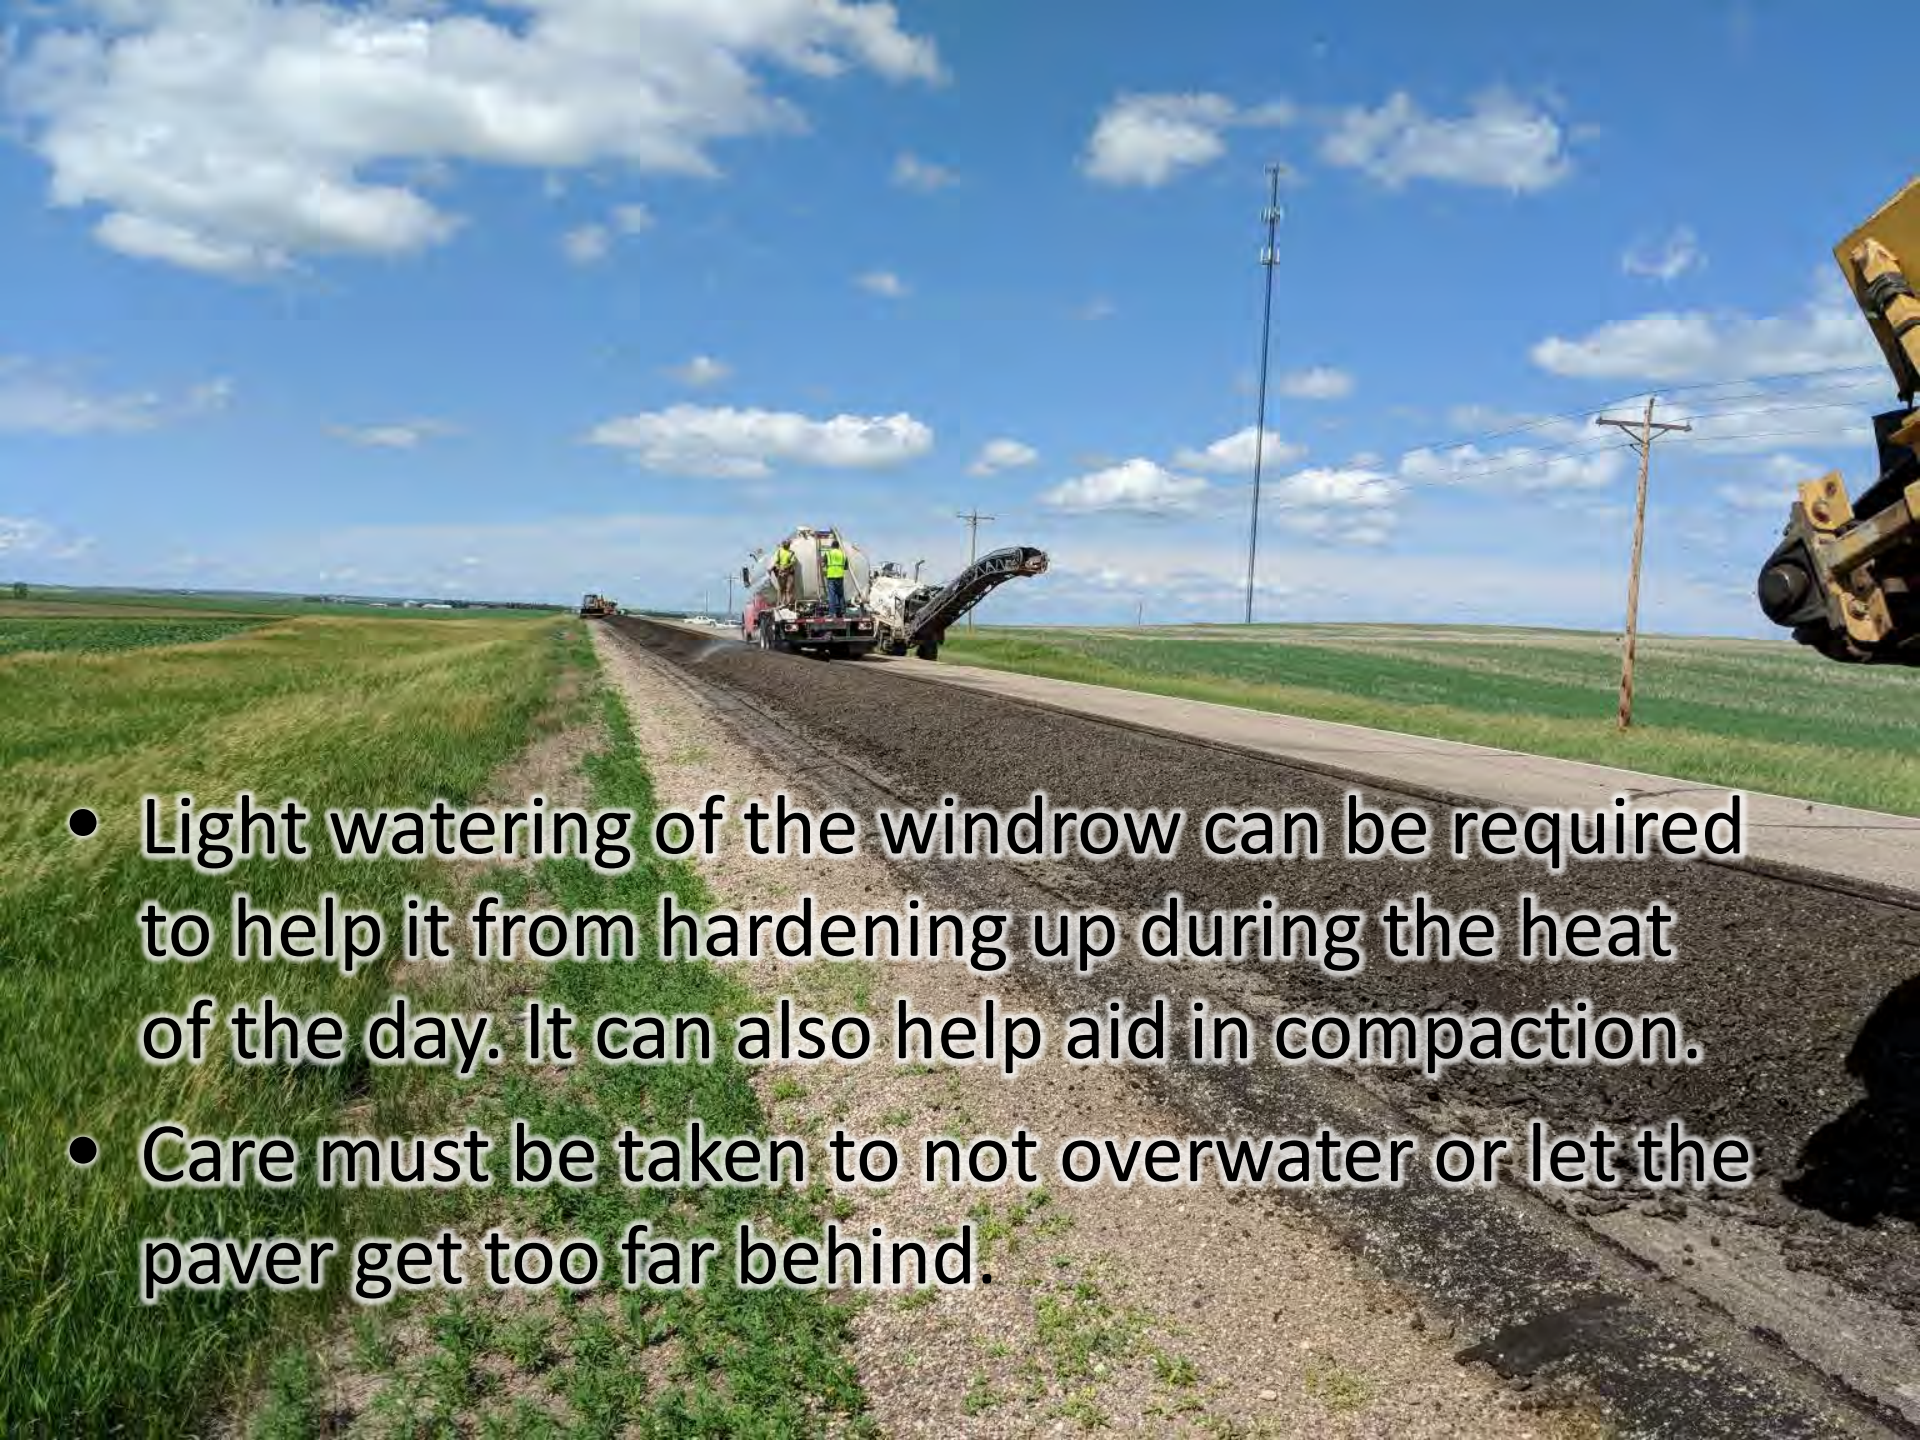
- Light watering of the windrow can be required to help it from hardening up during the heat of the day. It can also help aid in compaction.
- Care must be taken to not overwater or let the paver get too far behind.

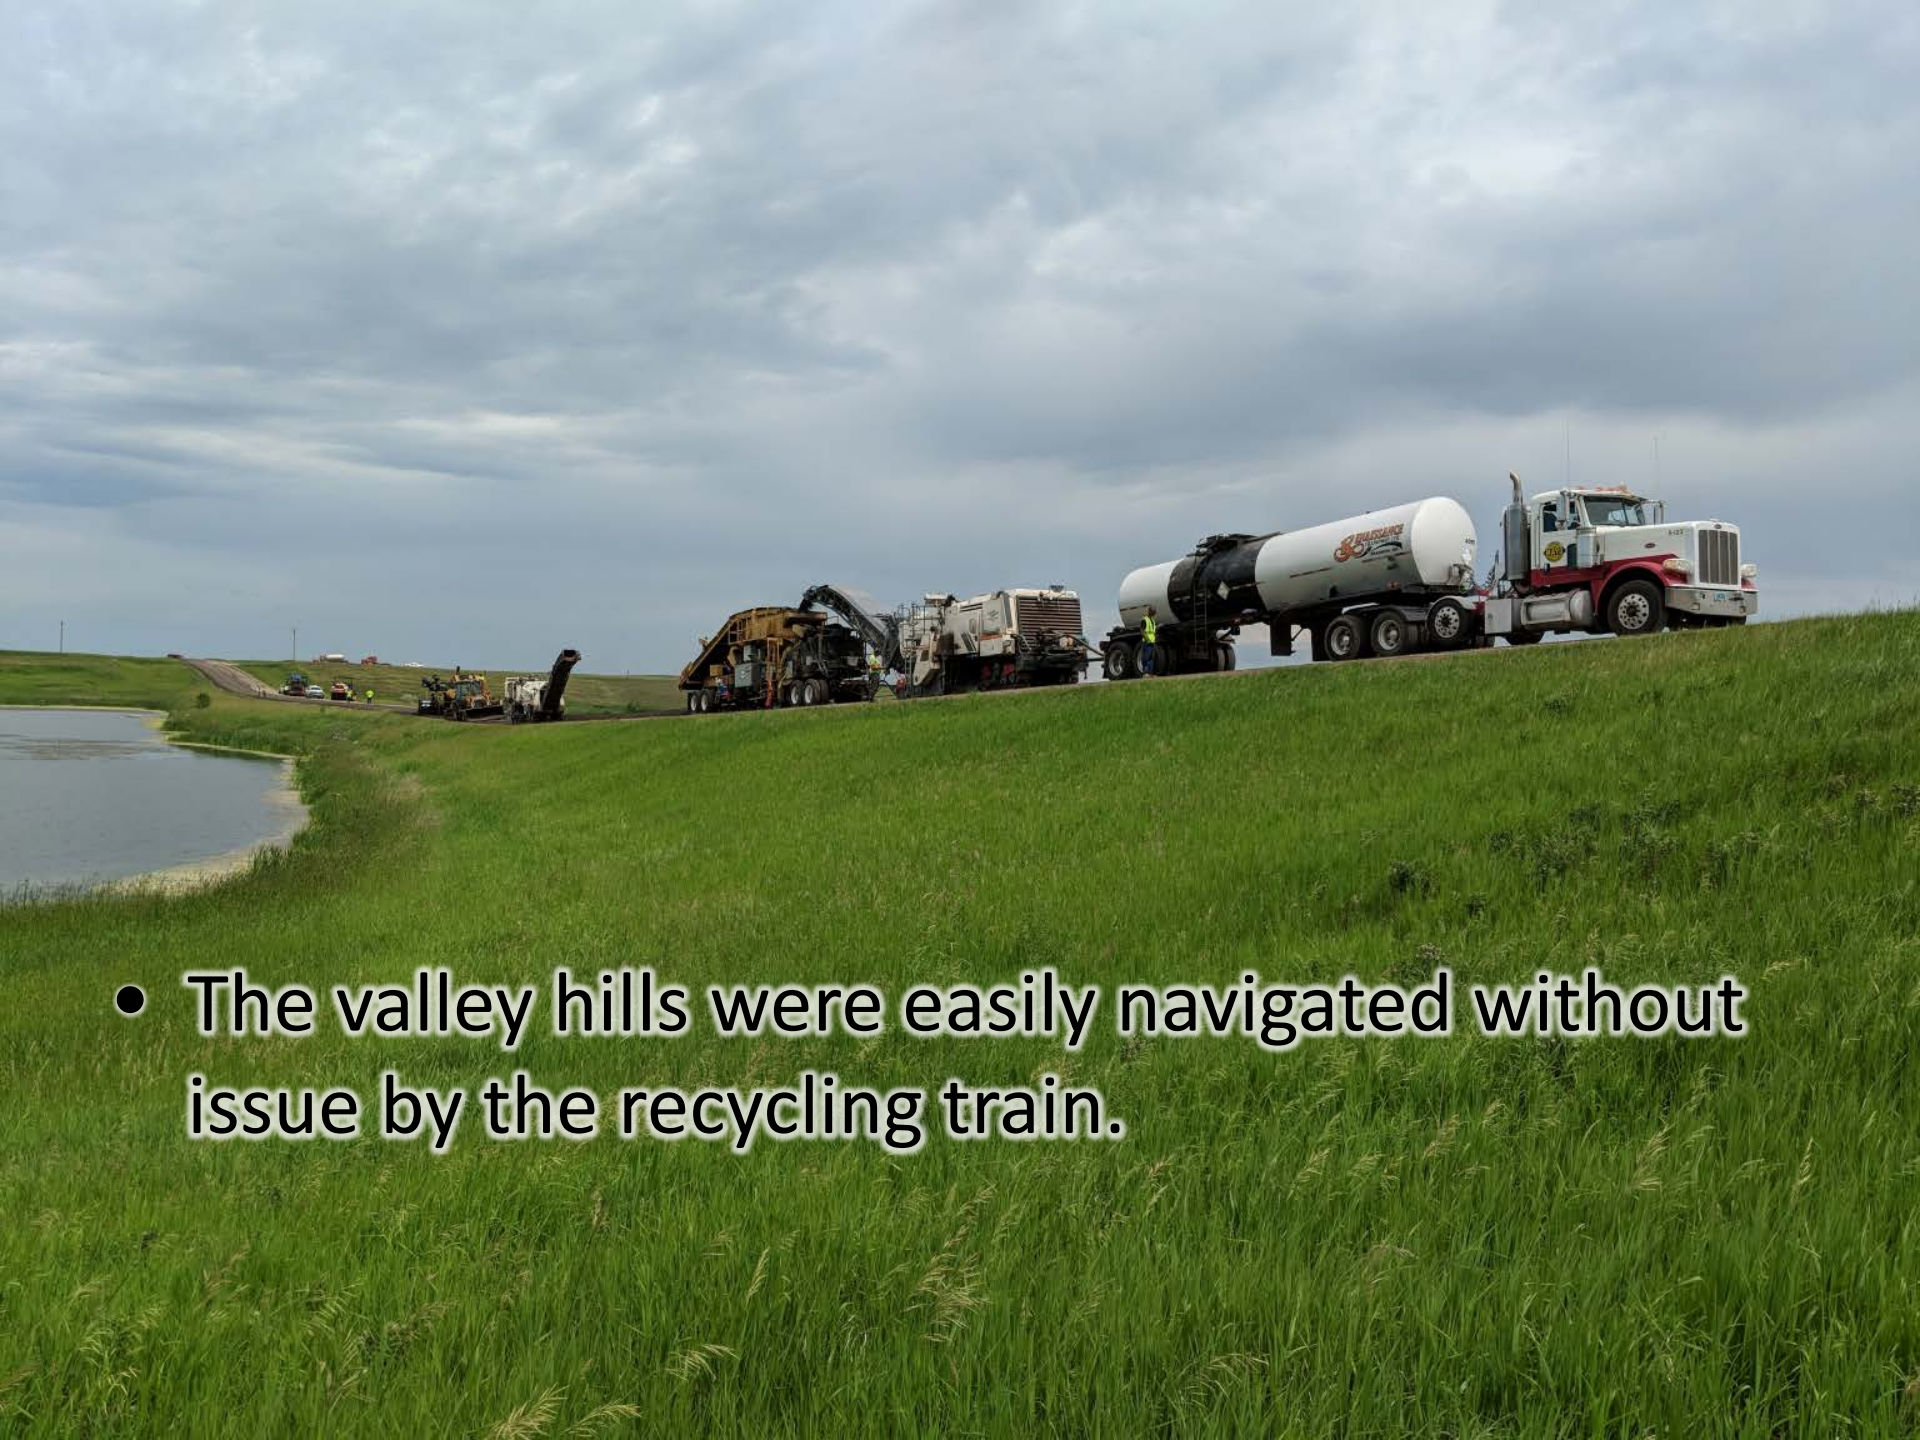
- The valley hills were easily navigated without issue by the recycling train.

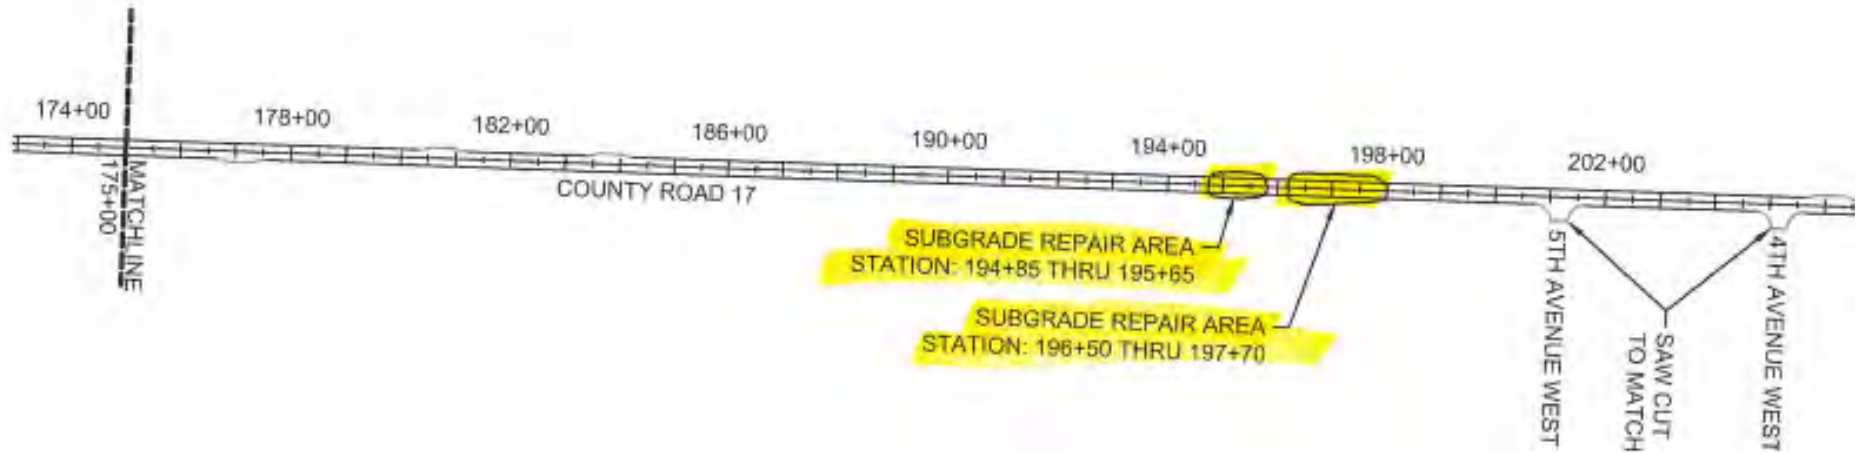
Sub cut

- We ran into 2 localised base problems which were repaired with a thin overlay. Its not uncommon to discover some base issues like this during the CIR process.
