# Bridge Basics 101

Bryon Fuchs, PE – NDLTAP Director  
701-371-3483  
bryon.fuchs@ndsu.edu

**NDSU** UPPER GREAT PLAINS TRANSPORTATION INSTITUTE  
NORTH DAKOTA LOCAL TECHNICAL ASSISTANCE PROGRAM

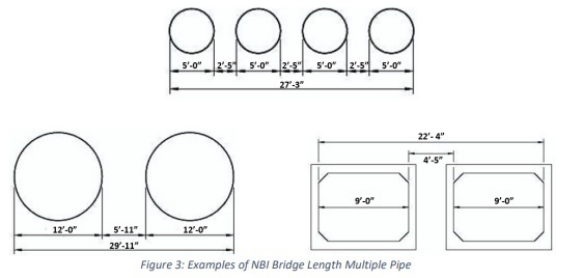
Figure 3: Examples of NBI Bridge Length Multiple Pipe

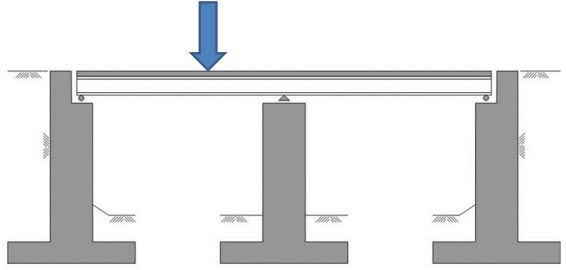
**Deck**

- Portion of the bridge that you drive on

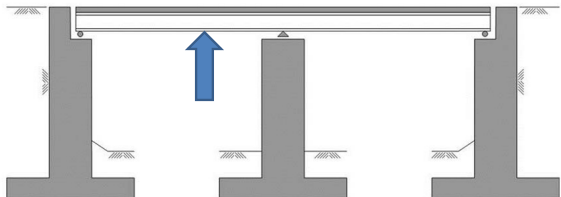
**Superstructure**

- Portion of the bridge that lies directly below and supports the deck
  - Beams, girders, truss, arch

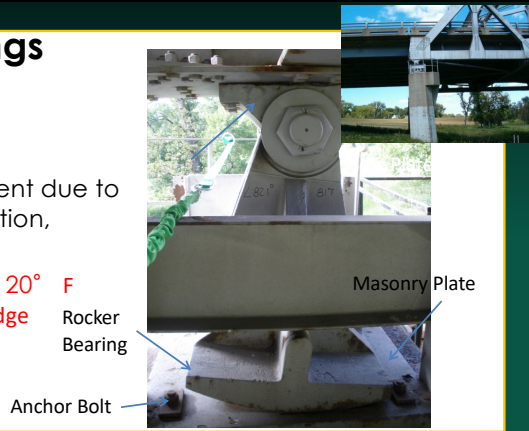
## Bearings

- Transfer loads from Superstructure to Substructure
- Provide for movement due to expansion, contraction, rotation
- $\frac{3}{4}$ " expansion with 120° F temp change - 100' bridge

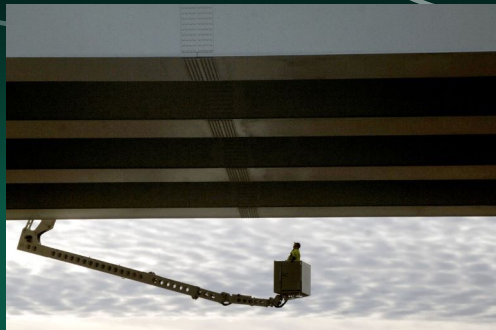
Jake Mertz, with the North Dakota Department of Transportation, maneuvers an aerial lift to reach under the Liberty Memorial Bridge during a routine structure inspection in Bismarck on Monday. The bridge, dedicated on Veteran's Day in 2008, replaced the original 1920 bridge spanning the Missouri River between Bismarck and Mandan. The inspectors look for cracks in the piers, corrosion and light bulb replacement. Burleigh County has 2,985 structures receiving inspections from the department on a two-year rotation. **November 28, 2017 Bismarck Tribune**
